# Hurricane Laura Damage Survey

Timothy P. Marshall<sup>1</sup>  
Haag Engineering Company

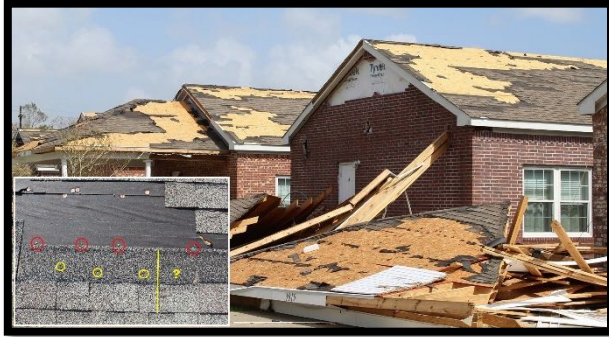
Frequently observed problems were improper attachment of roof coverings, especially when asphalt shingles were nailed too high above the sealant strips. In addition, overdriven fasteners

The combination of high nailing, overdriven fasteners, and fewer fasteners than required resulted in less than half the required number of fasteners in the shingles to resist wind uplift. The result was widespread wind damage to asphalt shingle roofs, particularly on windward slopes. Wind damage included flipped, creased, torn, and removed shingles. Asphalt shingle roofs that were nailed correctly sustained far less wind damage than those roofs where shingles were not installed correctly. Loss of roof coverings and underlayment allowed water ingress which greatly increased the amount of interior damage to residences. Refer to Figure 2.

**Figure 2.** Wind damage to asphalt shingle roof coverings on residences. The inset image shows high nailing (yellow circles) with nails missing top laps in the overlying shingles (red circles).

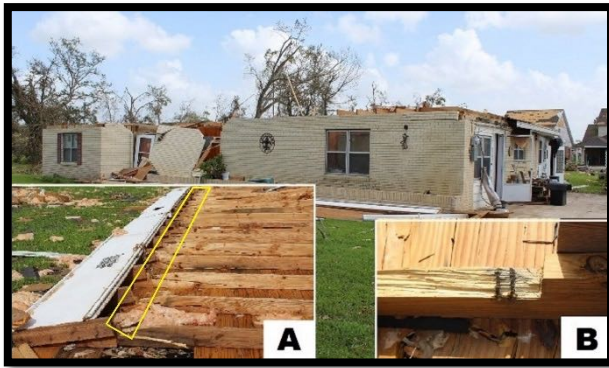
Where roof failures occurred, there was no evidence of metal straps or clips used to attach rafters to wall top plates. Roof failures initiated where rafters were toenailed to wall top plates. Nails were simply pulled out of the wood. Marshall (1983) has shown that toenailed connections are inherently weak against uplift. Tension pull tests on 30, 16d toenailed connections had an average pull-out strength of 1325 N (298 lbs.). There is no doubt that properly installed steel

**Figure 3.** House in Vinton, LA which lost its entire roof. The front side of house faced north and was windward to the strongest winds. Failure of the front doors and windows allowed internal pressure to help lift the roof. Inset image (A) shows upside down roof in the back yard with “birdsmouth” cut outs in rafters (yellow box) and close-up of broken toenailed connection (B) where two parallel rust stains indicate where angled nails had been.

straps would have prevented such roof failures. Pull-out strength of rafter/wall top plate connections secured with steel straps can exceed 5000 N (1124 lbs.).

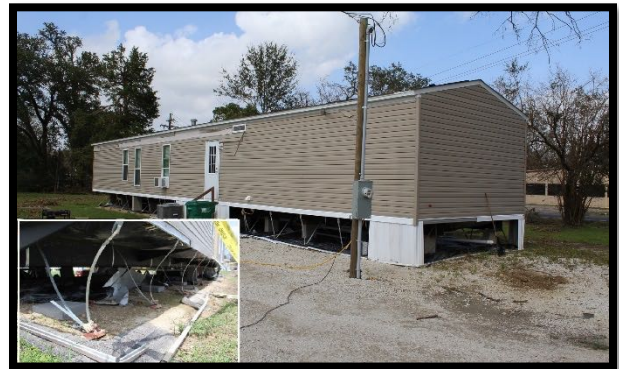
The author examined hundreds of manufactured homes during the damage survey including those in the Oakhurst Mobile Estates on the east side of Lake Charles which contained 256 single-wide homes. Most manufactured homes had both frame ties and over-the-top ties. All 256 homes remained intact on their foundations with no structural damage despite 59 m/s (132 mph) winds recorded at the FCMP tower at nearby Chennault International Airport. However, in many instances, galvanized steel straps were slack, apparently due to rocking movements of the manufactured homes in the wind. These straps will need to be re-tightened. Typical wind damage to manufactured homes included loss of skirting, vinyl siding, and asphalt roof shingles. Proper anchoring of manufactured homes proved they can survive major hurricanes. Refer to Figure 4.

**Figure 4.** Damage to a newer manufactured home with over-the-top and frame ties included loss of skirting, siding, and roofing. The inset image shows slackened ties, apparently due to rocking movement of the home during the hurricane.

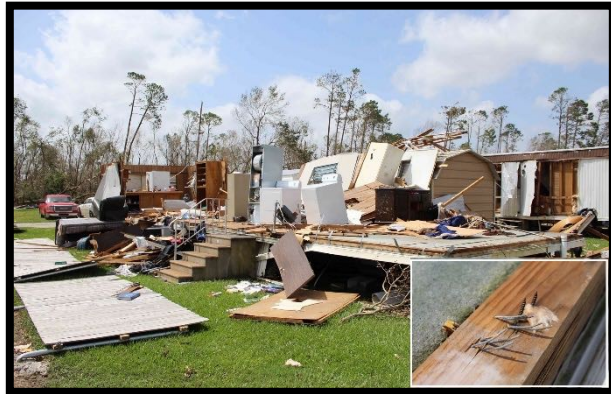
A total of 94 single-wide homes were examined at the Tommasi Mobile Village where the vast majority of homes only had frame ties. Eight homes were destroyed, with complete separation of the wood boxes from the floors; the anchored undercarriages remained in place. Close examination indicated that wall studs were stapled and screwed to wall bottom plates. In 3 of the 8 instances, termites had consumed the wall bottom plates, leaving wall studs hanging from their top plates. In all failed houses, no steel straps were observed between wall studs and the bottom plates

or between the roof structure. Destruction of the 8 manufactured homes was consistent with DoD 6 with expected failure wind speeds around 47 m/s (105 mph). Refer to Figure 5 and Table 2.

**Figure 5.** Separation of the wood box from the floor in this manufactured home. Inset image shows wall studs were secured to wall bottom plates with staples and screws, not steel straps as done today.

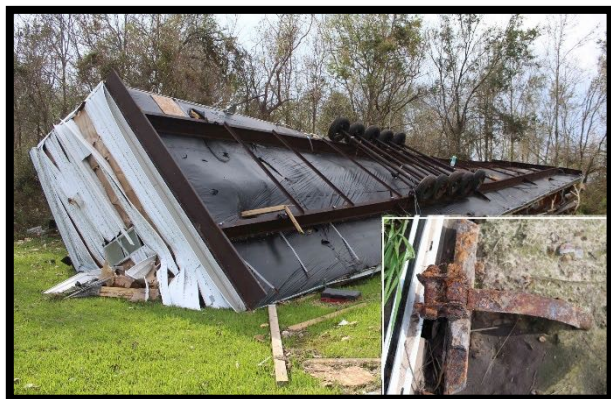
South of Sulphur, LA, there were five manufactured homes which rolled off their concrete block supports. Close inspection revealed all homes had frame anchors, but the steel straps were severely corroded and had broken. Refer to Figure 6. All five manufactured homes were oriented north-south, so they were perpendicular to the strongest hurricane winds from the east. Damage to these units was consistent with DoD 5 for manufactured homes with expected failure wind speeds around 44 m/s (98 mph).

**Figure 6.** Rolled manufactured home. The inset image shows a severely corroded and broken steel strap, along with corroded anchor head and stabilizer plate.

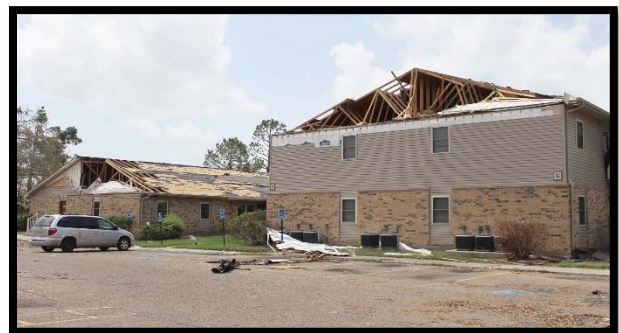
The author conducted detailed examinations of three apartment complexes in Lake Charles. Fairview Crossing consisted of 23 two-story, wood-framed apartment buildings and a one-story, wood-framed office building. Each apartment building, including the office, sustained damage to their east gable ends, including immediate portions of the roof structure. Winds pushed the east-facing gable ends inward and wind entered the attic spaces. Most roof coverings were removed. This level of damage was consistent with DoD 3 in the EF-scale and had an expected failure wind speed of 55 m/s (124 mph). Refer to Figure 7 and Table 3.

**Figure 7.** Failure of east facing gable ends on buildings at Fairview Crossing apartments.

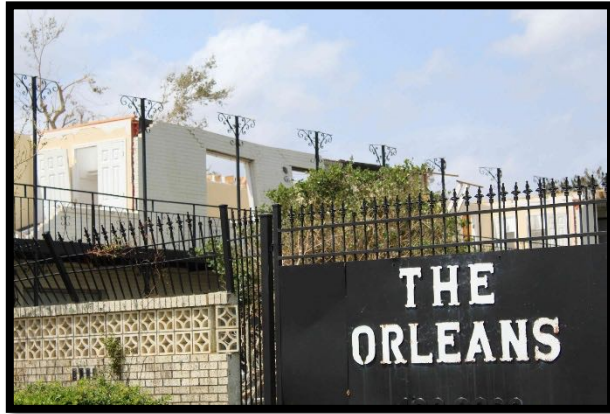
Damage to The Orleans and Bancroft Street Apartments consisted of complete removal of the roof structures. The Orleans apartment building had covered walkways that faced east and south, facing the strongest winds. Both apartment buildings had window glass failures on windward elevations. These window failures resulted in increased internal wind pressures which aided in uplifting these roofs. Rafters were toenailed (not strapped) to wall top plates, and these connections pulled loose as the roofs lifted, leading to their complete removal. Refer to Figures 8 and 9. This level of damage was consistent with DoD 4 in the EF-scale with an expected failure wind speed of 62

m/s (138 mph). However, due to inherent deficiencies, failure wind speeds (covered walkway facing the wind with interior wind pressure contributions) were closer to the lower bound of 54 m/s (120 mph).

**Figure 8.** Loss of the roof structure with an east-facing walkway overhang. Additional lift occurred due to the overhang and to internal pressurization due to broken windows.

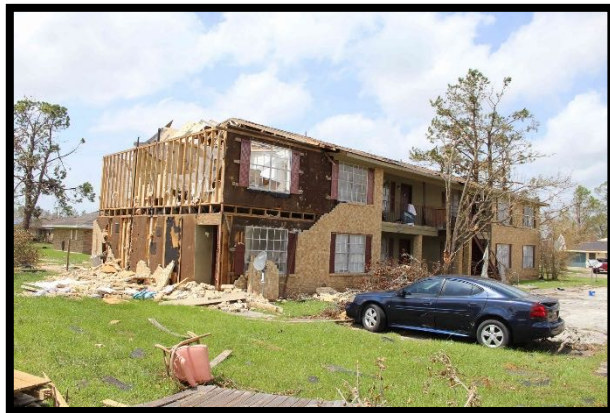
**Figure 9.** Lost brick masonry on south and east walls along with roof removal on an apartment building on Bancroft Street. The car remained in place.

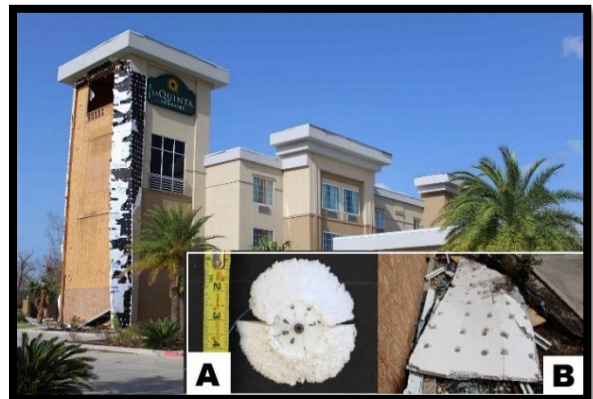
EIFS siding failed on a La Quinta in north Lake Charles along Sampson Street when bead board insulation wall panels pulled off the oriented strand board (OSB) sheathing. EIFS panels were secured to OSB sheathing with screws and plastic disks installed every 30 cm (12 inches). Failure of the EIFS left cone-shaped remnants of the bead board insulation beneath the disks which remained clamped to the OSB sheathing. Refer to Figure 10.

**Figure 10.** Loss of EIFS cladding from the motel. EIFS panels were secured to OSB sheathing with screws and plastic disks. Inset A shows the cone-shaped area of bead board insulation that remained attached to the walls beneath the fastener plate. Inset B shows the back side of the EIFS panel lying on the ground with holes at attachment points.

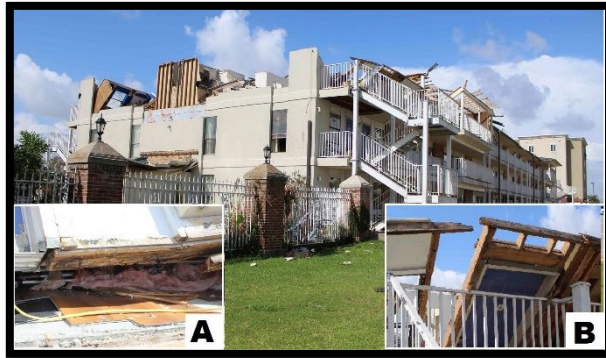
The most severe wind damage in this group of 8 motel buildings occurred to a Motel 6 where a portion of the roof structure was removed at the east end of the building. Close examination revealed wood roof trusses were toenailed to wall top plates and walls were straight nailed to bottom plates (no metal straps). Toenailed connections between the trusses and wall top plates pulled apart

leading to removal of the roof. North and south walls were no longer supported by the roof at the top and pivoted to the north as straight-nailed wall bottom plates pulled out of the concrete. This level of damage was consistent with DoD 6 on the EF-scale with expected failure wind speeds of 55 m/s (123 mph). Refer to Figure 11.

**Figure 11.** Removal of the roof structure at the east end of the Motel 6. Damage included toppling of top story walls. Inset A shows failed wall bottom plate connections. Inset B shows toppling of the north wall.

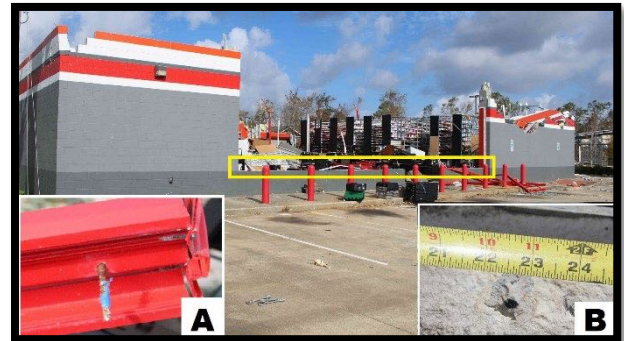
Several small retail buildings sustained catastrophic failures, and two examples are presented here. The Auto Zone store on Nelson Street in Lake Charles had concrete masonry unit (CMU) perimeter walls. A large, store-front metal framed window unit was anchored with screws into grouted cells in the CMU knee wall. Steel roof trusses were anchored to bond beams at the tops of the masonry walls and open web steel joists were welded perpendicular to the trusses. Failure of the window frames from strong east winds led to internal pressurization of the building which helped lift the entire roof structure off the walls. The roof became airborne landing upside down in the back yard of a residence to the west. Refer to Figures 12 and 13. Damage to this building was consistent

with DoD 6 for small retail buildings with expected failure wind speeds of 53 m/s (119 mph). Refer to Table 5.

**Figure 12.** Catastrophic failure of the Auto Zone building occurred when windward window frames blew inward resulting in internal pressurization and removal of the entire roof. The yellow box shows the failure location. Inset A shows where a screw, securing the window frame, simply pulled out of the grouted cell. Inset B shows the small divot in the grouted CMU cell where the screw had attached the window frame.

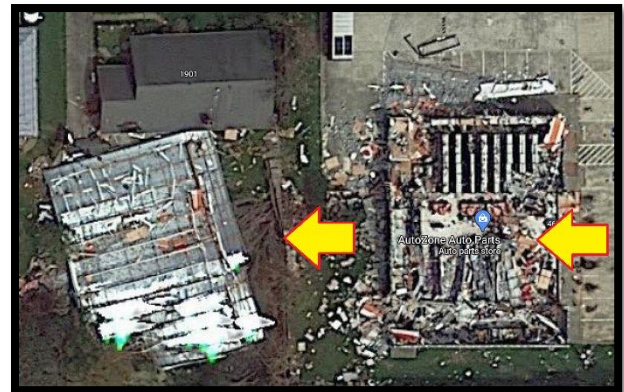
**Figure 13.** Aerial image showing complete removal and flipping of the Auto Zone roof into a neighboring back yard due to internal pressure effects after front window failure. Note the lack of damage to the house. Source: Google.

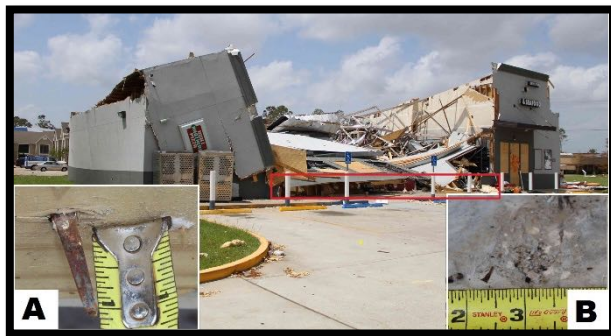
The convenience store at 5<sup>th</sup> Avenue and Prejean Drive in Lake Charles was a wood-framed structure with exterior insulation and finish system exterior (EIFS). The roof was constructed with wood trusses covered with metal panels. Failure of the front east wall frame occurred when cut nails, which attached the wall bottom plates, pulled out of the concrete foundation. This resulted in the wall being pushed inward and allowed wind to

pressurize the building. The roof structure lifted and collapsed due in part to internal wind pressure. The metal roof was folded back from the front. Cut nails never should have been used to attach exterior wall plates to the foundation and was the weak point in this wall system. The author deemed this type of construction to have lower than typical wind resistance and assigned a failure wind speed of 45 m/s (101 mph) in DoD 6 for small retail buildings. In contrast, the steel canopy over the gas pumps sustained only minor fascia damage and no structural damage. Refer to Figure 14.

**Figure 14.** Failure of front (east) wall at this convenience store when the wood frame wall, attached with cut nails. The red box in this image shows where the wall failure initiated. Inset A shows a cut nail protruding from the bottom side of the wall plate. Inset B shows the divot in the concrete slab where the cut nail had been installed.

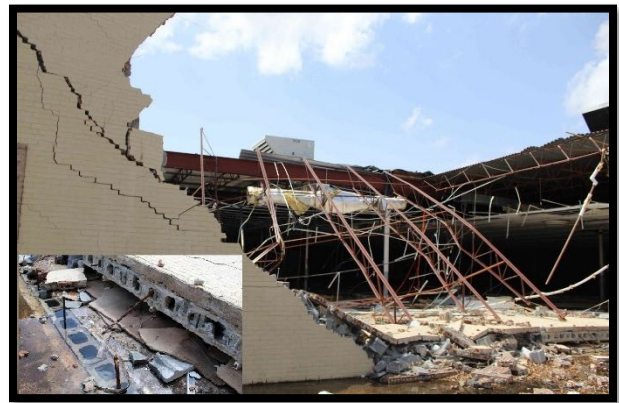
Many strip malls sustained damage during the hurricane. Most of the damage to strip malls involved failure of large window units or cladding on windward sides of the buildings as well as loss of roof coverings. Structural damage to a strip mall at Ryan Street and West Sale Road in Lake Charles involved the east CMU wall toppling into the building. This failure caused the open web steel joists, which supported the roof, to collapse. Wall and foundation rebar were present in ungrouted

cells. Foundation rebar extended 10 inches above the concrete slab while wall rebar extended up to 20 inches below the concrete slab. Depth of the rebar became visible when the wall failed. This degree of damage was between DoD 4 and 7 in the strip mall DI indicating a median failure wind speed of around 49 m/s (110 mph). Refer to Figure 15 and Table 6.

**Figure 15.** Collapse of the east-facing loadbearing wall on a strip mall. Inset image shows wall and foundation rebar at the base of toppled wall.

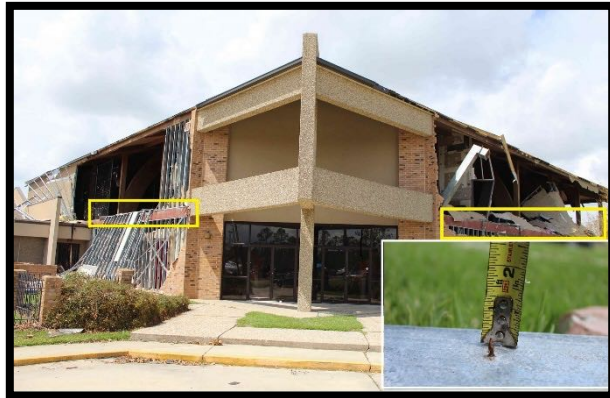
The author inspected several church buildings in Lake Charles classified as low-rise buildings in the EF-scale. Most churches sustained damage to steeples, wall cladding and roof coverings. There was a significant wall failure to the sanctuary of the Glad Tidings church at the intersection of East College and Texas Street. This two-story, steel-framed structure had perimeter steel stud walls enclosed with brick masonry. Steel studs were nailed into steel I-beams. The nails extended only 1.3 cm (1/2 inch) into the steel. This wall attachment had little lateral resistance and the connections failed at the bases of the walls. Strong winds pushed the northeast wall inward and the

southeast wall outward. Some wind damage occurred to the roof covering. The sanctuary structure remained intact. Applying the low-rise building DI in the EF-scale, DoD 3 would be closest to describing this damage, but failure wind speeds were determined to be at the lower bound of 37 m/s (83 mph). Refer to Figure 16 and Table 7.

**Figure 16.** East side of the Glad Tidings church building showing second story wall failures. Cold formed steel bottom plates were nailed into the underlying steel I-beams and simply pulled out of the steel (yellow boxes). The inset image is a close-up view of a protruding nail in the upside-down wall bottom plate.

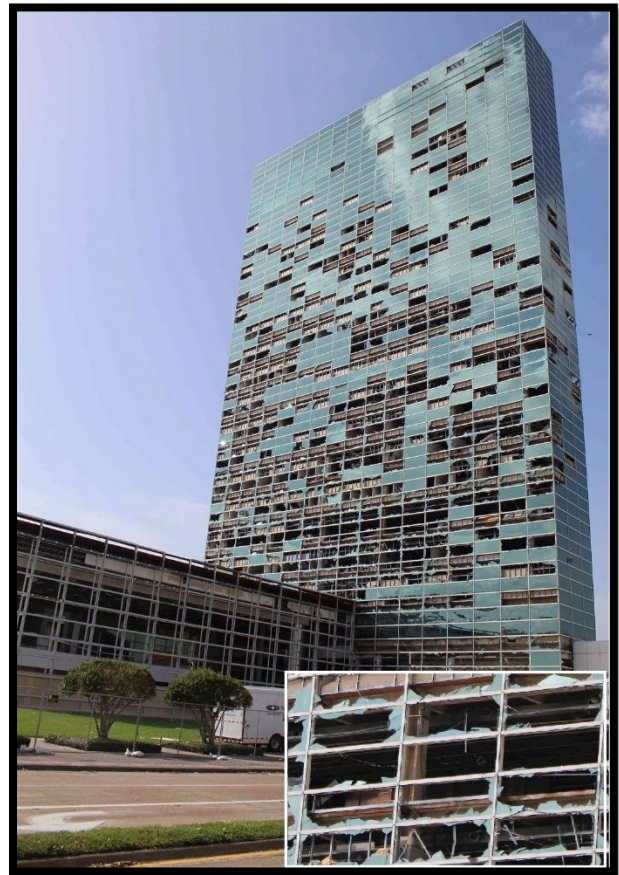
The Capital One Tower in downtown Lake Charles is the tallest building in the city with the rooftop elevation being around 95.7 m (314 ft). This 22-story, glass clad, steel-framed structure, built in 1981, had experienced several hurricanes. Storm chaser video taken from the adjacent parking garage during Laura showed glass breakage began in the northern eyewall and quickly escalated. Glass failure was attributed to the combination of glass type, wind pressure, flying/falling debris, and perhaps design/installation issues. Glass breakage was much less severe during Hurricane Rita in

2005. Peak wind gusts during Rita were around 49 m/s (109 mph) in Lake Charles, providing a good point of reference as to the wind speeds necessary to initiate damage. The level of damage in Rita was consistent with DoD 4 in the EF-scale with expected failure wind speeds of 45 m/s (101 mph). However, winds during Laura were stronger, resulting in more damage. In this case, wind duration caused cascading failures of windows breakage, as broken glass shards struck and broke additional windows. Refer to Figure 17 and Table 8.

**Figure 17.** Extensive glass breakage on a high rise in downtown Lake Charles.

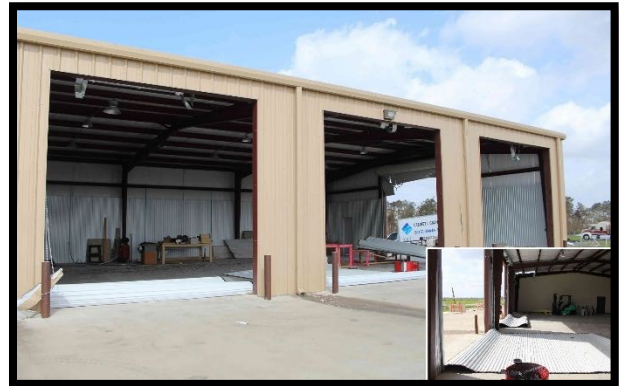
The author inspected more than a dozen metal building systems (MBS) from Vinton to Sulphur to Lake Charles, LA. The most common damage was to roll up door systems. Failures of roll up doors on building windward sides led to building pressurization unless leeward side doors also failed. Where opposing doors failed, there was little or no structural damage to the steel framing or cladding. Roll up door failures on opposite sides of buildings prevented internal pressure build-up. Failures of roll up doors are listed as DoD 2 on the EF-scale with expected failure wind speeds of 40 m/s (89 mph). Refer to Figure 18 and Table 9.

**Figure 18.** Failure of overhead doors on the windward (east) side of this metal building resulted in outward failure of the north side door. The building frame and cladding remained undamaged. The inset image is a closer view of the failed doors.

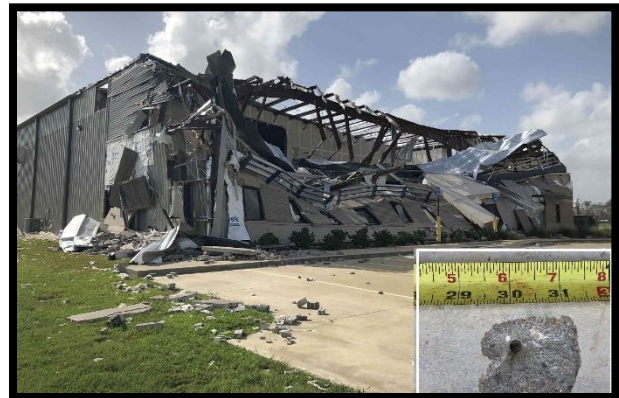
Five metal building systems (MBS) at the Calcasieu Industrial Park in Sulphur, LA, sustained various degrees of damage ranging from damage to roll up doors to complete building collapse. One building in this Industrial Park sustained complete failure of the windward (east) end wall. Close examination revealed shot pins were fastened to cold formed steel bottom wall plates into the concrete foundation. End wall failure occurred when the shot pins securing the east wall bottom plate pulled out of the slab, leaving spalled spots of concrete at 76 cm (30 in) intervals. Removal of roof and wall cladding was limited to the easternmost bay. This level of damage was consistent with DoD 3 and expected failure wind speeds of 42 m/s (95 mph). Refer to Figure 19.

**Figure 19.** End wall failure on the windward side of this metal building system. The cold formed steel base plate was shot pinned to the concrete foundation and was a connection too weak to resist lateral wind loads.

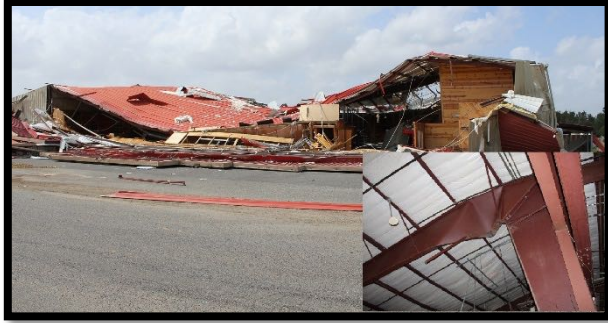
A collapsed metal building in Vinton, LA experienced peak wind gusts of around 45 m/s (100 mph) out of the north. The north end wall blew in, and the south end wall blew out, and the center of the building collapsed. Plastic hinges developed in beams adjacent to stiffened beam-column connections, and the columns rotated inward. This building collapsed during winds far below expected failure wind speeds of 70 m/s (155 mph) as listed in the EF-scale. It was suspected that the building design/construction did not conform to ASCE 7 wind loads. Refer to Figure 20.

**Figure 20.** Collapse of a metal building system in Vinton, LA. The north wall blew in, and south wall blew out. The inset image shows plastic hinges developed on the beam (rafter) side of the stiffened beam-column connection.

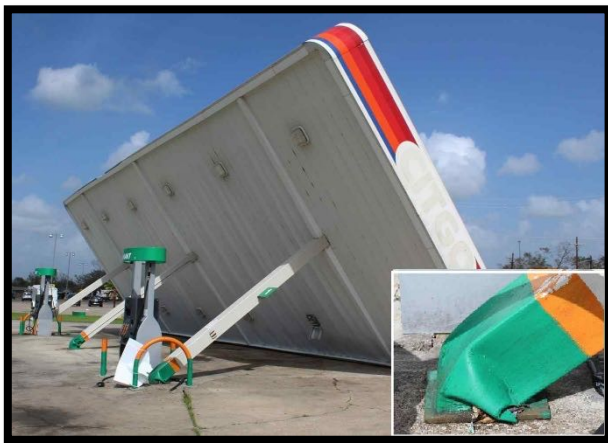
Damage to service station canopies usually involved removal of cladding and roof panels. However, several canopies toppled in the strong winds. Single column line canopies were prone to tipping over. Plastic hinges formed at the bases of the columns. According to the EF-scale, this level of damage (DoD 4) was consistent with expected failure wind speeds of 49 m/s (109 mph), about ten percent higher than the peak winds experienced at this location based on the level of the surrounding damage. Refer to Figure 21 and Table 10.

**Figure 21.** Toppled single column canopy in Vinton, La from strong north winds. The inset image shows plastic hinge formation at the base of the tubular steel column.

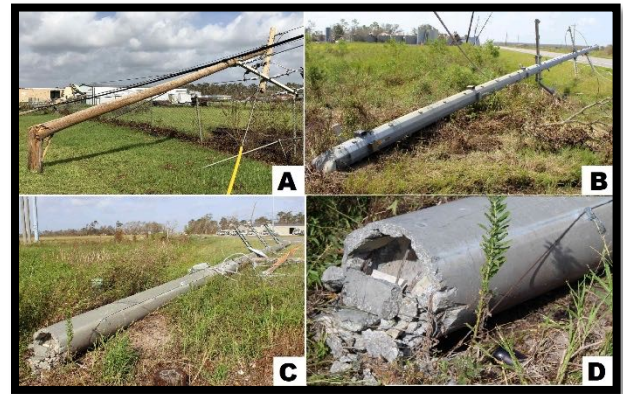
There was widespread damage to electrical transmission lines during Hurricane Laura. It did not matter whether poles were wood, concrete, or steel. All pole types failed, failing mostly at their bases. Refer to Figure 22. According to the EF-scale, toppling of wood poles (DoD 4) has an expected failure wind speed of 53 m/s (118 mph). Refer to Table 11. However, toppling of steel and concrete poles (DoD 5) listed in the EF-scale has an expected failure wind speed of 62 m/s (138 mph). The author believed these failure wind speeds were about ten to twenty percent higher than necessary to fail these poles.

**Figure 22.** Broken poles: A) wood, B) steel, and C) concrete with D) showing a close-up view of a failed concrete pole at ground level.

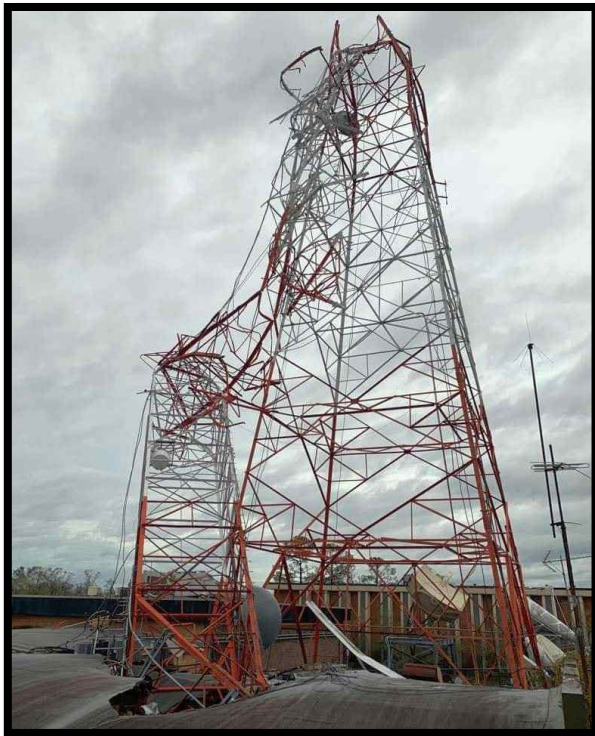
**Figure 23.** Collapsed four-legged tower at KPLC TV in Lake Charles.

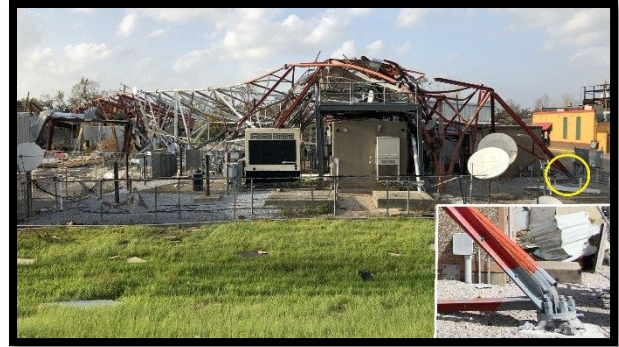
The three-legged steel tower at KSWL fell northwest, striking two adjacent buildings. Tower legs were solid steel sections that tapered in width with increasing height above the ground. Refer to Figures 24 and 25. In the EF-scale document, collapse of a microwave tower is listed as DoD 3 with an expected failure wind speed of 61 m/s (136 mph), a number slightly higher than the peak winds measured during the hurricane.

**Figure 24.** Toppled three-legged tower at KSWL TV in Lake Charles. The inset image is a closer view of the base of the bent leg, inside the yellow circle in the main image.

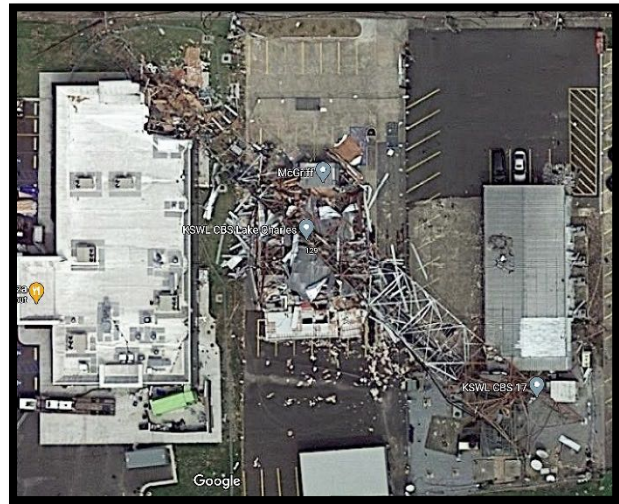
**Figure 25.** Aerial image showing the KSWL TV tower which fell northwest striking two adjacent buildings. Source: Google.

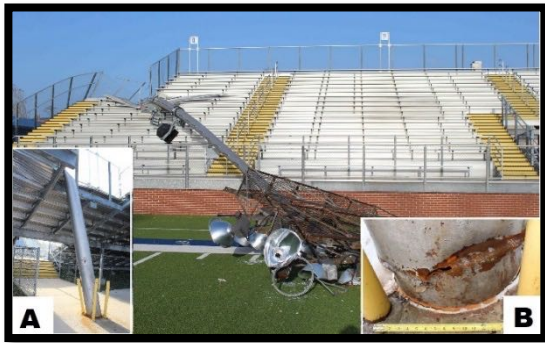
embedded into concrete piers. All light poles buckled at their bases falling southwest. Refer to Figure 26. According to the EF-scale, toppling of such poles (DoD 3) would yield expected failure wind speeds of 53 m/s (118 mph). However, given the large array of lights at the tops of the poles and presence of corrosion at pole bases, the expected failure wind speeds probably were closer to the lower bound of DoD 3, or near 45 m/s (99 mph). Refer to Table 13. By comparison, the FCMP tower in Sulphur, LA recorded a peak gust of 49 m/s (110 mph).

**Figure 26.** Topped tapered steel light poles at the high school stadium in Sulphur, LA. Poles buckled at their bases then bent again when hitting the stands (inset A). Close examination of the pole bases revealed corrosion (inset B).

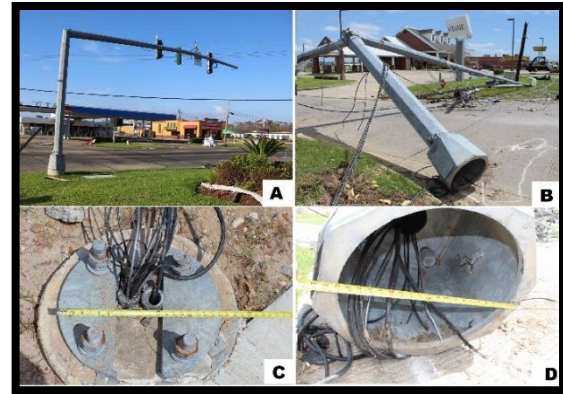
One universal success story was the many cantilevered steel poles with luminaries (traffic signals) designed to vane in the wind. These poles had slip plates securing their pedestals. In strong winds, these poles simply pivoted downwind, thereby saving them from severe damage. However, one cantilevered pole did fail. Close examination revealed the slip plates were not tightened sufficiently, causing the pedestal and cantilevered pole assembly to topple. Refer to Figure 27.

**Figure 27.** Light poles vane in the wind, pivoting about their bases (A). Failure of one pole exposed the slip plates which allowed the pole/pedestal to rotate in the strong winds (B through D).

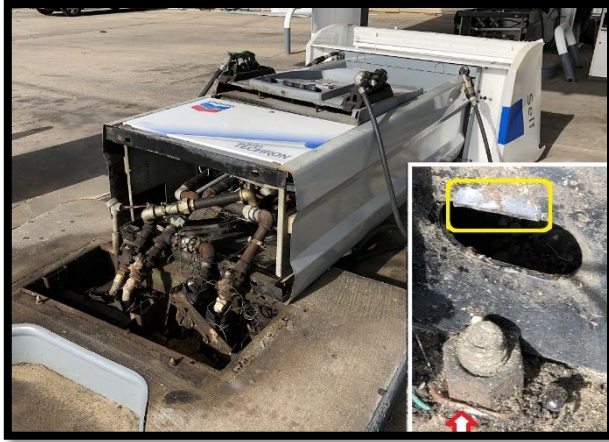
The author conducted a detailed inspection of toppled gasoline pumps at the Chardele Auto and Truck Plaza located at the intersection of East Ward Line Road and Fruge St. in Lake Charles. The gasoline pumps were anchored to pairs of steel angles that contained holes used to secure anchor bolts into the underlying concrete. Steel washers on the anchor bolts bridged the holes in the steel angles. However, the washers were too small and had little bearing. As a result, edges of the washers bent upward slightly while corresponding edges of the holes in the angles were bent downward slightly. These small deformations resulted in the gasoline pumps becoming detached from their foundations under lateral wind loading. Other gasoline pumps had corroded steel angles that failed around the anchors. Refer to Figure 28.

**Figure 28.** A toppled gasoline pump. The inset image shows a close-up of the bolted connection at the base of the pump. Note the slight downward deformation in the steel angle (yellow circle) and slight upward deformation in the steel washer (red arrow).

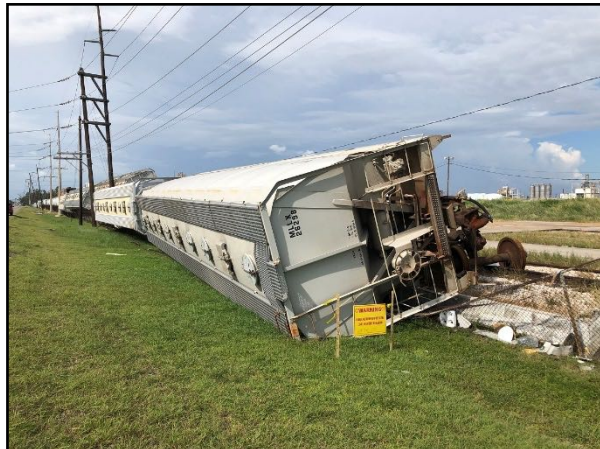
At least four trains at the Citgo Refinery in Sulphur, LA had boxcars topple to the west. The boxcars were oriented north-south and were broadside to the strongest hurricane winds. A total of 7 boxcars overturned while the remaining cars remained upright. According to the FCMP tower in Sulphur, peak wind gusts were 96 kts (110 mph) out of the east. Refer to Figure 29.

**Figure 29.** Overturned boxcars at the Citgo Refinery in Sulphur, LA. The cars were oriented north-south and toppled to the west with the strongest winds being from the east.

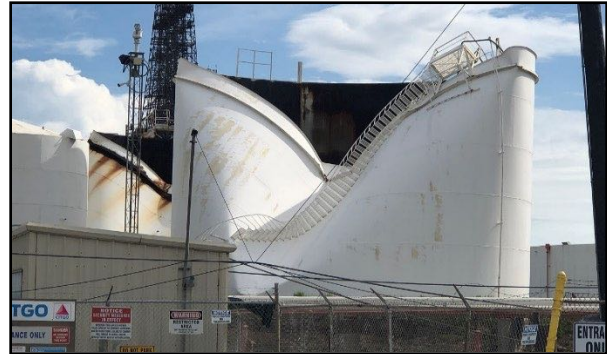
The shells of two smaller oil tanks buckled inward at the Citgo Refinery in Sulphur, LA during the hurricane. Both tanks were near empty at the time and their plunger type roofs were positioned near the bottoms of the tanks. Thus, steel walls of the tanks were not supported laterally by their roofs. Both tanks buckled on their northeast (windward) sides. Refer to Figure 30.

**Figure 30.** Buckled oil tanks at the Citgo Refinery in Sulphur, LA.
