Performance of Manufactured Housing in Louisiana during Hurricanes Katrina and Rita

Kirby Hebert¹, Marc Levitan²

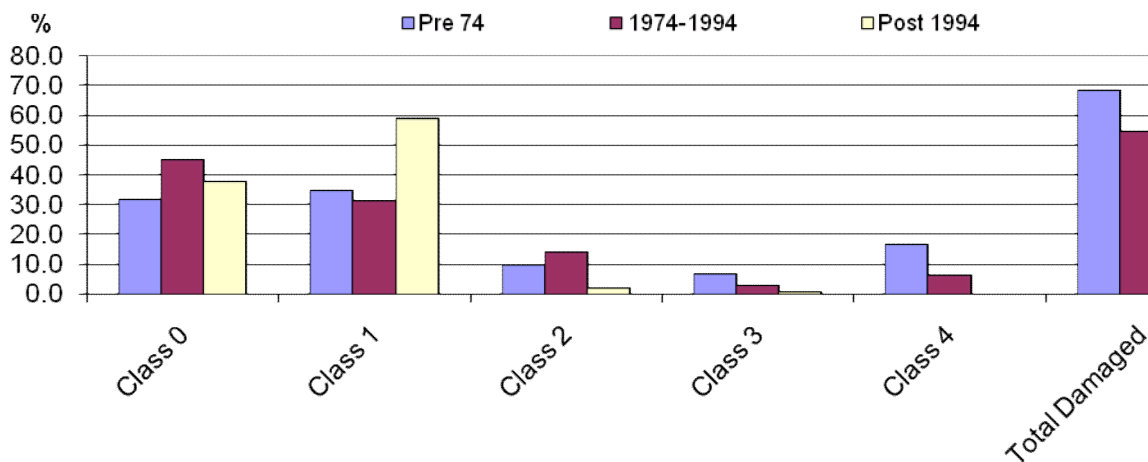
Figure 5: Damage Analysis by Class and Category for all Detailed Surveys

The pre-1974 group experienced damage to 68.3% of the units in the group. There was also an increase in the damage intensity, as indicated by the classes of damage. Total destruction occurred in 16.7% of the units and all other classes of damage were higher than both newer groups except for Class 1 when compared to the post-1994 group for the same reason previously mentioned, and the Class 2 damage when compared to the 1974-1994 group. Class 3 and Class 4 damage in the pre-1974 group are both more than double the values for the 1974-1994 group. The bar chart in Figure 5 compares the overall damage by class and age.
