Tech Notes

MECHANICAL SYSTEMS

Replicating Historic Elevator Enclosures

GUARANTY BUILDING Buffalo, New York

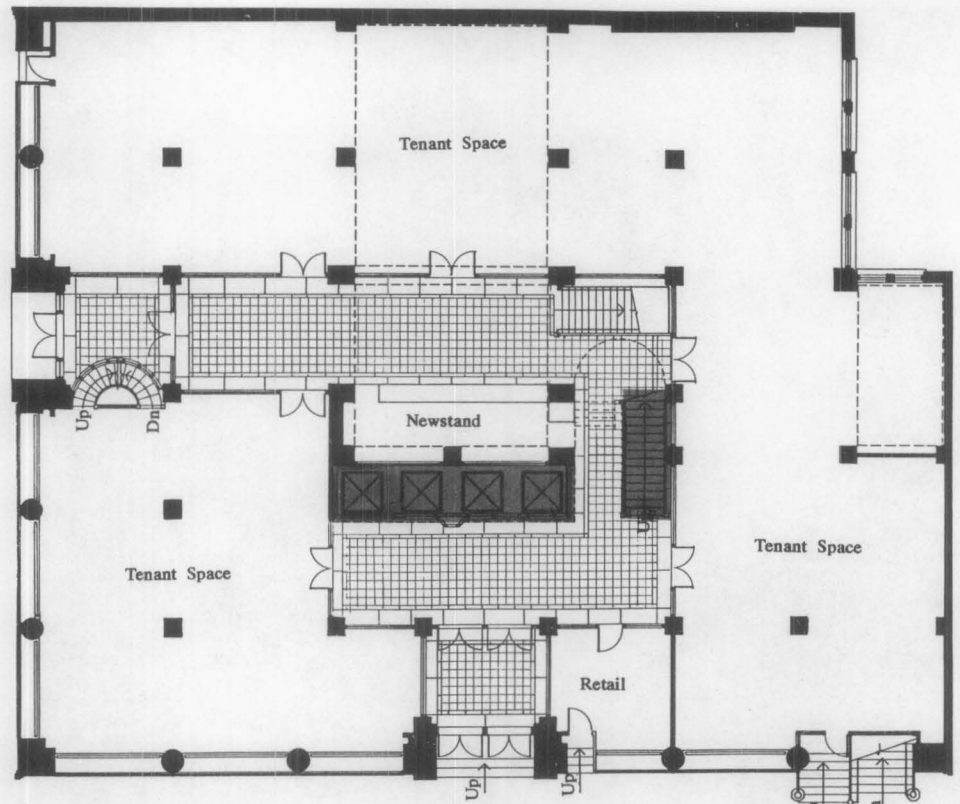
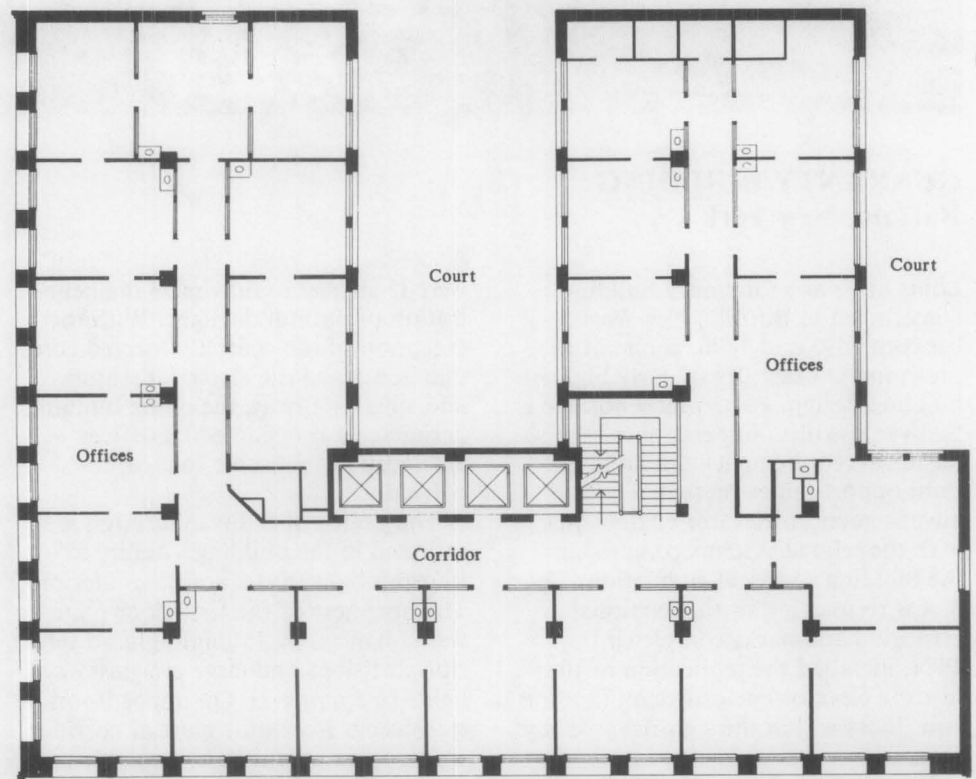
Figure 1. First and typical upper floor plans, 1897. Extensive skylit circulation area on the first floor and glazing at corridor partitions contributed to the building's openness and transparency. Drawing: Cannon, Javier Salazar.

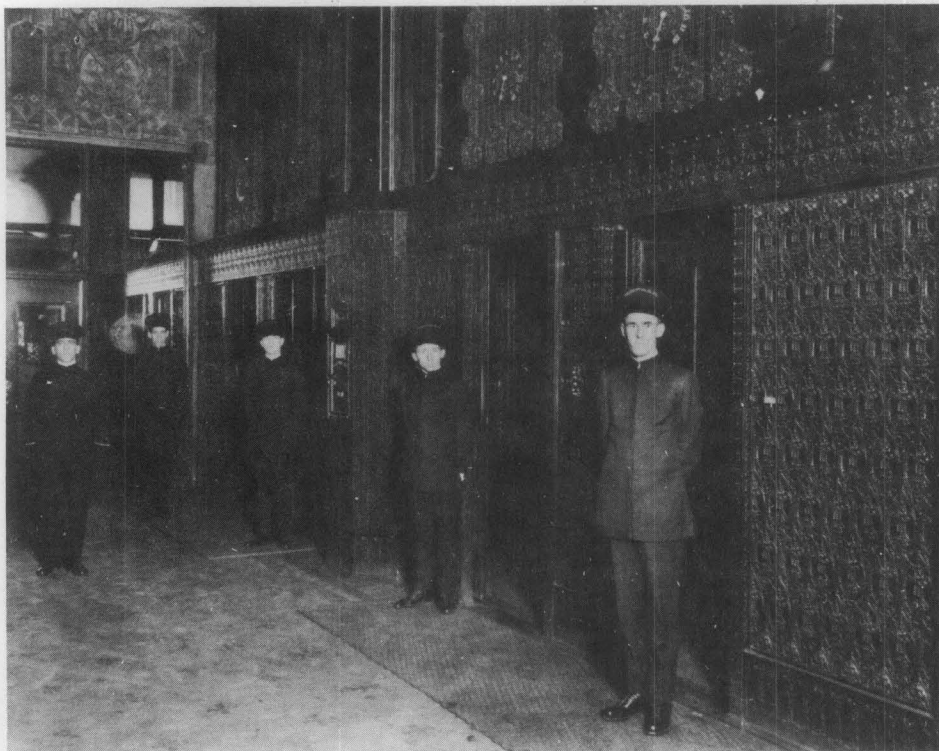
Figure 2. First floor elevator lobby, c. 1897, from northwest. Photo: United Founders Life Insurance Company of Illinois.

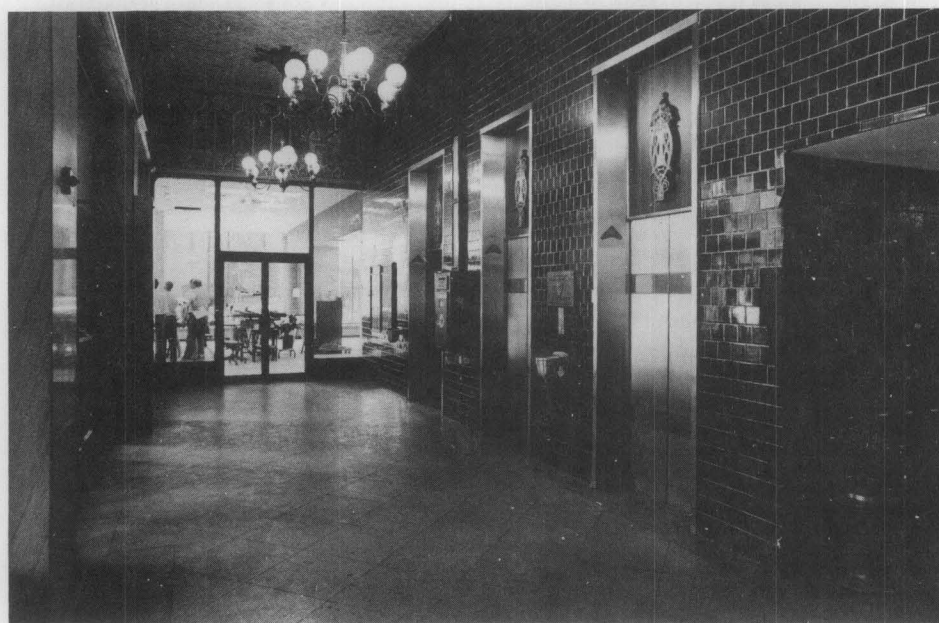
The 1962 changes had a major impact on Sullivan's original design. The four 1903 cabs were replaced with a 3-cab, electrically powered system, with the remaining shaft left vacant for future use. The glazed elevator cabs were replaced with fully enclosed ones, and the open elevator shaft and single stairway were enclosed with two-hour, fire-rated masonry walls (see figure 3). Throughout the building, almost all elevator ornament was removed, leaving only a small piece of the elevator framework exposed within

Figure 3. First floor elevator lobby, c. 1962. Modifications included reduction in number of elevators and addition of masonry enclosure around open elevators and main building stair. Photo: Cannon.

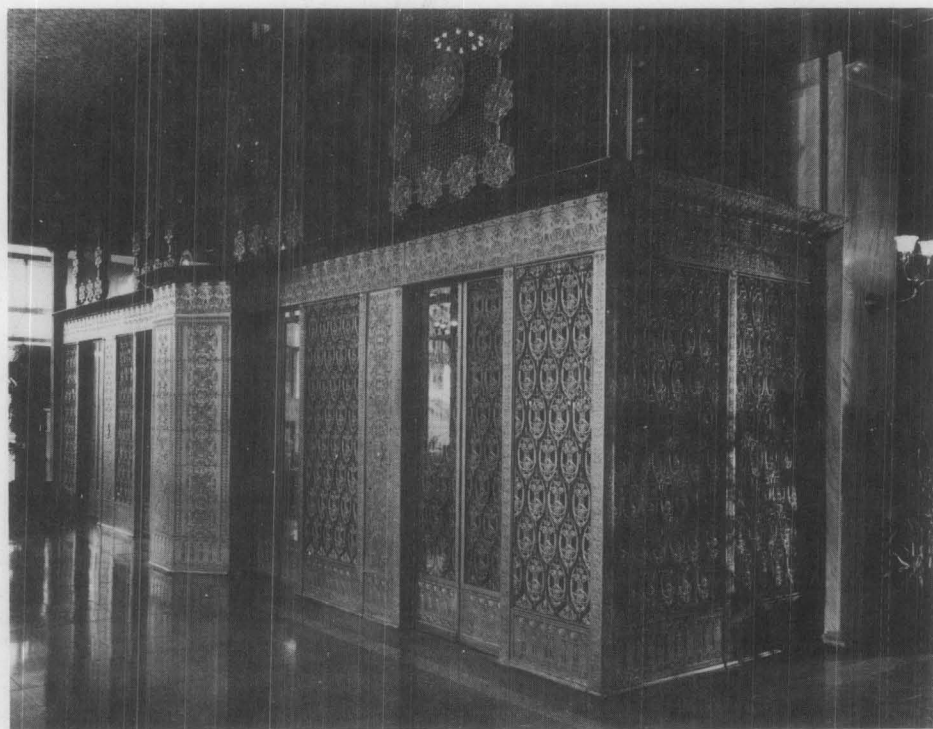
Figure 4. First floor elevator lobby as restored, 1984, showing the replicated cast ornament on the elevator enclosure, with sprinkler heads discreetly placed to protect elevator cabs. The elevator door far left (number 4) is inoperable since the cab and equipment had been removed in 1962. Photo: Patricia Layman Bazelon.

At the first and second floor levels, the elevator enclosures and original lobby floor plans were restored (see figure 4). Replication of all elements comprising the enclosures required the recasting of new elements in molds taken from original samples. Cast iron was used (as had originally been specified by Sullivan), and throughout the casting and finishing processes the architects worked closely with the artisans at the foundry. Only a few surviving elements were able to be refinished and reused.

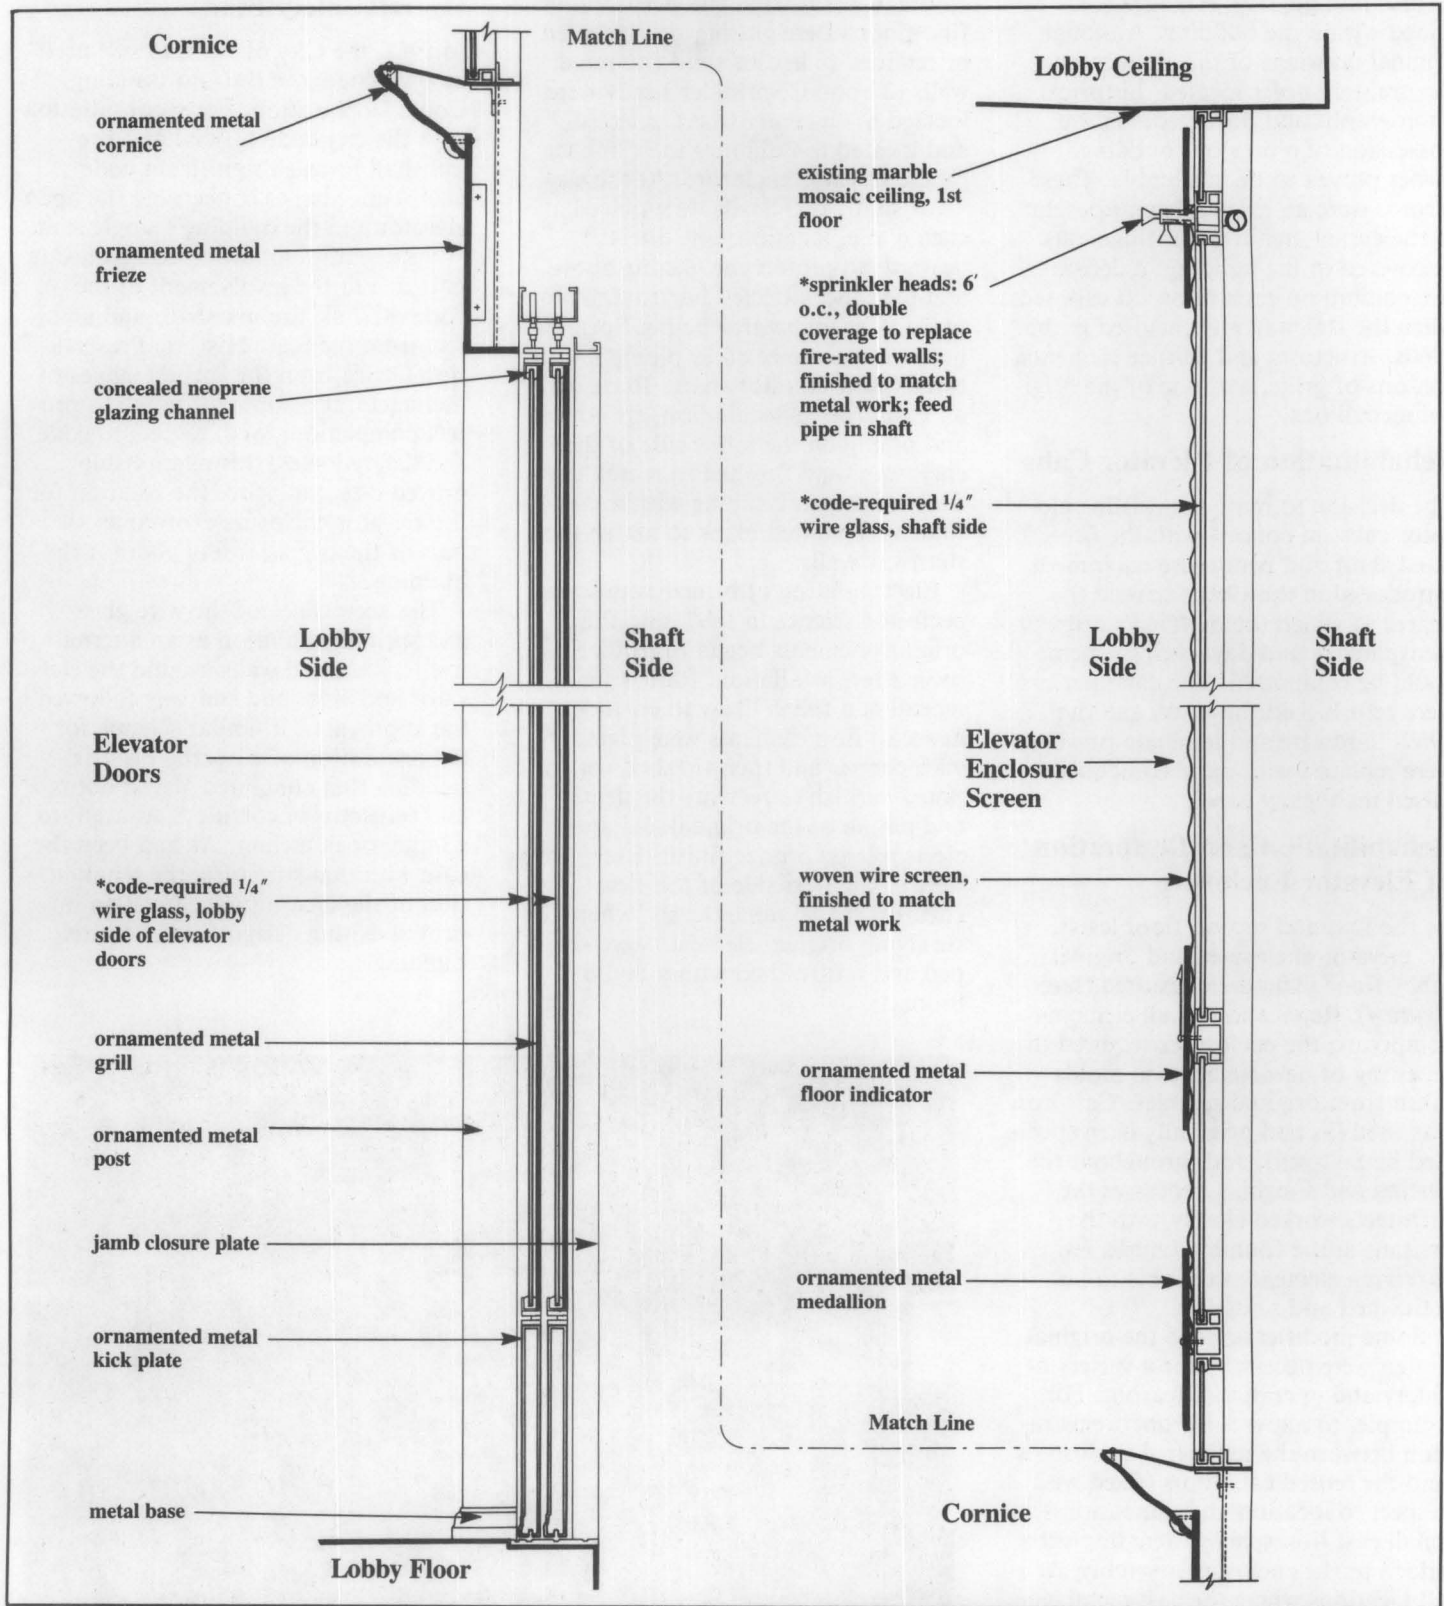
Figure 5. The reconstruction of the elevator enclosures was a complex integration of code-required features (marked by an *) and architectural elements. Wire glass and double-coverage fire sprinklers replaced fire-rated walls while retaining the quality of light in Sullivan's original design. The metal ornament was reproduced in copper-plated cast iron and finished with a tinted varnish to match the original bronze electroplated finish.

Some modifications to the original design were necessary for a variety of safety and operational reasons. For example, to allow for proper registration between the replicated enclosures and the reused cab doors (fixed with respect to location and dimensions), small cast iron spacers were discreetly added to the enclosure assembly. At all locations where the cast metal elevator enclosures was fixed, 1/4" wire glass was installed on the shaftway side with a specially designed, concealed glass gasket. The portion of the enclosure that opened with the elevator doors was double faced with wire glass installed on the lobby side as added protection (see figure 5).

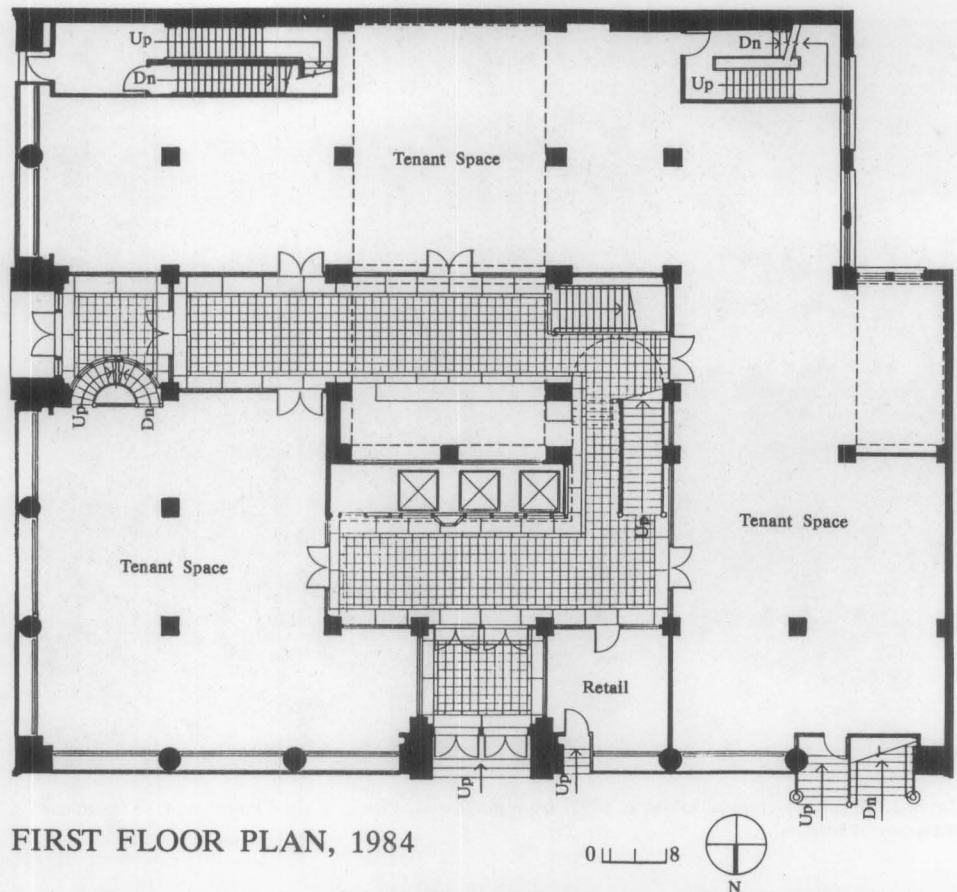
FIRST FLOOR PLAN, 1984

Figure 6. First floor as restored, 1984. With the exception of two new exit stairs added at southeast and southwest corners, the first floor has been faithfully restored to its 1897 appearance, including the 4-bay elevator enclosure. Drawing: Cannon, Javier Salazar.

New stairs exiting directly to the outside were unobtrusively added at the southeast and southwest corners of the building (see figure 6). The stairs at the southwest connected to the building's original open stair; at
