MILLS NOS. 5, 6 and 8 Suffolk Manufacturing Company (Wannalancit Office and Technology Center)

Lowell, Massachusetts

WINDOWS NUMBER 13

Aluminum Replacement Windows with Sealed Insulating Glass and Trapezoidal Muntin Grids

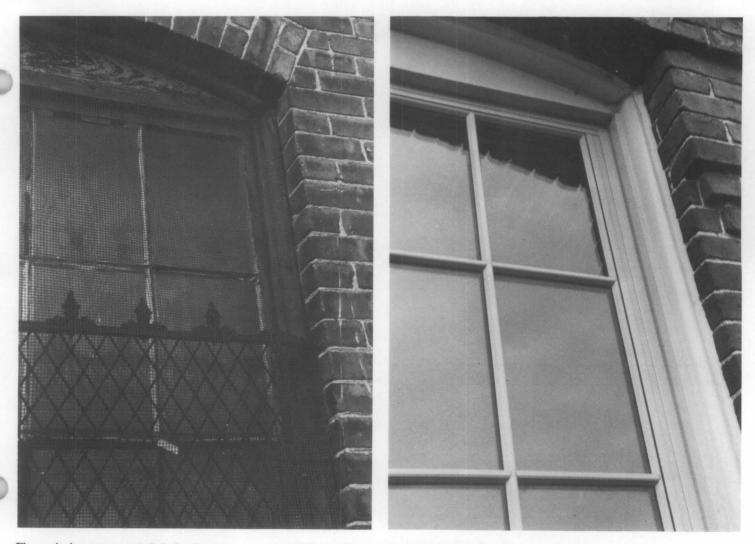
Figure 4. A custom-extruded aluminum pan was installed, duplicating the brick molding detail and, at the head of the frame, custom bent to follow the segmental curve of the masonry opening. Photos: Charles Fisher

At the head of the wooden frame, the aluminum pan was constructed in two pieces, both custom extrusions. The flat face of the lower piece was cut on a curve to follow the segmental curve of the masonry opening. The upper piece, which replaced the original brick molding, was custom-bent to the segmental curve and blind attached to the lower piece of aluminum (see figure 4). An additional aluminum pan was fitted tightly to the original wooden window sill (see figure 5).

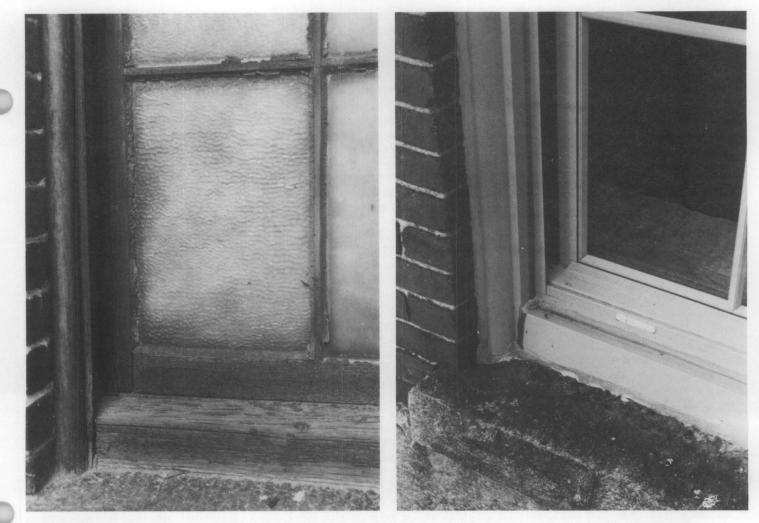
When the aluminum window frame was inserted, it included its own sill in the place where the bottom rail abutted the sill of the original window. This second sill unfortunately added an element not present in the original window (see figure 6).

Figure 6. The manufacturer's stock window used for the project unfortunately created the appearance of a double sill, which the historic window never had. Photos: Charles Fisher

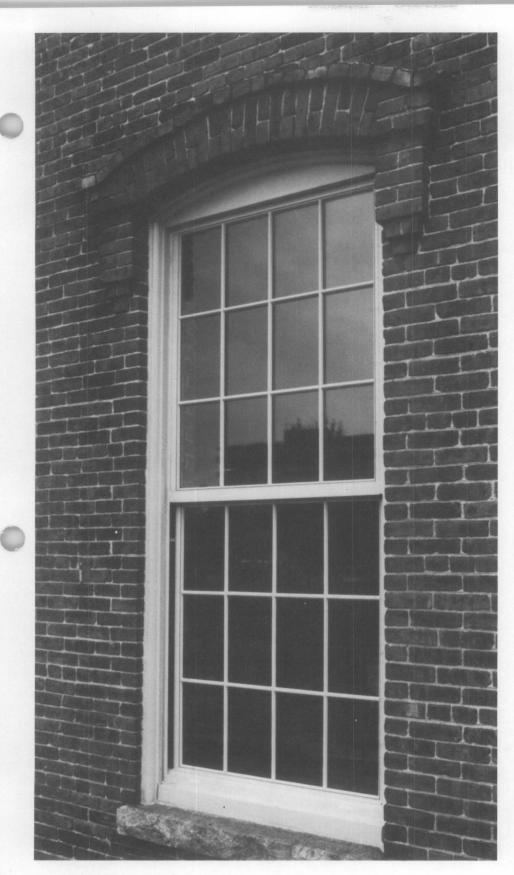
For purposes of preserving the historic appearance of the building, matching the visual details of the historic wooden windows at the Suffolk Mills was of foremost importance. It was felt that the aluminum window maintained the overall appearance of the original window. This was achieved by retaining the historic frame width, using custom aluminum brick moldings (including a curved head molding), setting the two sash in offset glazing planes as in the traditional double hung window, incorporating an exterior grid on each sash simulating the trapezoidal muntins of an authentic wooden window, and using appropriate paint color (see figure 7).

Figure 7. Replacement window after installation. Photo: Charles Parrott
