RESEARCH PAPER RP1046

TEST OF FLOOR COVERINGS FOR POST-OFFICE WORKROOMS

By Warren E. Emley and Carl E. Hofer

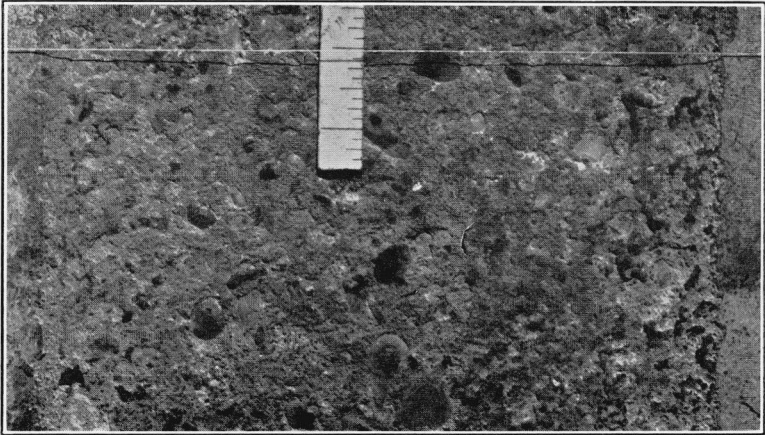
FIGURE 2.—*Plain concrete—no surface treatment.*

Concrete specimens 2, 3, 5, and 6 were made of 1:1:1½ concrete 1½ inches thick. Number 2 was given no surface treatment; number 3 had an abrasive aggregate in the wearing surface; number 5 was treated with three coats of liquid hardener after the concrete had set; and number 6 had a fine metallic aggregate or hardener in the wearing surface. Number 4 was made of 1:3 cement mortar, ¼ inch thick. The photographs show that the cement-mortar finish (no. 4) did not stand up well under this test. The plain concrete (no. 2) was not particularly durable, nor was it much improved by any of the three treatments tried.

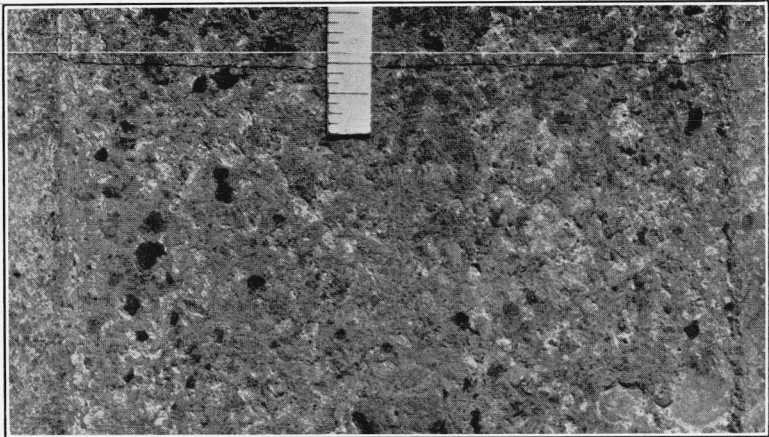
FIGURE 3.—*Concrete with abrasive aggregate in wearing surface.*

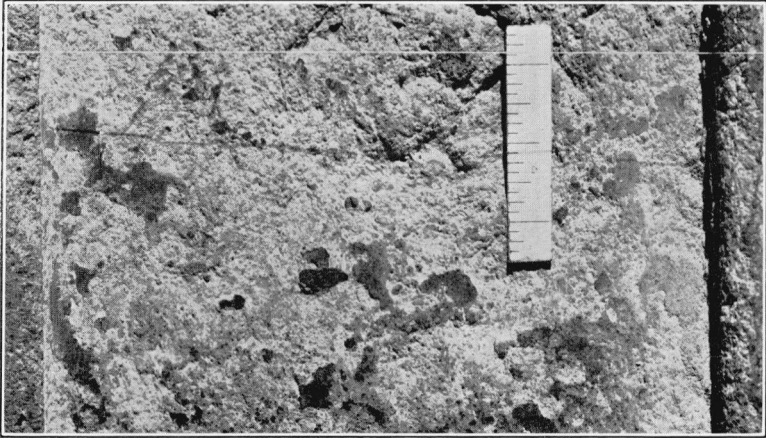
FIGURE 4.—Concrete surfaced with 1:3 cement mortar.

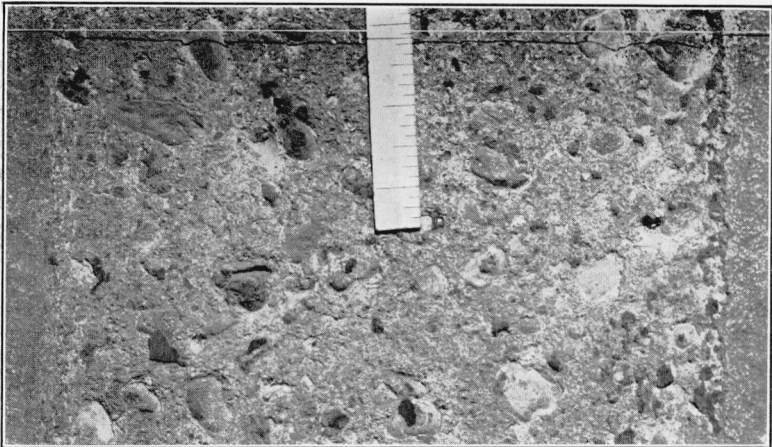
FIGURE 5.—Concrete treated with three coats of liquid hardener after the concrete had set.

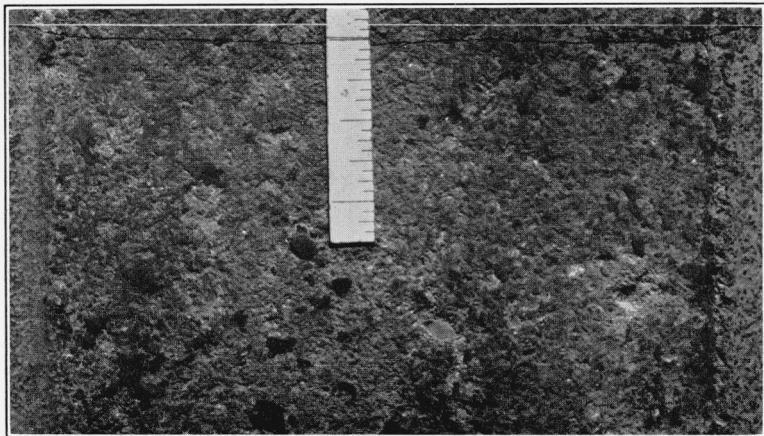
FIGURE 6.—Concrete with fine metallic hardener in wearing surface.

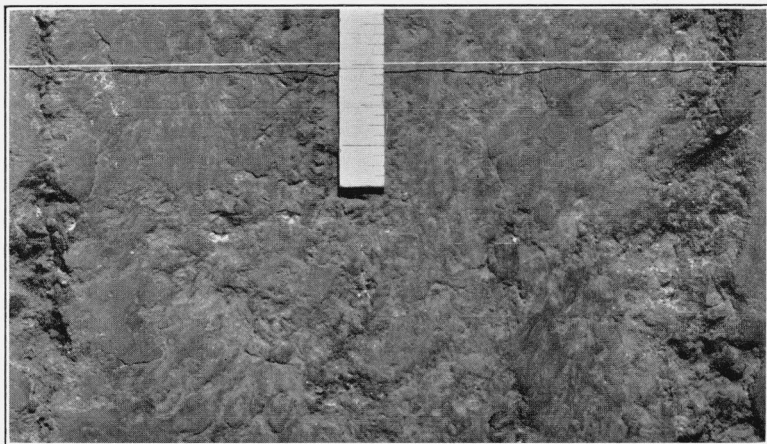
FIGURE 7.—Asphalt blocks 5 by 12 by 2 inches.

Asphalt specimen 7 was made of blocks 5 by 12 by 2 inches set in ½ inch of mortar. Specimen 8 was asphalt plank, ½ inch thick. The surfaces of both block and plank roughened quite readily under this treatment, and for this reason they could not be kept clean by sweeping. The plank showed considerably more wear than the block.

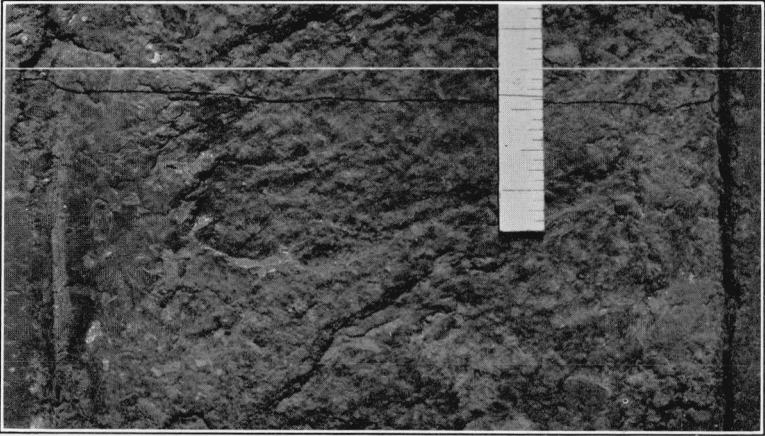
FIGURE 8.—Asphalt plank $\frac{1}{2}$ inch thick.

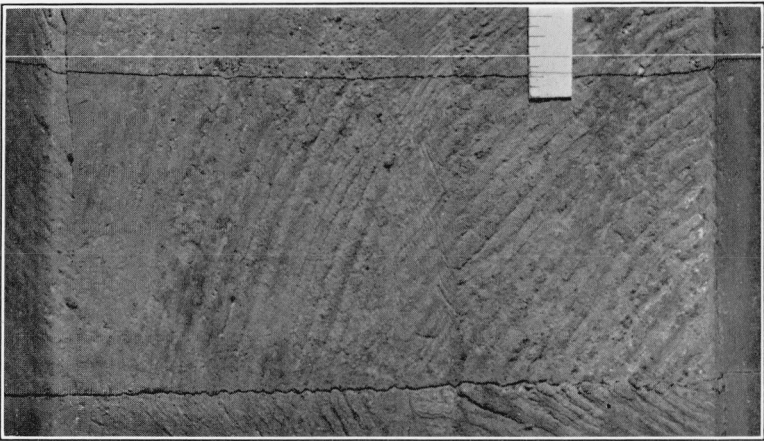
FIGURE 9.—Southern yellow pine end-grain blocks $2\frac{1}{2}$ inches thick, set in mastic.

The photographs show that the end grain (nos. 9 and 10) and the quartersawed grain (no. 11) wore appreciably under this test. Of the maple floors, there is little choice between the edge grain (no. 12) and the flat grain (no. 13); both stood up very well. Of the three methods of finishing examined, the four-coat job (no. 14) is better than the two-coat job (no. 15), and both are better than the linseed-oil finish. The differences, however, are in the appearance and the ability to keep the floor clean; there is not much difference in the wear.

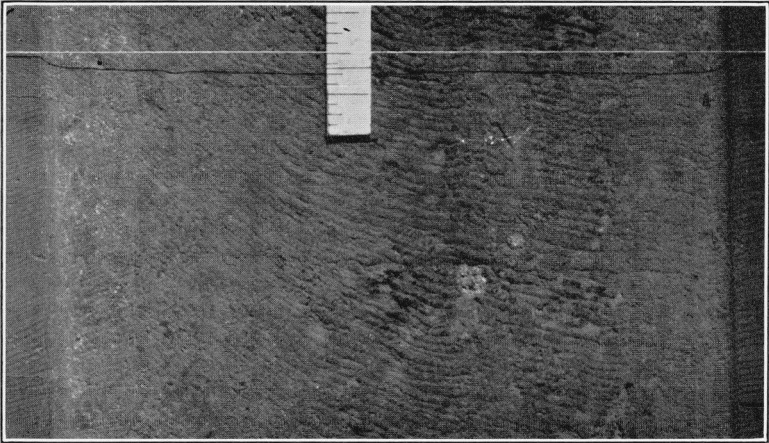
FIGURE 10.—*Douglas fir end-grain blocks $2\frac{1}{2}$ inches thick, set in mastic.*

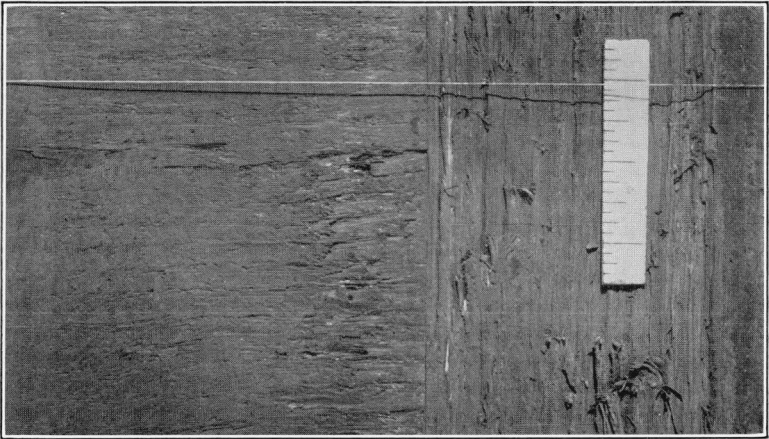
FIGURE 11.—*Quarter-sawn red oak $2\frac{5}{32}$ inch thick, set in mastic.*

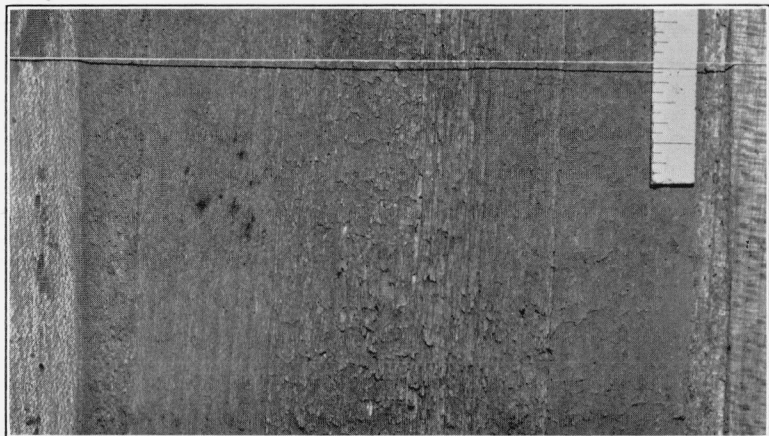
FIGURE 12.—Maple, edge grain $2\frac{1}{8}$ inches thick set in mastic.

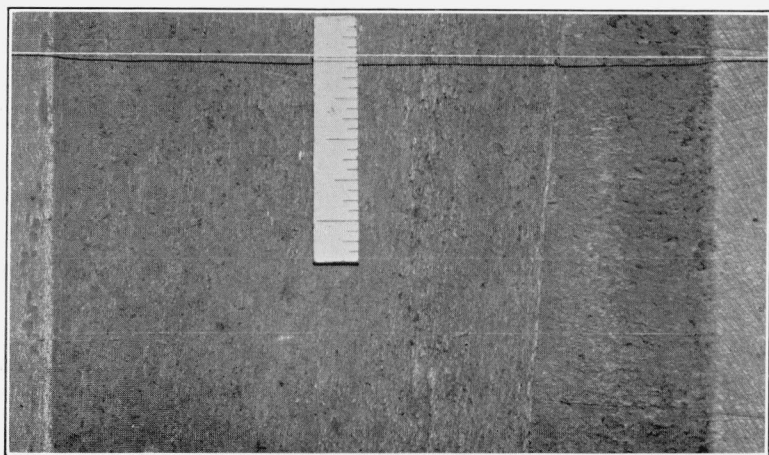
FIGURE 13.—Maple unit blocks $3\frac{1}{32}$ inch thick, set in mastic.

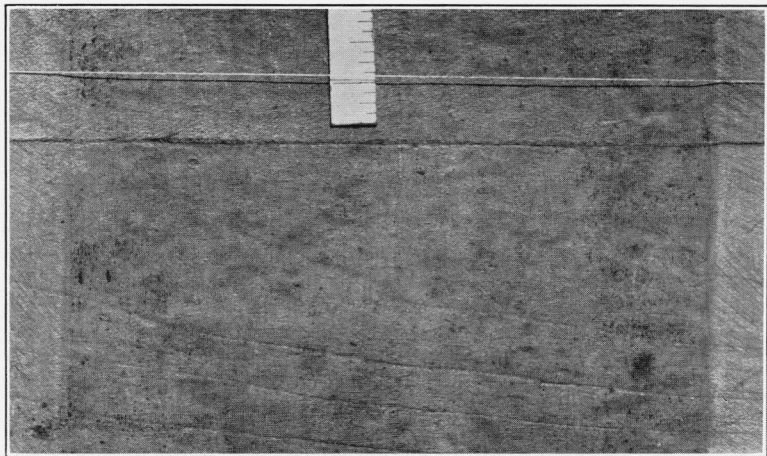
FIGURE 14.—*Maple plain strips* $3\frac{3}{32}$ *inch thick, set on sleepers.*
Finished with one coat sealer, two undercoats, one finish coat.

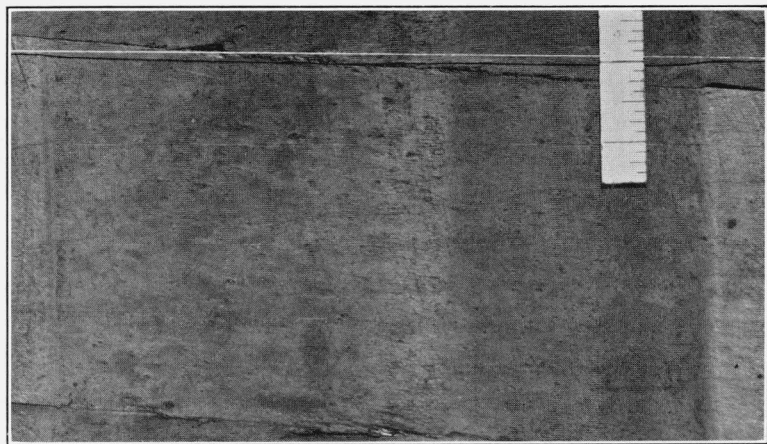
FIGURE 15.—*Maple plain strips* $3\frac{3}{32}$ *inch thick, set on sleepers.*
Finished with one coat sealer and one finish coat.

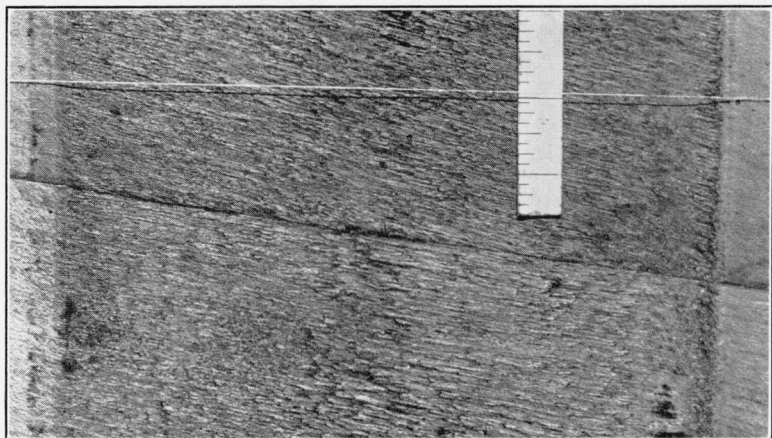
FIGURE 16.—*Maple plain strips $\frac{33}{32}$ inch thick, set on sleepers.*
Finished with two coats linseed oil and turpentine.

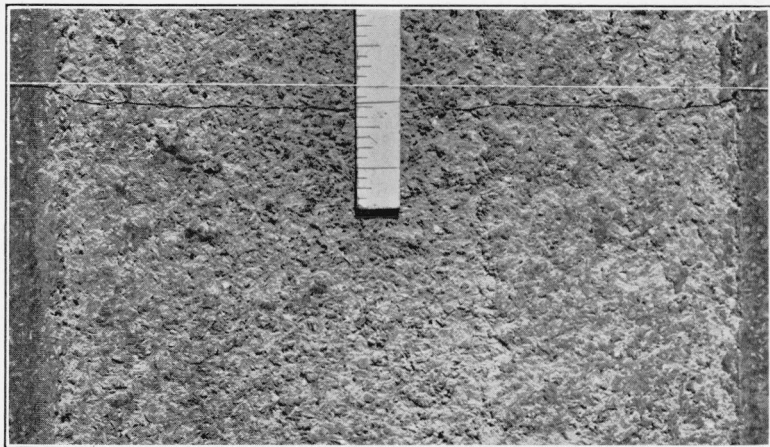
FIGURE 17.—*Magnesite with hardwood fiber aggregate 1 inch thick.*

Magnesite specimen 17 contained an aggregate of hardwood fiber and was 1 inch thick; no. 18 was ½-inch plain magnesite. Both of these specimens showed wear to such an extent as to indicate their unsuitability for this kind of service.

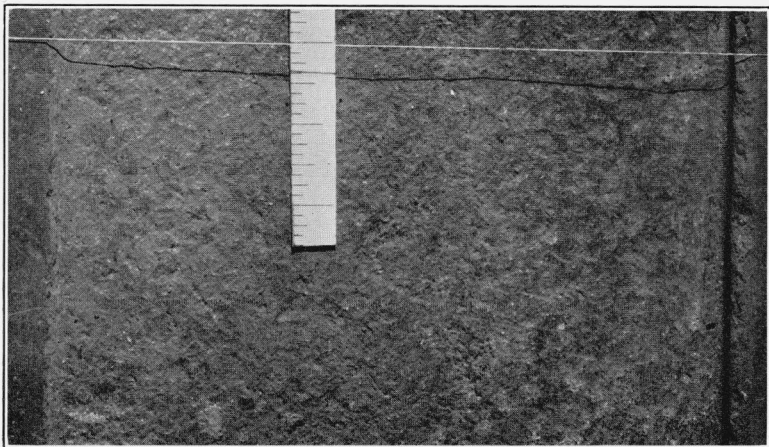
FIGURE 18.—*Plain magnesite* $\frac{1}{2}$ inch thick.

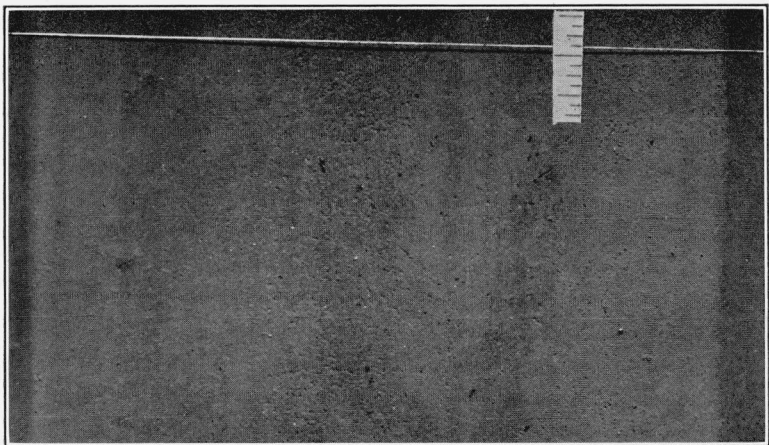
FIGURE 19.—*Battleship linoleum* $\frac{1}{4}$ inch thick.

Specimen 19 was ¼-inch battleship linoleum. This showed very little wear. There was a tendency to creep in the direction of the traffic, but the movement was not sufficient to break the bond between the linoleum and the concrete subfloor.

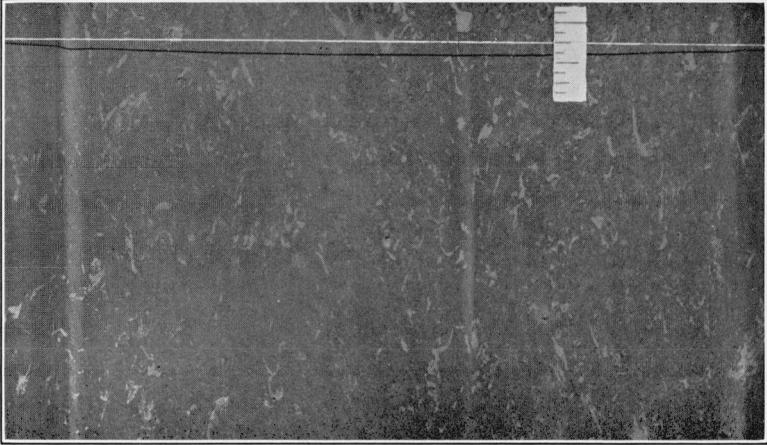
FIGURE 20.—*Rubber sheet 1/4 inch thick.*

The first sample of rubber tile (no. 20) could not be made to stick to the concrete. It was finally taken up on November 14 and replaced by sheet-rubber flooring ¼ inch thick. The second sample of rubber tile (no. 21) adhered somewhat better, but it caused a great deal of trouble, tiles having to be replaced every few days. The results indicate that rubber will withstand the service fairly well, if some adhesive can be found to hold it to the concrete.

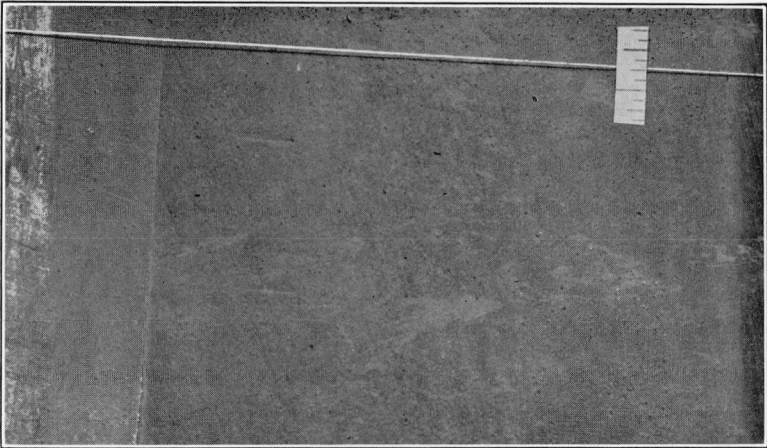
FIGURE 21.—*Rubber tile 1/4 inch thick.*
