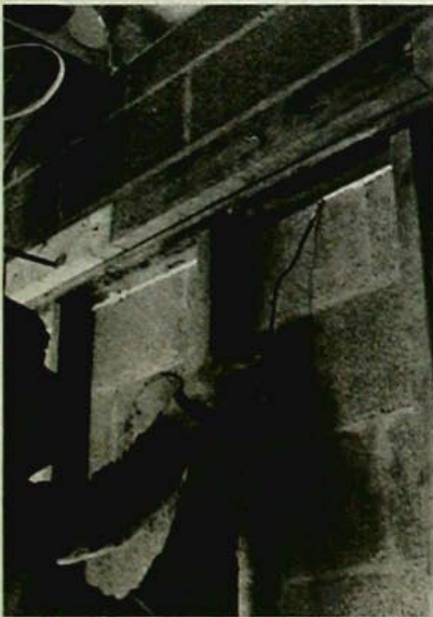
In multifamily work, PEP frequently encounters concrete-block party walls connecting the living space and attic. Warm air rises through the block cores, is cooled in the attic, and falls again. Whether the block is open or closed to the attic, this robs heat from the house and chills the wall. Easily treated in new construction with a course of solid block at the ceiling level, block party walls are a challenge to retrofit. In the photo, PEP cures a related problem—leakage between the party wall and wood framing.
