HAMM BUILDING ST. PAUL, MINNESOTA

HISTORIC GLASS NUMBER 1

Repair and Reproduction of Prismatic Glass Transoms

Technical Preservation Services
National Park Service

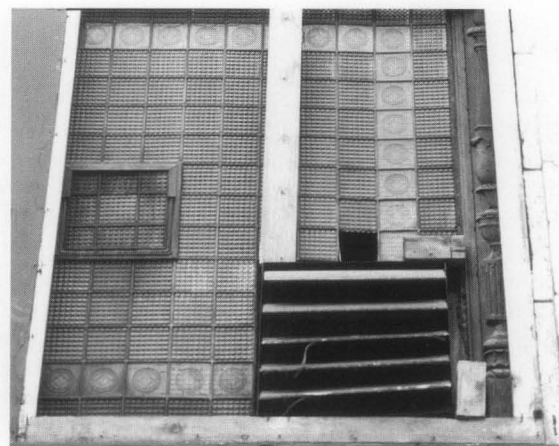
After removing the plywood, the individual panels were found to be in various states of disrepair. In approximately 20 percent, the tiles were either completely missing or had fallen to a pile at the bottom of the frame. Most panels that survived were bulging or sagging and had severely pitted and corroded came and cracked solder joints.

Numerous paint layers covered the exterior surface of the panels and several had holes cut to accommodate the addition of air conditioning or ventilation ducts (see figure 5).

Figure 5. Transoms hidden beneath the plywood covers were in varying condition. Tiles had been removed from the panel above to fit a ventilation duct. When the panels were later rebuilt new material was needed to replace missing tiles. Photo: Oertel Architects.

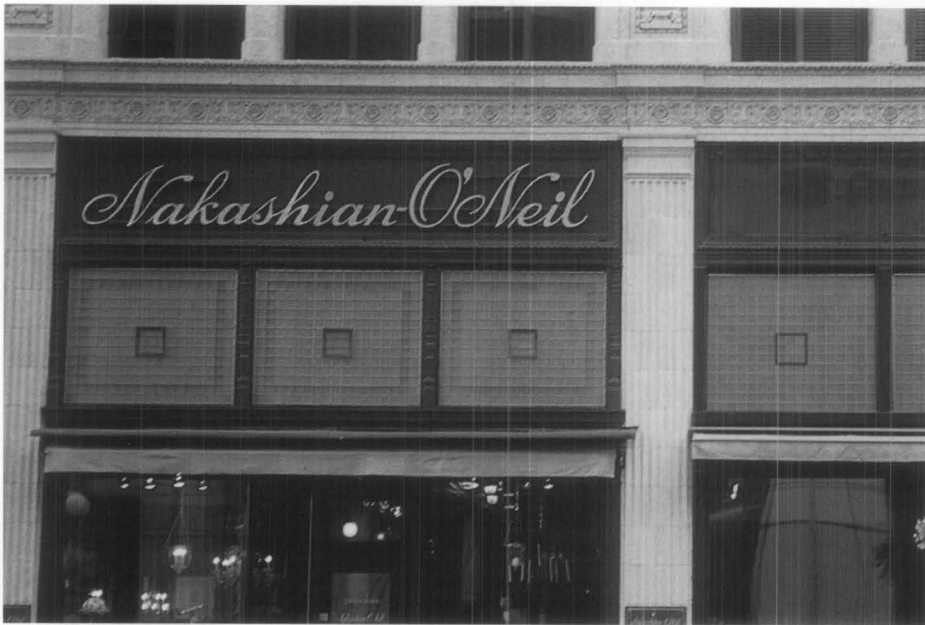
Figure 9. Panels with original tiles are shown on the left next to those featuring replacement textured glass. Photo: Chad Randl.

missing or damaged elements required replacement, new materials approximated the appearance of the original features (see figure 9). Lastly, modifications to the transoms improved the strength of the transoms but did not intrude upon the historic appearance of the prismatic tiles and the Hamm Building exterior.
