TECHNICAL BRIEF | #2019-01

Hip and Ridge Mortar Generated Surface Efflorescence

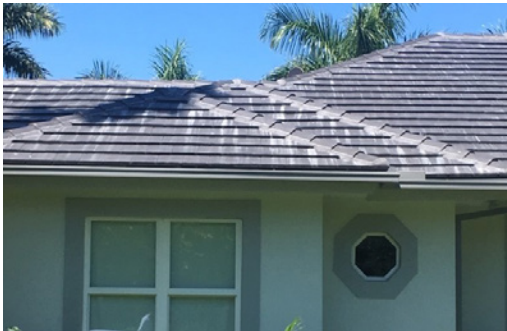
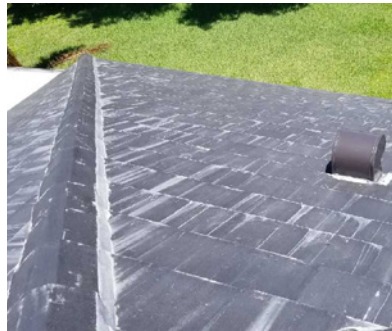
Efflorescence is caused by the chemical nature of the cement. Manufactured cement contains free lime, and when water is added, a series of chemical reactions take place. These reactions are accompanied by the release of calcium hydroxide, which can form an overall "white chalky" crystalline salt deposit on the tile surface when reacting with carbon dioxide. This reaction can appear as an overall "bloom" (overall softening of color) or in more concentrated patches.

Picture of superficial efflorescence caused by the mortar installed at the ridge.

The manufacturer of the mortar materials may help provide additional methods for reducing, sealing or cleaning efflorescence created by their products.
