The Preservation and Repair of Historic Clay Tile Roofs

Preservation Briefs

30

Anne E. Grimmer and Paul K. Williams

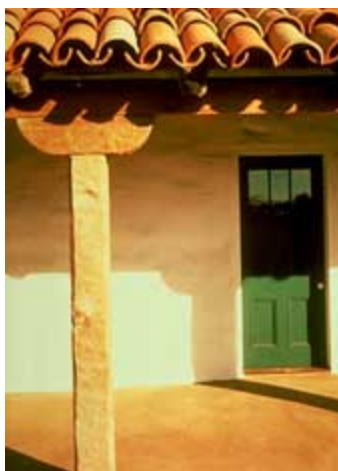
Tapered barrel clay roof tiles were custom made for the restoration of the 1820s Indian barracks at Mission Santa Cruz in California. Photo: NPS files.

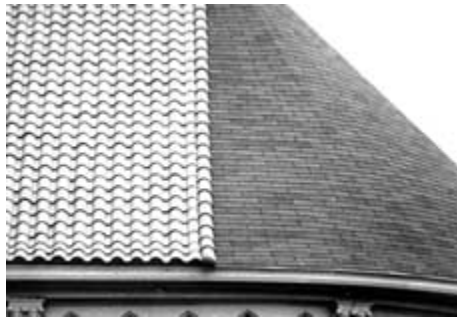
Asphalt shingles are an incompatible replacement substitute for the original Spanish clay tiles. Photo: NPS files.

The most important repair to avoid is replacing broken or missing roof tiles on a historic building with materials other than matching natural clay tiles. Concrete, metal or plastic tiles are generally not appropriate substitutes for clay roofing tiles. They lack the natural color variations of clay tile, and they do not have the same texture, shape, thickness or surface irregularities.

Although much concrete tile and composition tile is produced to resemble the general shape, if not the exact profile, of clay roofing tiles, concrete tile is generally too thick and also lacks the range of colors inherent in natural clay tile. Concrete tile is not a compatible substitute material to repair or replace individual historic clay tiles.

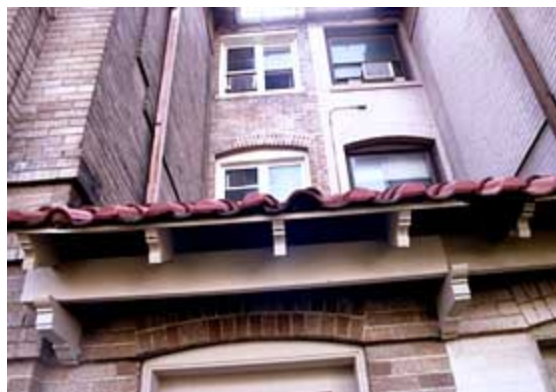
An eave closure or *birdstop* to keep out birds is notably absent from the replacement tile in the center of the bottom row. Photo: NPS files.

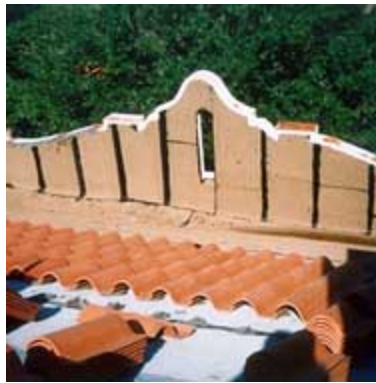
Projections on the underside of these replacement Spanish clay tiles help them adhere to the cement mortar on the roof sheathing. Photo: NPS files.

Sometimes cement mortar, or another underlayer such as grass, moss or straw, or hair-reinforced mortar was added under the tiles. Before the use of felting this was a particularly common practice on some of the plain flat tile or Spanish tile roofs with low rises that were themselves not especially waterproof. Mortar also helped to keep driving rain from getting under the pantiles, and it is still customary in contemporary roofing to add a dab of cement mortar to help secure them.

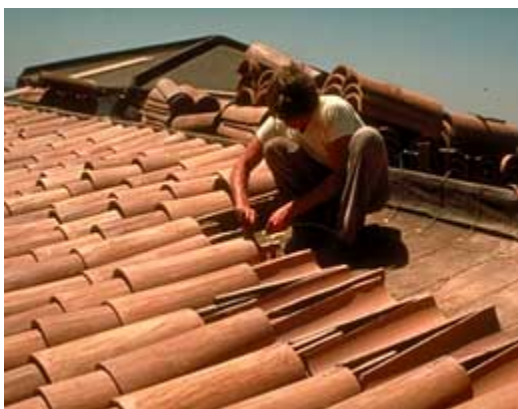
These tapered barrel clay tiles were accurately reproduced from archeological materials found on site.

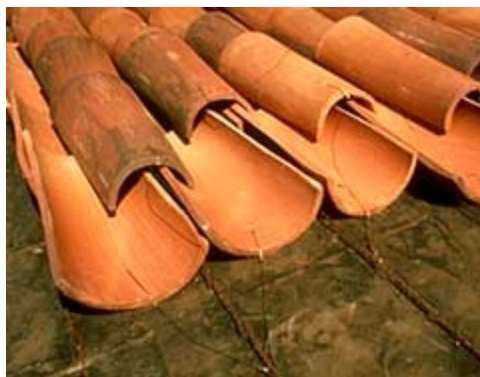
A special system consisting of brass or copper wires is used to attach these tapered barrel roof tiles.
Photo: NPS files.

With Mission or Barrel tiles, where one half-cylinder overlaps another inverted half-cylinder to form a cover and pan (cap and trough) arrangement, the fastening is more complicated. While the pantiles that rest directly on the sheathing are simply nailed in place, there are two ways of attaching the cover tiles that rest on the pantiles. They can be secured by a copper wire nailed to the sheathing or tied to vertical copper strips running behind the tiles. Another method requires the installation of vertical battens or nailing strips on the roof to which the cover tiles are nailed, or the use of tile nails or hooks, which are hooked to the pantile below and secured with twisted copper wire.
