Tech Notes

MASONRY

Non-destructive Evaluation Techniques for Masonry Construction

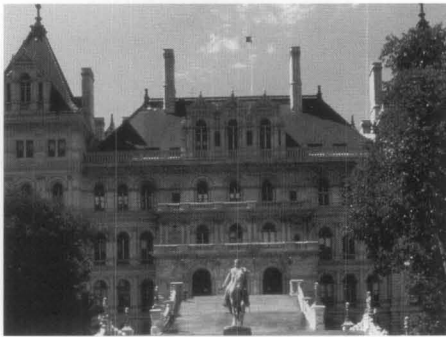
Figure 1. At the New York State Capitol in Albany, New York, non-destructive evaluation techniques were used to determine existing structural conditions and to locate hidden structural elements. Most construction documents had been lost in an early 20th century fire; data collected through non-destructive evaluation served to re-create the structural drawings. Photo: Marie Ennis, P.E.

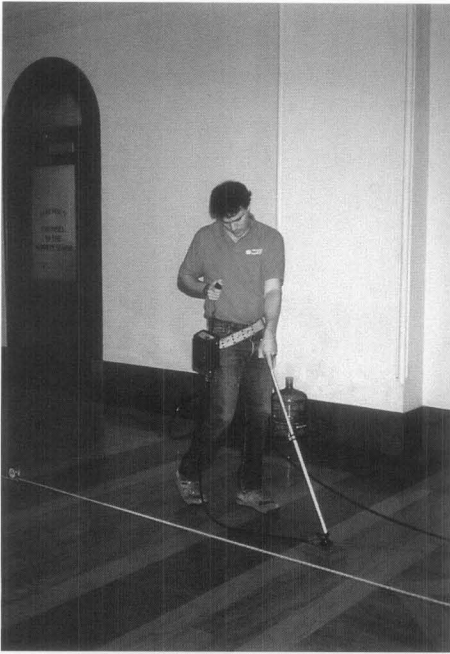
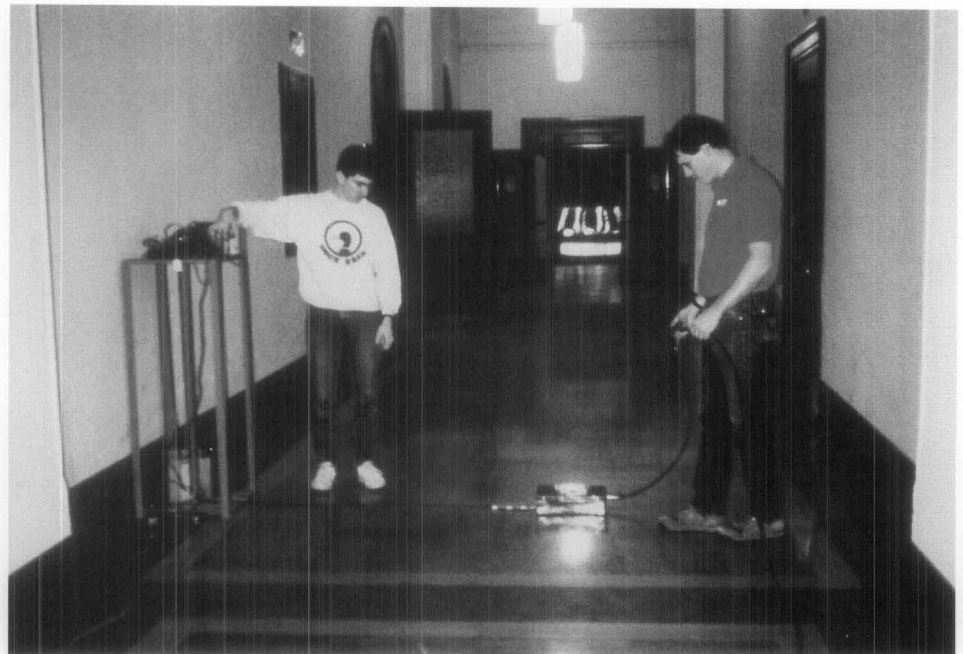
Figure 2. (a) The floor structure is scanned using impulse radar. An operator is shown, pushing the transducer across the floor surface at a constant speed. (b) The transducer is being pulled, by machine, at a constant speed. Photos: Marie Ennis, P.E.

Impulse Radar. For the New York State Capitol project, the radar tests successfully located embedded beams, girders, columns, and metal ties/anchors (see figure 2). The readings enabled the investigators to profile brick arches spanning

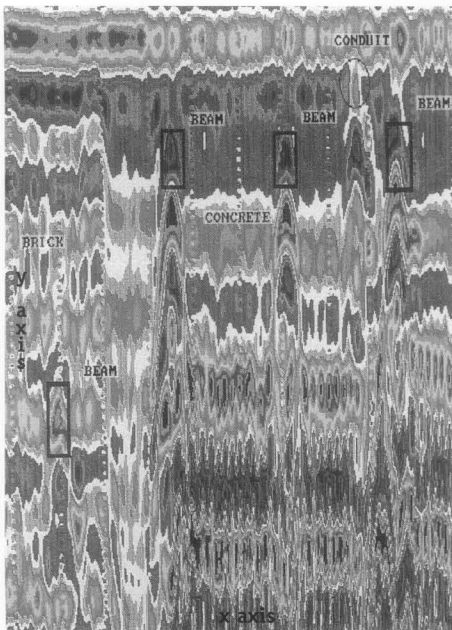
Figure 3. This is the raw output from a radar scan. The beams, brick arches, and concrete slab have been noted. (x-axis= velocity of transducer; y-axis = wave response time.) Photo: U.S. Army Construction Engineering Research Laboratory.

roughly 5 feet between beams, and to locate H-shaped steel columns in masonry walls showing the orientation of the flanges. The tests readily measured the thickness of masonry walls that were well bonded. They were also able to determine the depth-of-cover over beams and girders and brick arches, and the location of voids, pipes and flues in walls up to 2 feet 8 inches thick (see figure 3).

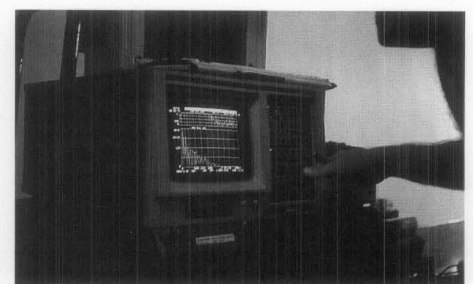
Figure 4. (left) The impact echo equipment includes a hammer, receiver, and water soluble coupling gel and was used to locate a steel column concealed behind the granite facing. Photo: Dennis Sack. (right) Impact echo data is shown on the field computer screen. Photo: Marie Ennis, P.E.

Impact Echo. Impact echo produced good data for reading wall thicknesses and the integrity of granite and sandstone columns, veneer walls, and brick walls less than two feet thick (see figure 4). While steel columns behind granite facing were located, the orientation of flanges was not discernible. The impact echo test provided excellent results in detecting stone cracking parallel to the surface. Its optimal use was when working with homogenous stone materials; with multiple layers of material (example: terrazzo over brick) it did not pro-

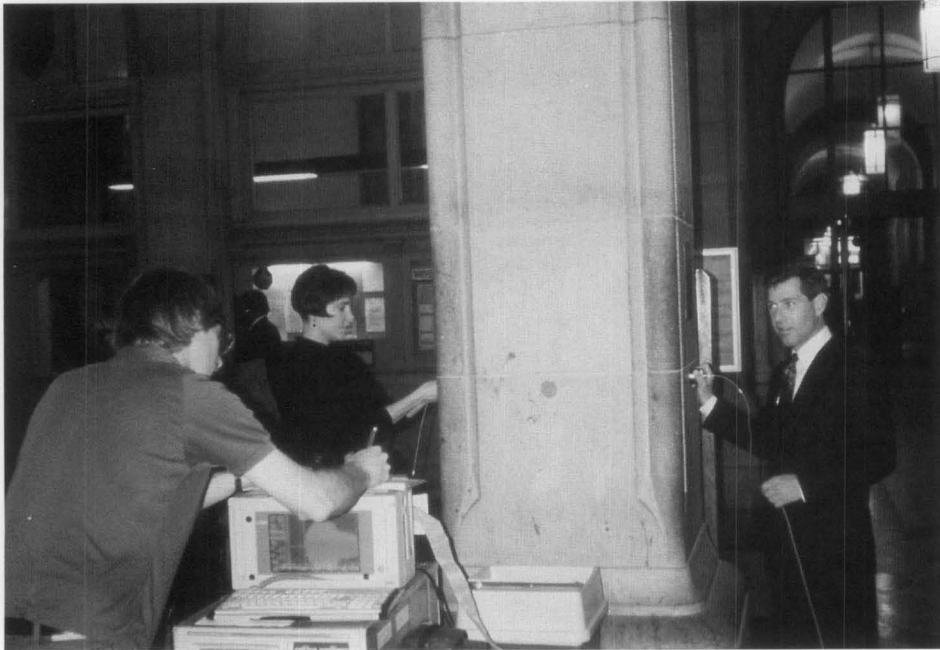
Fig. 5. Ultrasonic pulse velocity is being used to obtain characteristic wave velocities for granite. A transmitter is placed on one side of the column and a receiver on the opposite side. Photo: Andrea Lazarski.

Ultrasonic Pulse Velocity. Ultrasonic pulse velocity proved to be an excellent technique for determining the thicknesses and relative soundness of solid granite and sandstone columns (see figure 5). In composite walls, the velocity and signal strength dropped across mortar joints. Low frequency pulse velocity signals can provide good results for thick brick

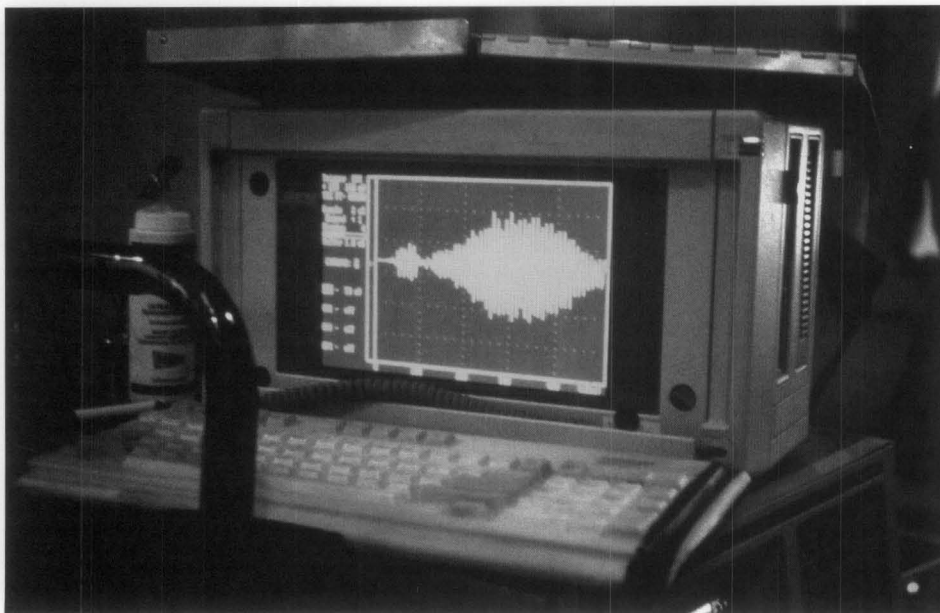
Fig. 6. Ultrasonic pulse velocity data is shown on the field computer screen. Photo: Marie Ennis, P.E.

walls where multiple mortar joints would otherwise block the transmission of higher frequency signals (see figure 6). A disadvantage of the low frequency energy is that the long wavelengths result in an "averaging" effect, which decreases the resolution of the method and does not allow for the location of smaller scale damage, such as brick unit de-bonding. In general, the results correlated well with the impact echo results. The two techniques should be used in conjunction; ultrasonic pulse velocity provides characteristic wave velocity

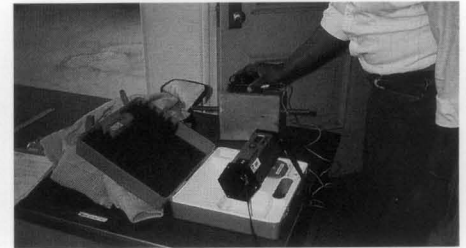
Fig. 7. This electromagnetic detection instrument is designed to locate rebars in concrete for quality control inspections. The diameter of the bar and the depth-of-cover is calculated and digitally displayed. Photo: Marie Ennis, P.E.

Electromagnetic Detection. This imaging technique worked well at locating iron beams and girders supporting brick arches that had as much as 9 inches of cover, provided no wire mesh existed (see figure 7). It was also successful at locating steel columns behind up to 8 inches of granite, and locating iron anchors in stone walls. Where wire mesh exists, such as in flat concrete slabs, the results were inconsistent.

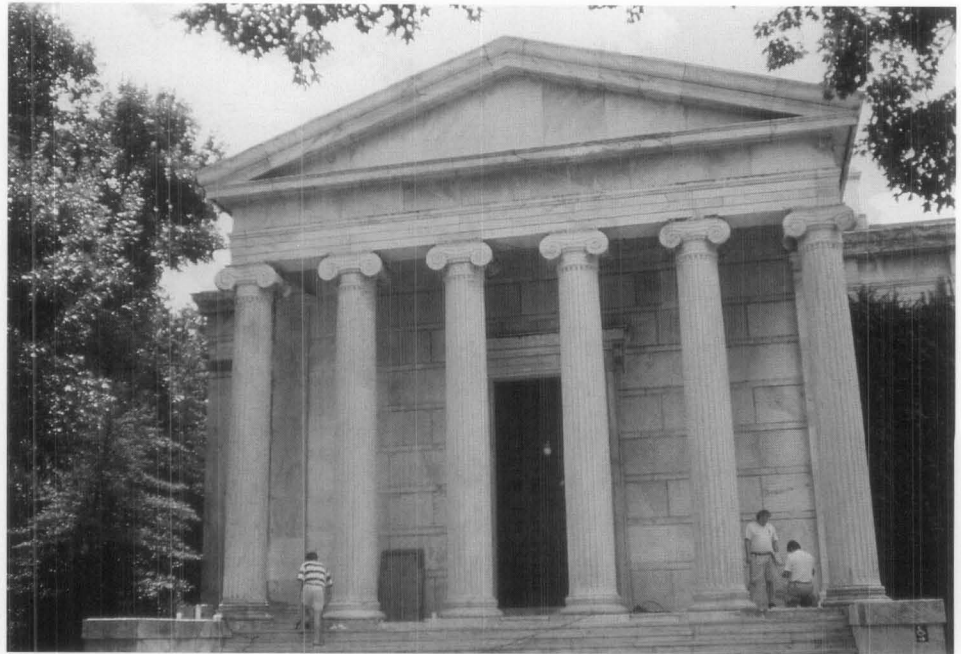
Fig 8. At Princeton University's Whig Hall, almost 100 years of weathering and a fire caused extensive damage to the masonry portico. Originally targeted for replacement, non-destructive testing techniques allowed isolated areas of damage to be evaluated and localized repairs conducted. Photo: Edmund P. Meade, P.E.

The portico of Whig Hall is primarily constructed of unreinforced, load bearing masonry. Weathering over the past 100 years and a major fire resulted in extensive cracking of the column bases and plinths; sugaring, erosion and pitting of marble surfaces; and erosion of mortar joints. Although initial reports commissioned by the university concluded that the portico substructure and columns should be replaced, less intrusive methods of repair were sought.

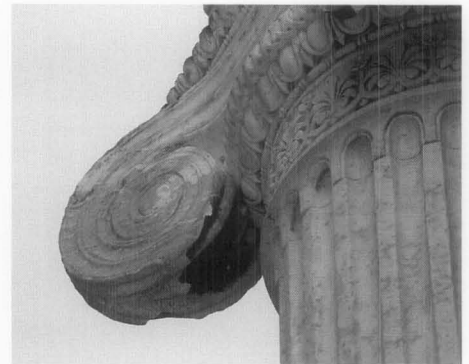
Fig. 9. The column capital volutes were cracked and spalled. Photo: Edmund P. Meade, P.E.

Initial condition investigations of the stone elements and the supporting structural members of the portico included a visual examination as part of the survey of the entire exterior of the building. All major elements were examined using "cherry pickers," scaffolding, and ladders. The examination focused on the cracked pieces of stone at the entablature level; the cracked or spalled column capital volutes; the cracked stone columns; the cracked stone column bases and plinths; the deteriorated pieces of masonry that were immediately below or adjacent to the column plinths; and the deteriorated support structure below the portico floors (*see figure 9*).

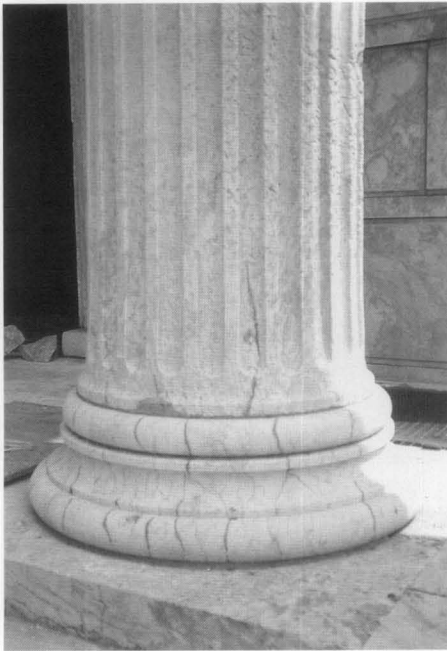
Fig. 10. The column base and plinths had extensive exterior cracks. The internal column cracks were detected by ultrasonic pulse velocity and impulse radar investigation techniques. Photo: Edmund P. Meade, P.E.

At Whig Hall, Column A exhibited severe surface cracking, and an extensive internal crack pattern within the plinths

(see figure 10). Additional cracking was noted at the bases of a number of other column shafts. Some deterioration of the masonry walls beneath the column plinths was also observed, although without signs of differential movement between different portions of the portico foundations.

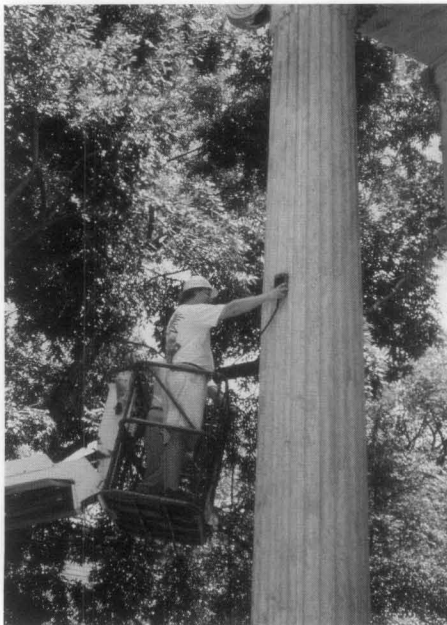
Fig. 11. Impulse radar is being used to evaluate both the orientation and depth of cracks visible on the surface of the column shaft. Photo: Edmund P. Meade, P.E.

Impulse Radar. The radar readings indicated that the column shafts were constructed of monolithic marble, with the same type of marble used for the column bases and capitals (see figure 12). The radar detected anomalies near the junctions of the column shaft with the base and the capital. The readings also indicated that there may be cramps or ties between the columns and the bases/capitals. It could not be determined whether the objects detected were metallic, or if they were possibly "Lewis holes" that had been used to maneuver the stone blocks during construction. Magnetic detection equipment with the ability to penetrate large diameter columns could have been used in conjunction with the radar to verify the nature of the internal anomalies.

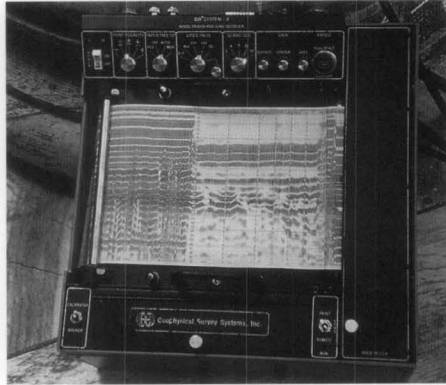
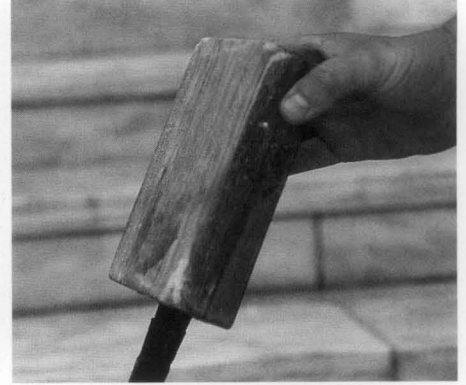
Fig. 12. (left) Raw radar output was analyzed by the geophysicists. Correlations could then be made to provide qualitative and quantitative evaluations of the stone. (right) This impulse radar transducer emits and receives electromagnetic energy. The unit is attached directly to the equipment shown at left. Photos: Edmund P. Meade, P.E.

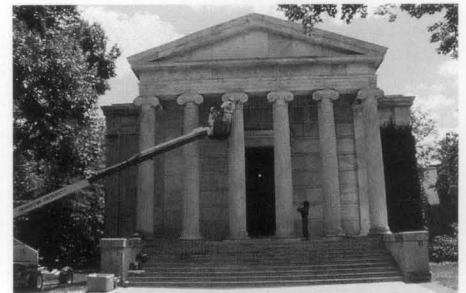
Fig. 13. The non-destructive evaluation of Whig Hall allowed the diagnosis of the condition of the masonry and the specification of a relatively low impact repair. Photo: Edmund P. Meade, P.E.

To help maintain the integrity of the masonry during the repairs, it was recommended that Column A, as well as several areas of other stone elements be pinned. It was necessary to support the column shafts while the bases and plinths were removed. This could be accomplished by the use of high strength steel pins through the column shaft, or the placement of steel clamps around the column shaft to establish a friction hold around the column.
