The Seismic Rehabilitation of Historic Buildings

Preservation Briefs

41

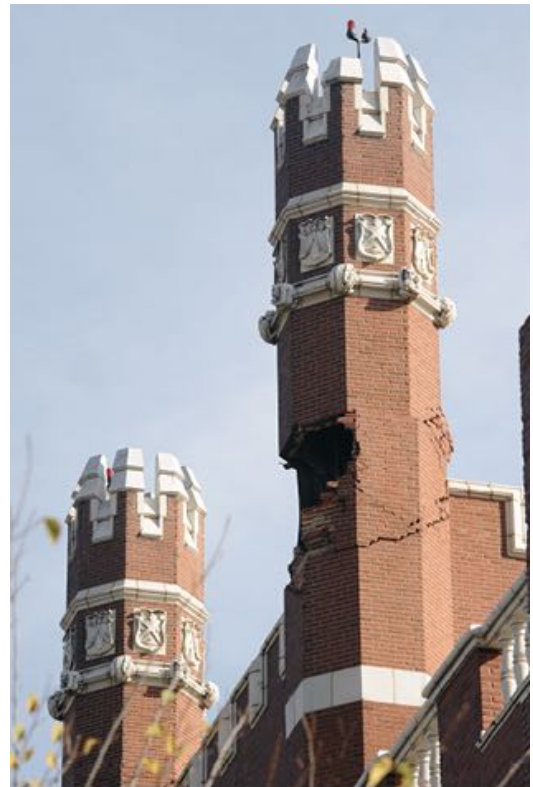
Figure 1. In 2011, a 5.6 magnitude earthquake substantially damaged all four turrets atop St. Gregory's University Benedictine Hall in Shawnee, Oklahoma.
Photo: St. Gregory University.

for seismic retrofit of existing buildings. And, despite popular misconceptions, the risks of earthquakes are not limited to the West Coast (Figures 1 and 7), but exist across much of the United States.

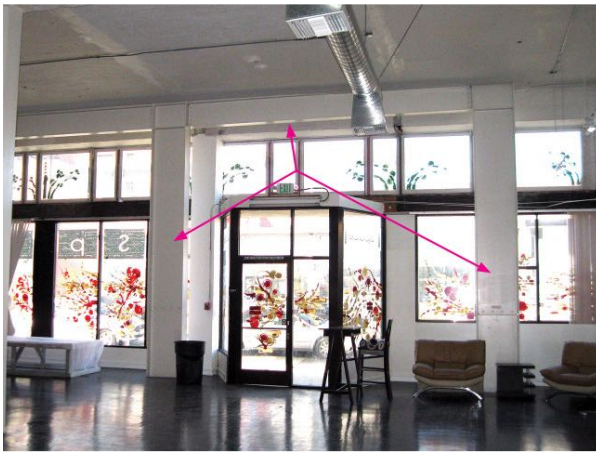
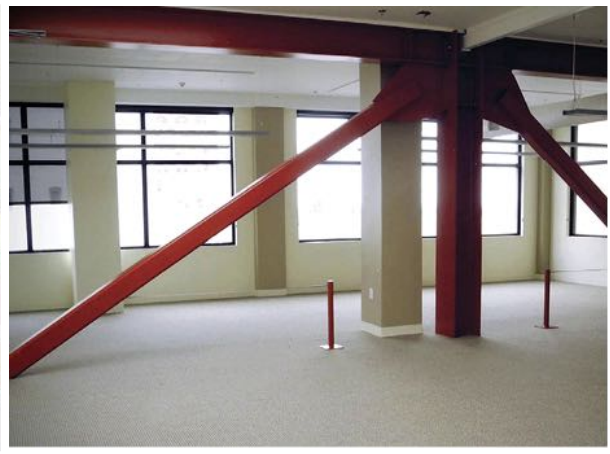
Figures 4 - 5. Using moment frames (horizontal and vertical steel members identified by the arrows) set back behind storefront openings as seen in Figure 4 (top), or placing brace frames (in red) away from the windows as illustrated in Figure 5 (bottom) are solutions that meet historic preservation goals. Figure 4. Photo: Elizabeth Hilton.

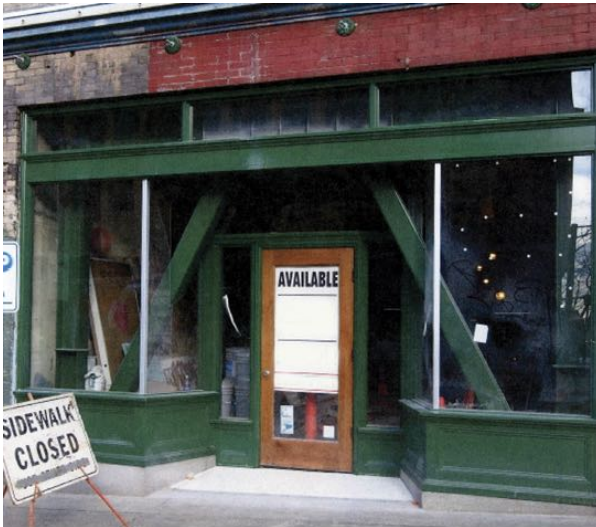
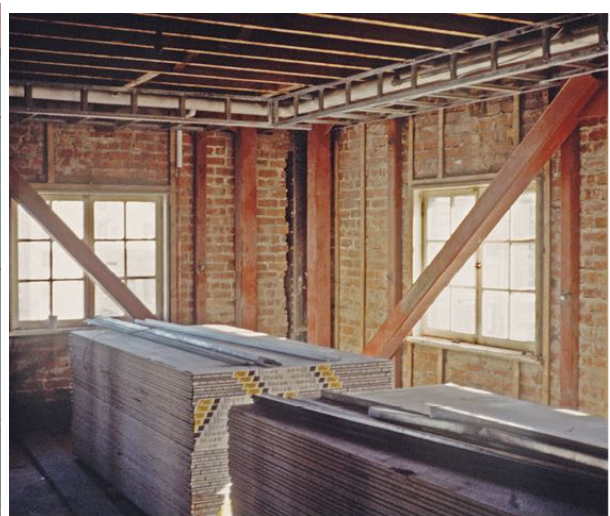
Figures 2 - 3. Standard approaches to seismic rehabilitation, such as adding diagonal bracing to reinforce window and storefront openings as seen in these photos, can be visually intrusive. Figure 2 (top). Figure 3 (bottom). Photo: Steade Craigo.

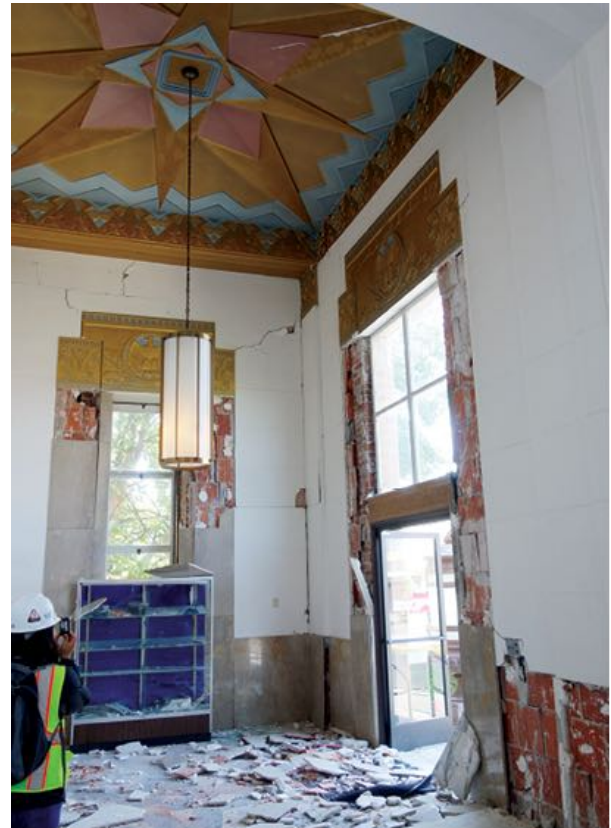
Figure 6. Failing nonstructural elements such as the stone-veneer window and door surrounds shown in this image can become a life-safety hazard when they block or impede an exit path.

Nonstructural failures generally account for the majority of earthquake damage repair costs during earthquakes. Thus, it is critical to consider the risk and consequences of potential nonstructural failures. This is particularly important for historic buildings located in areas of low or moderate earthquake hazard, where the danger of collapse may be relatively small, but nonstructural elements such as unanchored stone veneers, cornices, parapets, chimneys, and gable ends may dislodge and fall to the ground during a moderate earthquake and pose severe life-safety hazards (Figure 6).

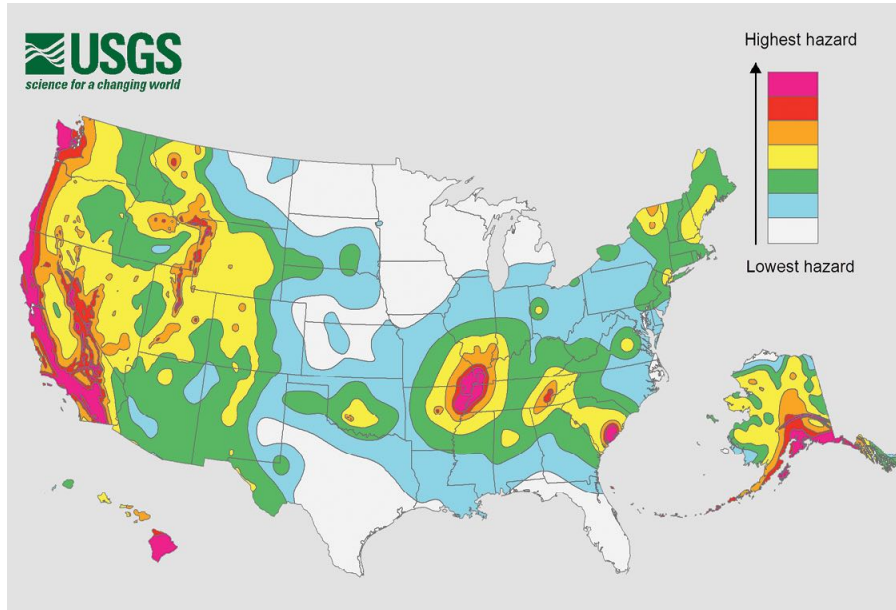
Figure 7. A simplified 2014 United States Geological Survey (USGS) seismic hazard map. Owners of certain classes of high-risk buildings in regions of high seismic activity are advised, and often required by local ordinances, to take immediate action in undertaking a comprehensive vulnerability assessment and make any necessary seismic rehabilitation measures. Owners of buildings in moderate seismic zones are advised to do further investigation of their building's exposure to earthquake risk, identify seismic rehabilitation needs, and consider mitigation of risks primarily due to nonstructural hazards. Owners of buildings in low seismic areas are advised to consider low-cost rehabilitation measures that protect against casualties and property loss, if such measures are found to be necessary, even though the potential occurrence of an earthquake might be low.

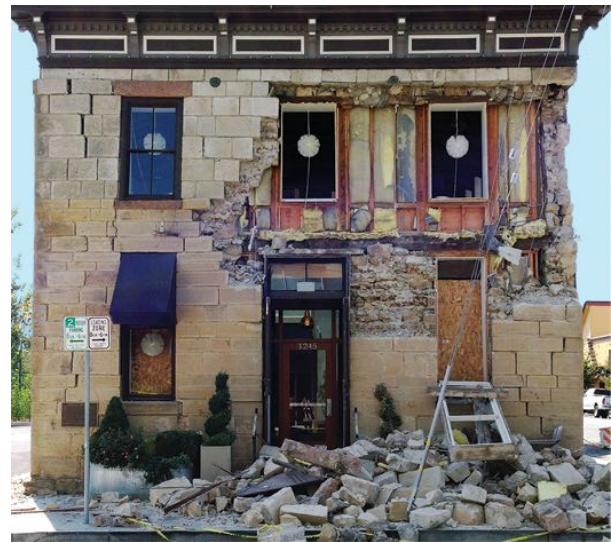
Figure 8. Unreinforced masonry buildings, such as this 1875 stone building damaged during the 2014 South Napa, California earthquake, can be particularly vulnerable to earthquake damage. Photo: Architectural Resources Group.

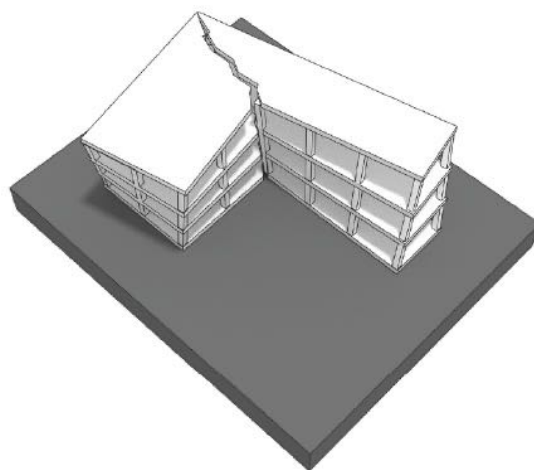
Figure 9. This image shows structural deformation due to stress concentration in structures with re-entrant corners, the inside corner where the two perpendicular exterior walls meet.

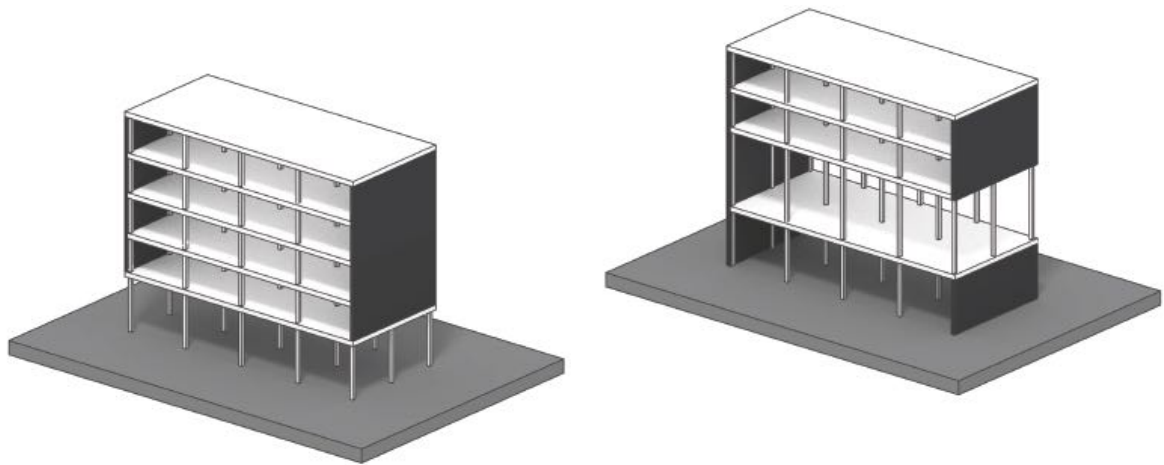
Figures 10 - 11. Figure 10 (top): open first floor. Figure 11 (bottom): double height second floor. These renderings show examples of “weak” or “soft” story irregularities.

Similarly, the more complex and irregular buildings are in elevation, the more susceptible they are to damage, especially tall structures. Other building features such as large ground-level storefront or garage openings, or floors with columns and walls running in only one direction, are commonly known as “soft” or “weak” stories, which increase the seismic vulnerability of historic buildings (Figures 10 and 11).

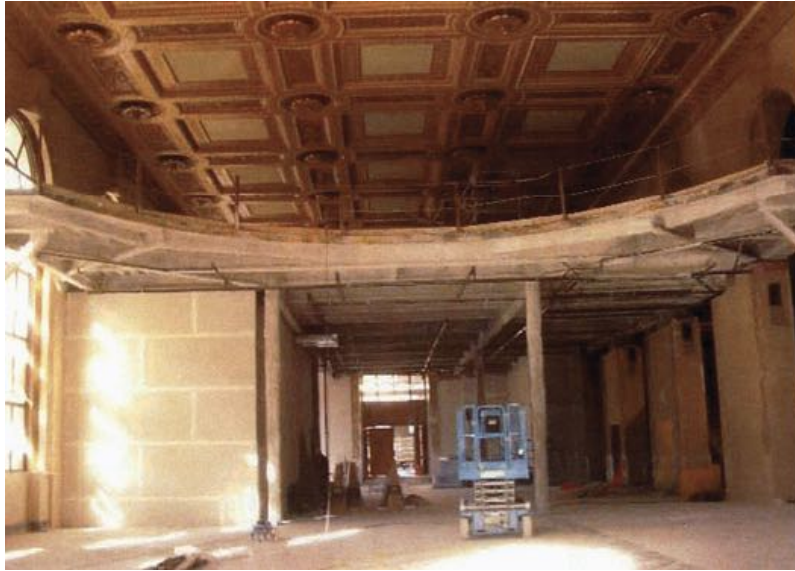
Figure 12. A mezzanine was added to the original banking hall of this 1921 former bank building as a seismic strengthening measure. Subdividing such an important character-defining space can result in a severe loss to a building's historic integrity.

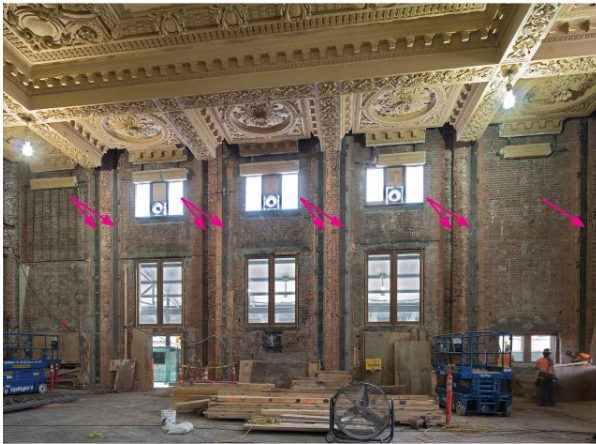
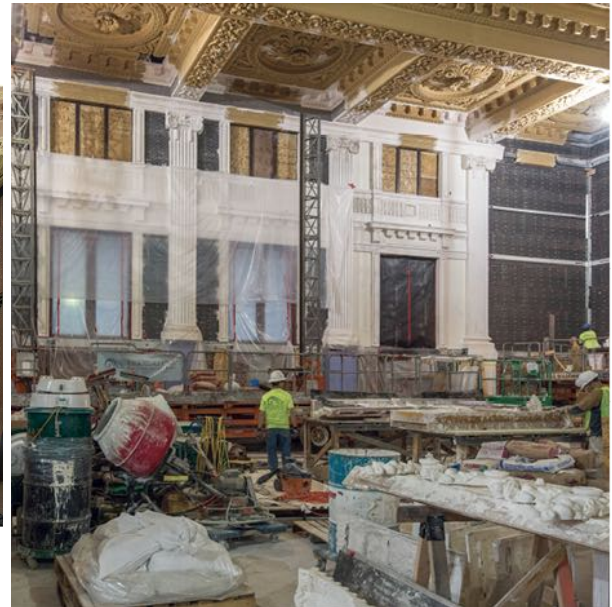
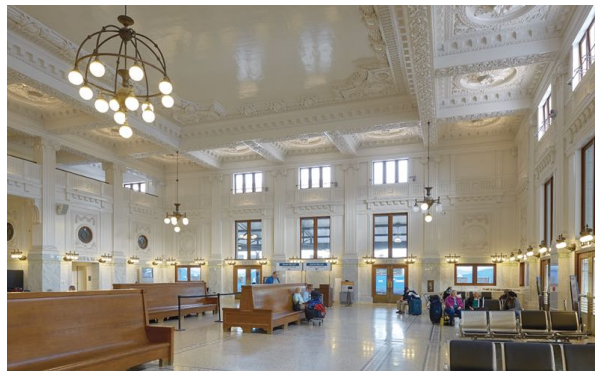
Figures 13 - 15. Vertical steel reinforcement members were inserted and grouted into the walls of the main waiting room in Seattle's historic 1906 King Street Railroad Station to strengthen them (top). To replace the original plaster ornamentation, molds were made to cast new replacement plaster elements as shown on this work-in-progress photo (middle). Photos: John Stamets.

After completion of the seismic reinforcement, the replicated plaster ornamentation was installed and the decorative painted finishes restored, returning the waiting room of King Street Station to its historic appearance (bottom). Photo: Doug Scott.

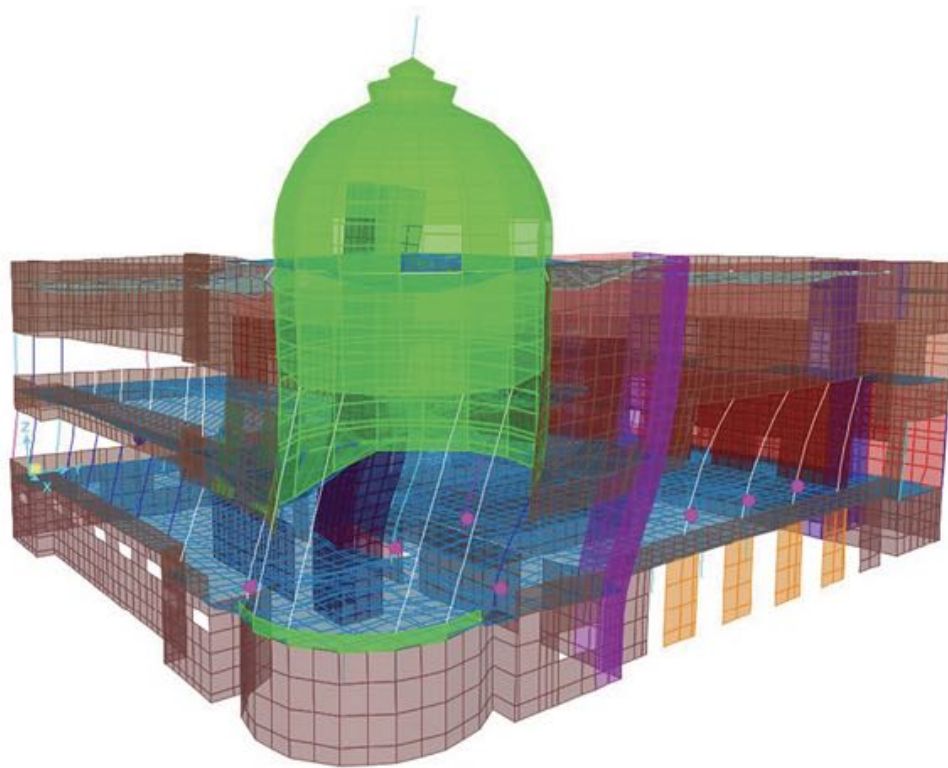
Figure 16. Computer modelling is a useful analytic tool that helps assess the strengths and weaknesses of a building and evaluate different seismic strengthening options. Three-dimensional dynamic analysis is required for a number of different structures located in certain seismic zones.

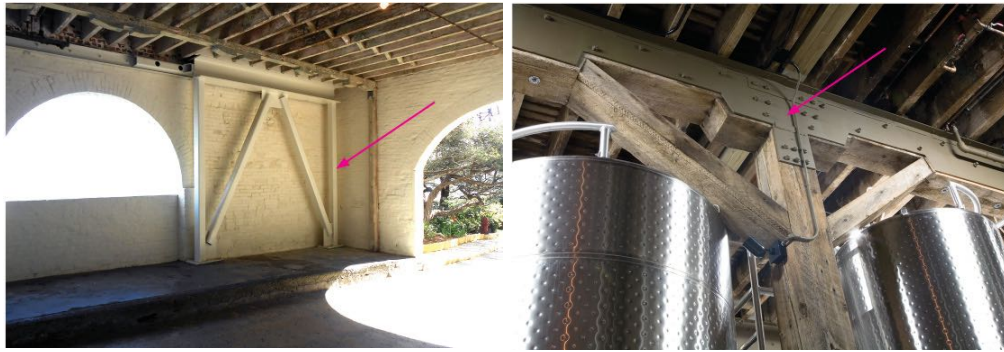
Figures 17 - 18. Careful placement of the new structural reinforcement, painted to match the surrounding building elements, if left exposed, minimizes its visual impact. New added structural elements may be left exposed when their visibility does not impair the historic character of the building. Figure 17 (top). Photo: Jason Hagin. Figure 18 (bottom). Photo: Architectural Resources Group.

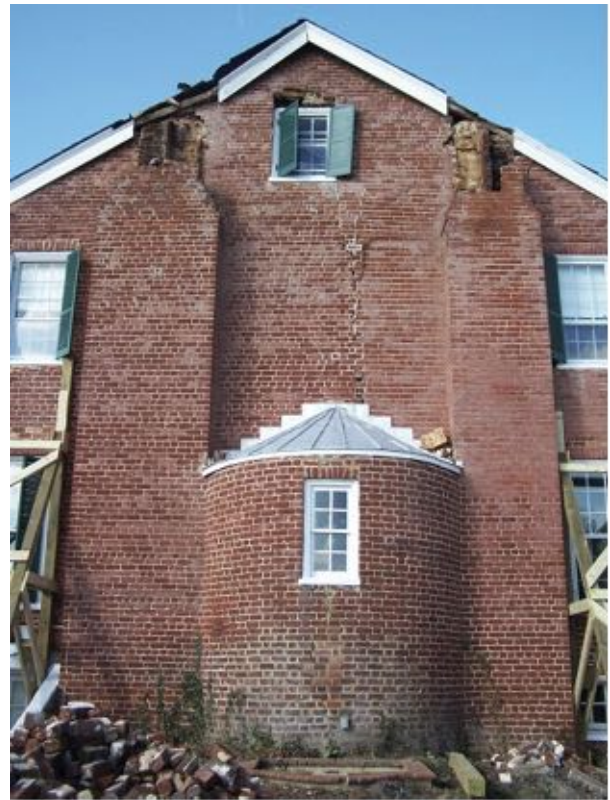
Figure 19. Chimneys are common nonstructural features susceptible to earthquake damage, even in zones of low-to medium-seismic activity as shown on this building in Virginia damaged in a 2011 earthquake. Photo: Suzanne Tripp.

Nonstructural components are all those elements other than the columns, bearing walls, floors, beams or trusses, bracing elements, foundation, and other elements that make up a building's structure (Figures 19-20). In the past, seismic rehabilitation of existing buildings has focused on mitigating structural deficiencies. However, nonstructural components represent a substantial portion of a building's initial capital investment; and, based on post-earthquake surveys, losses from nonstructural components also represent a high percentage of losses during an earthquake (see FEMA E-74: Reducing the Risk of Nonstructural Earthquake Damage—A Practical Guide).

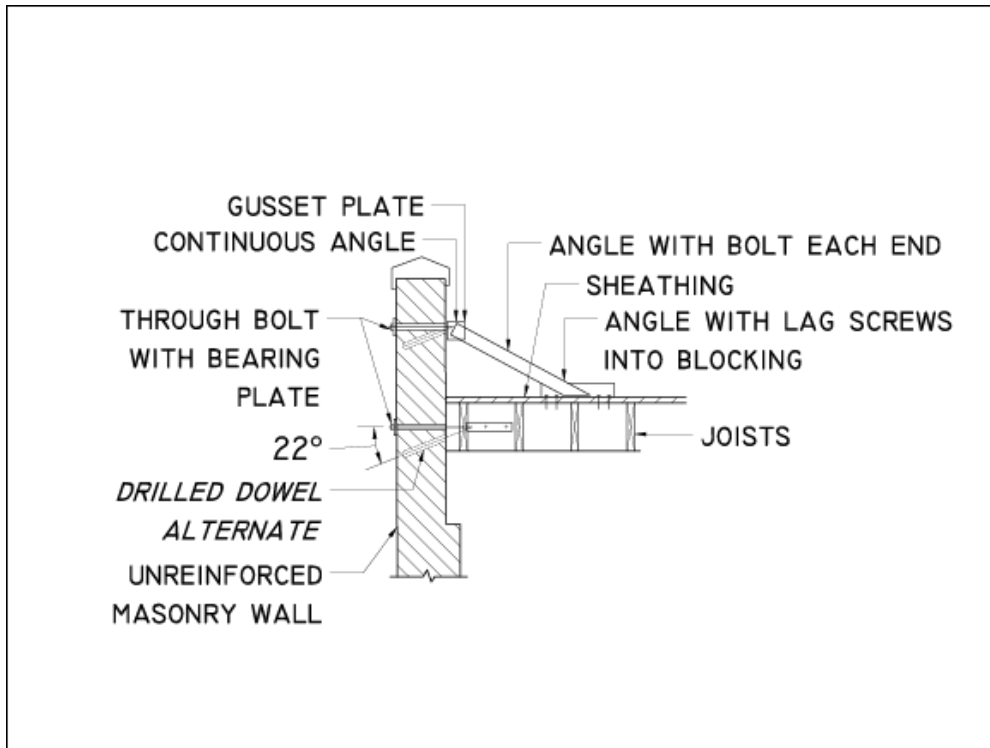
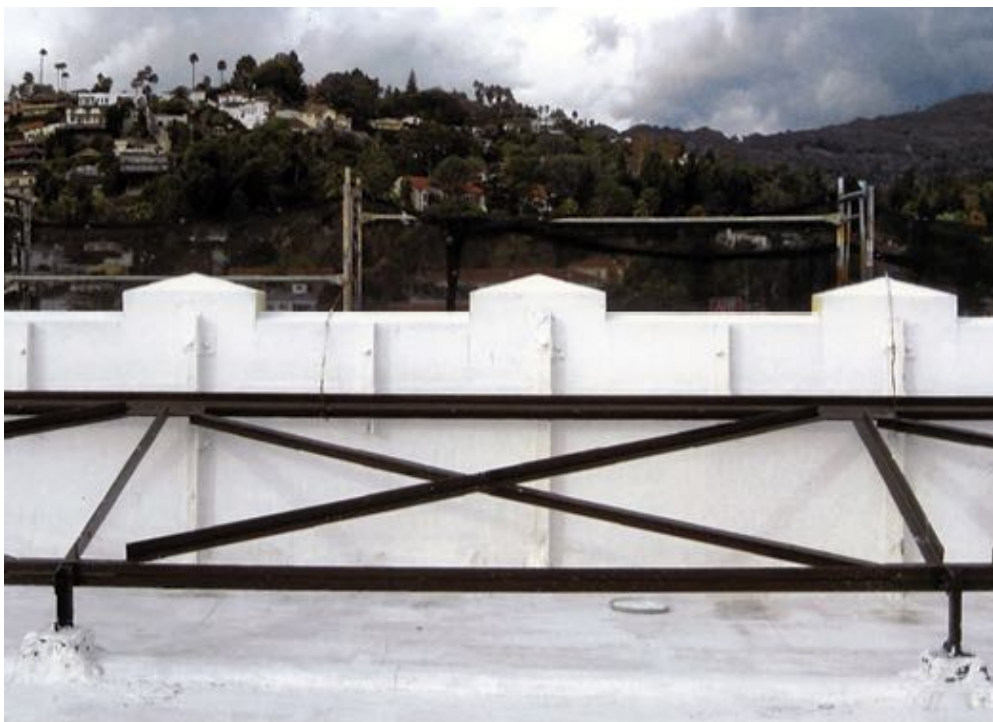
Figure 20. Bracing parapet walls, as illustrated in the typical detail drawing (top) and as installed in the image (bottom), helps avoid hazards from falling debris.

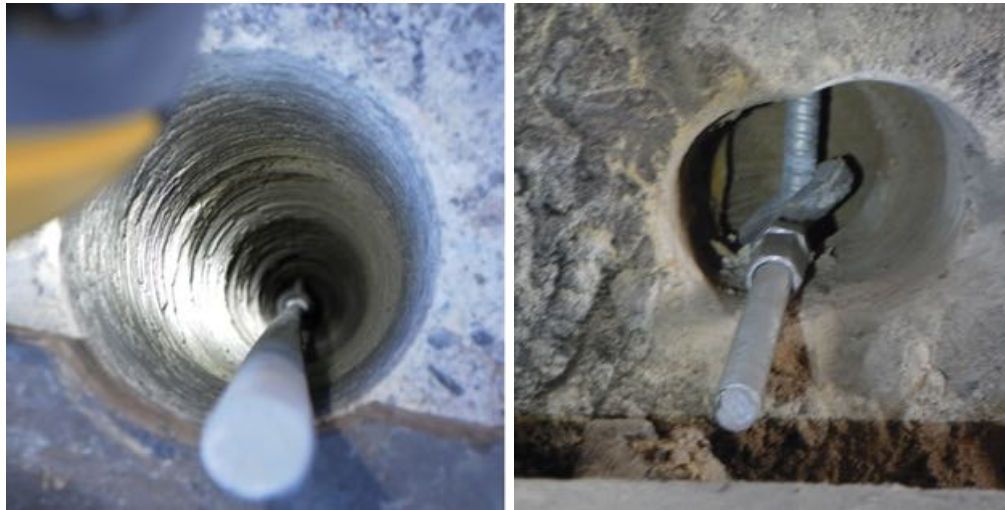
Figures 23 - 24. View of one of the center cores drilled down through the wall (top). Eye bolts are used to anchor the floor to the wall (bottom).

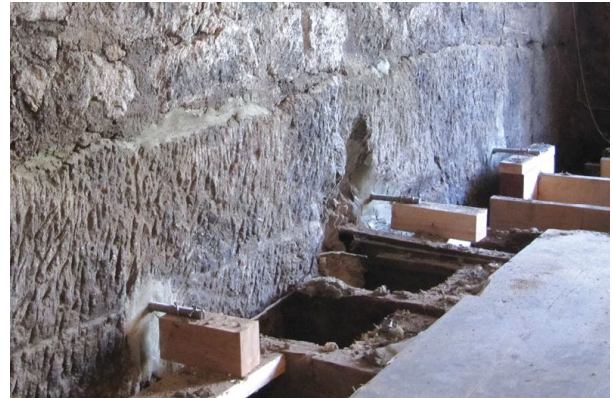
Figure 25. Location of the eye bolts after grouting. The seismic rehabilitation of this historic wine cellar building shown in Figure 21 included center coring of the exterior stone walls to add steel reinforcement, as illustrated in Figures 22 and 23. The floors were tied to the steel reinforcement in the walls using eye bolts, as seen in Figures 24 and 25, eliminating the need for exterior washers or plates. Figure 21. Photo: Architectural Resources Group. Photos: MKM & Associates.

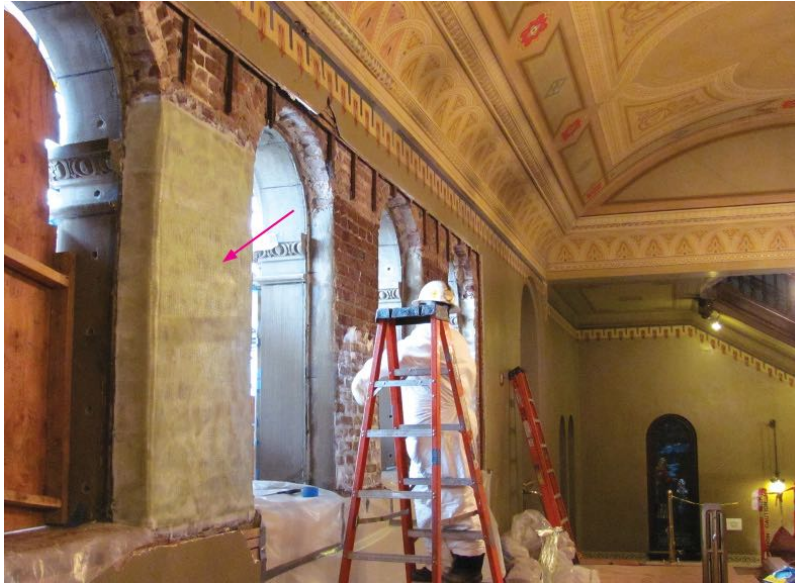
Figure 26. Epoxy-embedded fiberglass mesh is being bonded to the back of the brick pilasters of this 1906 unreinforced masonry building. New finishes matching the appearance and detailing of the original finishes will be applied over the mesh.

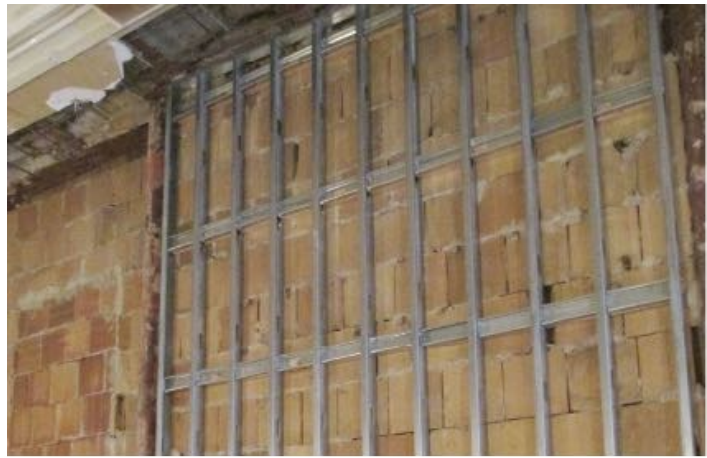
Figure 27. A new steel stud wall is being added to one side of this interior hollow-clay tile wall. The side with the least amount of historic finishes was chosen as the least disruptive location for the added reinforcement. The wall will be returned to its original appearance by installing new finishes matching the historic finishes.
Photo: Wiss, Janney, Elstner and Associates, Inc.

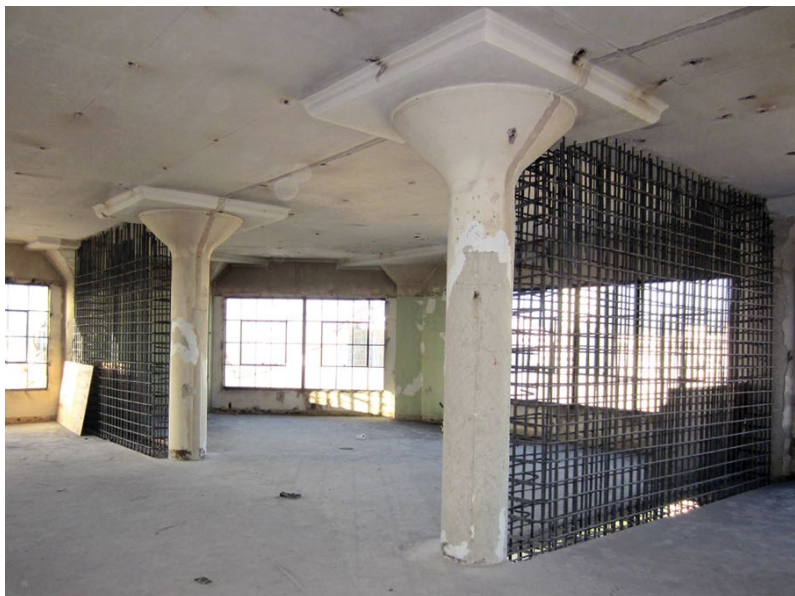
Figure 28. Steel reinforcement for the new sheer walls, perpendicular to the windows, is being installed in this concrete-frame building. Photo: Robert Chattel.

Concrete Frame. Most historic concrete building assemblies consist of concrete columns and floor systems of various types (flat slabs, two-way slabs, and beam-and-slab). Exterior and interior walls are often unreinforced masonry, commonly called infill, and are typically nonstructural, presenting the deficiencies described previously. The most important structural vulnerability of this construction type is the lack of ductility. Prior to 1960, building codes may not have required concrete-frame buildings to be designed and detailed for ductile performance (i.e., not fail when loaded beyond capacity) to resist lateral forces, depending on the region. Concrete-frame buildings were required to be “ductile” in the 1976 Uniform Building Code. In many historic concrete-frame buildings, because the connection between the columns and beams is not strong enough to resist the lateral loads during an earthquake, the buildings are in danger of collapsing. Particularly vulnerable buildings of this type are those with relatively few concrete walls and columns that are weaker than the beams or slabs. Mitigating this condition is typically accomplished by adding a new system, such as shear walls (Figure 28).

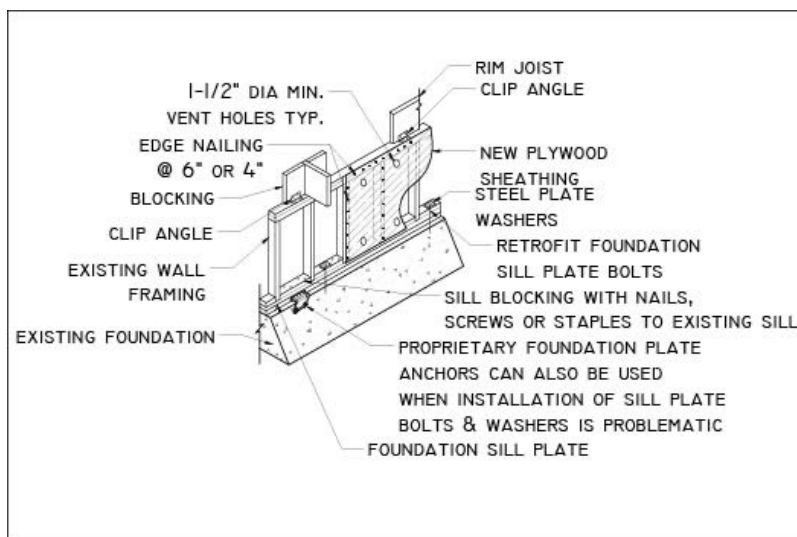
Figure 29. Cripple-wall reinforcement. Simple approaches such as nailing plywood between crawlspace studs, bolting sill plates to the foundation, and strapping the cripple wall to the floor above can make a dramatic difference in protecting a building from seismic damage.

Unbraced cripple walls and poor foundation anchorage are common vulnerabilities in many one-and two-family detached dwellings of one or more stories. In these buildings, interior walls usually provide sufficient bracing to resist lateral loads during a seismic event, but the crawlspace often only has perimeter framing which may become highly stressed and collapse during an earthquake. Adequate anchorage to the foundation in wood-frame dwellings prevents them from sliding off their foundation. Mitigating the lack of adequate bracing of cripple walls and proper foundation anchoring are high priority seismic rehabilitation measures in light wood-frame buildings (Figure 29).

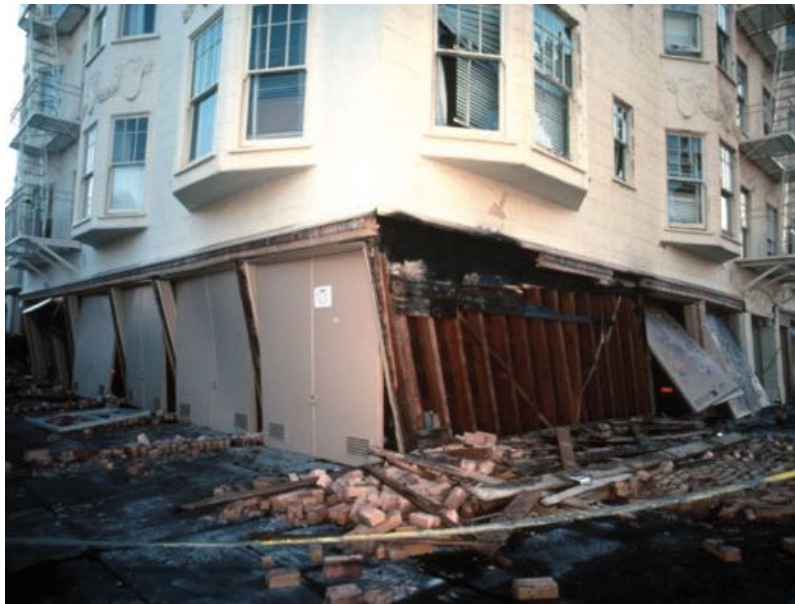
Figure 30. Large perimeter openings and a limited number of interior partitions on the ground floor can create a “weak story” condition that makes buildings particularly vulnerable to earthquake damage. Photo: USGS.

floors however, because they typically have larger exterior openings and may have more varied interior configurations and large open spaces, often create a “weak story” condition (Figure 30).
