# Lessons Drawn from Attempts to Unclog an ASR Well in an Unconsolidated Sand Aquifer

Paul Pavelic<sup>1</sup>, Peter Dillon<sup>1</sup>, Karen Barry<sup>1</sup>, Don Armstrong<sup>2</sup>,  
Allin Hodson<sup>3</sup>, Jim Callaghan<sup>4</sup> and Nabil Gerges<sup>5</sup>

February 2008

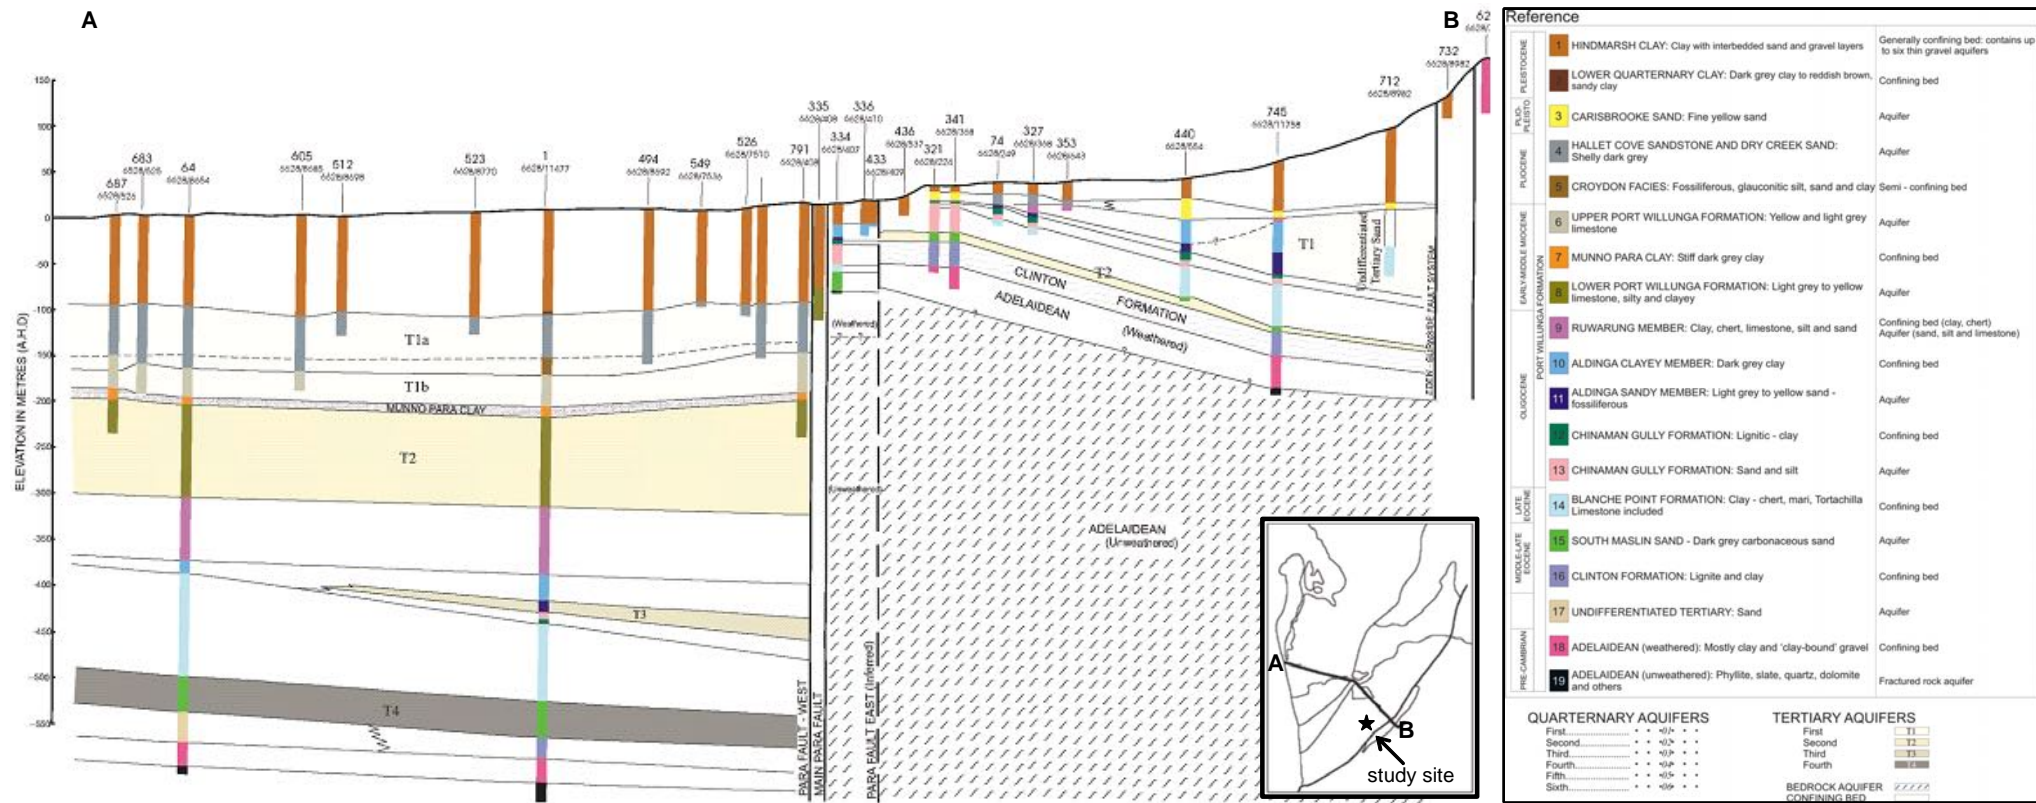
Figure 1. Hydrogeological transect across the Adelaide Plains (from Gerges, 1996)

Local drilling at the trial site identified the upper 63 m to be Hindmarsh Clay, a fluvial Quaternary unit comprised of stiff clay inter-bedded with thin aquifers. This was underlain by around 8 m of Carisbrooke Sand, the oldest Quaternary deposits, then by 23 m of Port Willunga Formation, which is of the Tertiary period (John Botting and Associates and Lisdon Associates, 1998; Gerges, 1999). The Carisbrooke Sand and the Port Willunga Formation are the most productive aquifers and were targeted for ASR. The Carisbrooke consists of medium- to fine- grained calcareous sand with some ferruginous and possibly some inter-bedded silt layers. The Port Willunga formation consists of coarse sands and gravels with varying lignitic content.

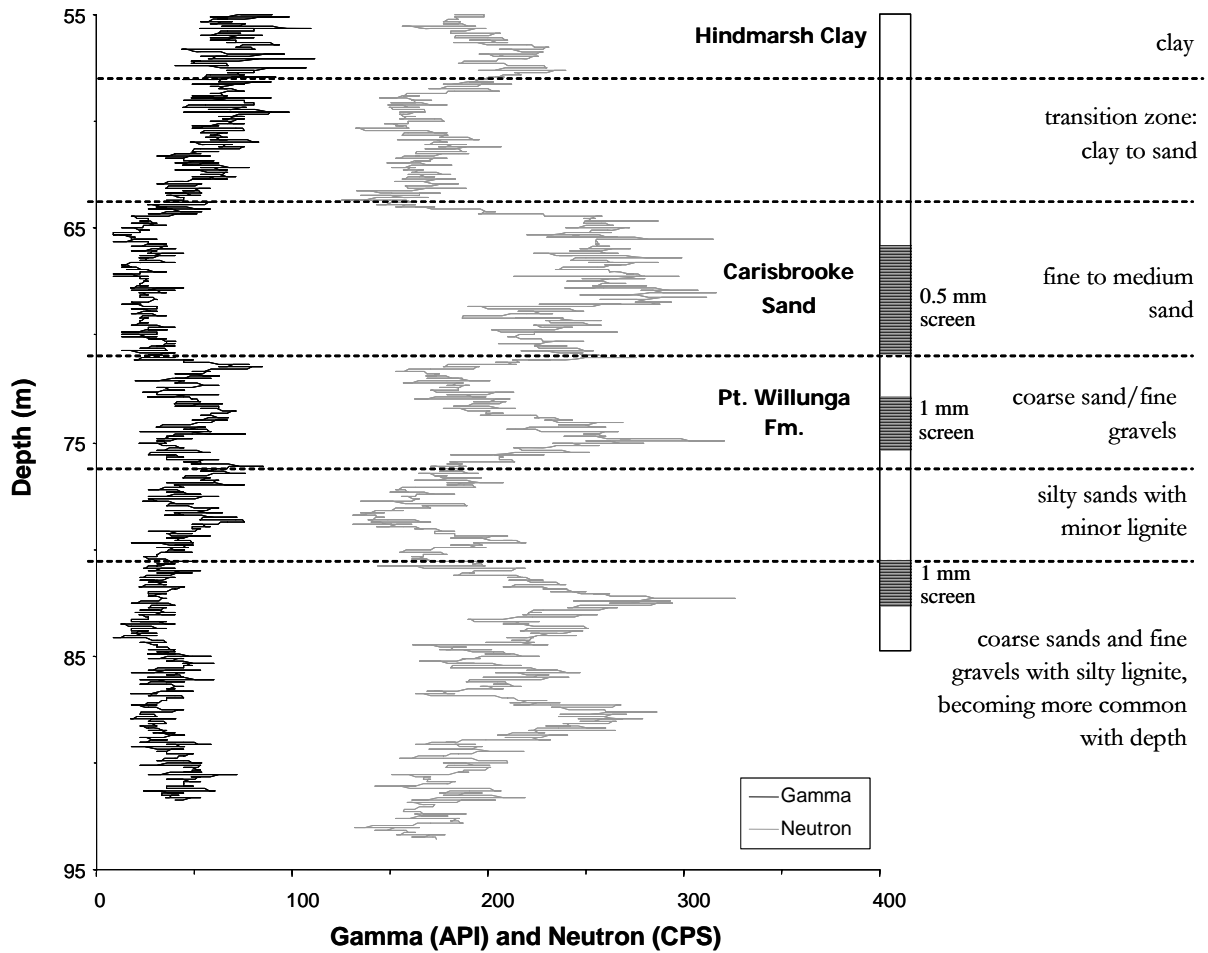
Figure 2. Geophysical logs, hydrogeology and completion arrangement of the Urrbrae ASR well (from John Botting and Associates and Lisdon Associates, 1998)

In July 1997 the ASR well (Unit Number 6628-18576) was drilled to a depth of 93.6 m using the rotary mud drilling method. Drilling ceased at this depth due to increasing lignite content and the well was later backfilled to 84.7 m (John Botting and Associates and Lisdon Associates, 1998; Appendix 1). The original pilot hole was reamed to a diameter of 229 mm (9-inch) then the well was cased in 203 mm (8-inch) UPVC and cement grouted to the surface, with a larger, 298 mm (12-inch) UPVC collar casing in the top 5 m. A 152 mm (6-inch) wire-wrapped stainless steel screen assembly was installed on the basis of geophysical logs and a limited amount of sample cuttings. Screen was installed over three intervals representing the most productive zones, with blanks fitted to avoid the more lignitic layers (Figure 2). Interpretation of the hydrogeological log presented in Figure 2 can be found within the report by John Botting and Associates and Lisdon Associates, (1998) provided in Appendix 1. The uppermost screen aperture was 0.5 mm for the finer-textured Carisbrooke sand and the lower two screens were 1.0 mm for the coarser textured Port Willunga Formation. The well was extensively airlifted and backwashed to dislodge residual drilling muds and develop a natural gravel pack. The airlift yield of the well was 3 L/s and discharge testing with the pump positioned immediately above the screens at 63.5 m (>30m below the standing water level) led to cavitation of the pump at a flow rate of 4.3 L/s. The anticipated long-term yield based upon well coefficients derived from step testing and the 33 m of available drawdown was estimated to be 3 L/s. The combined transmissivity of the aquifers was estimated to be around 6 m<sup>2</sup>/day. The ASR well is situated on the south-western corner of the holding pond, within close proximity to the source water and necessary power supply (Figure 3).

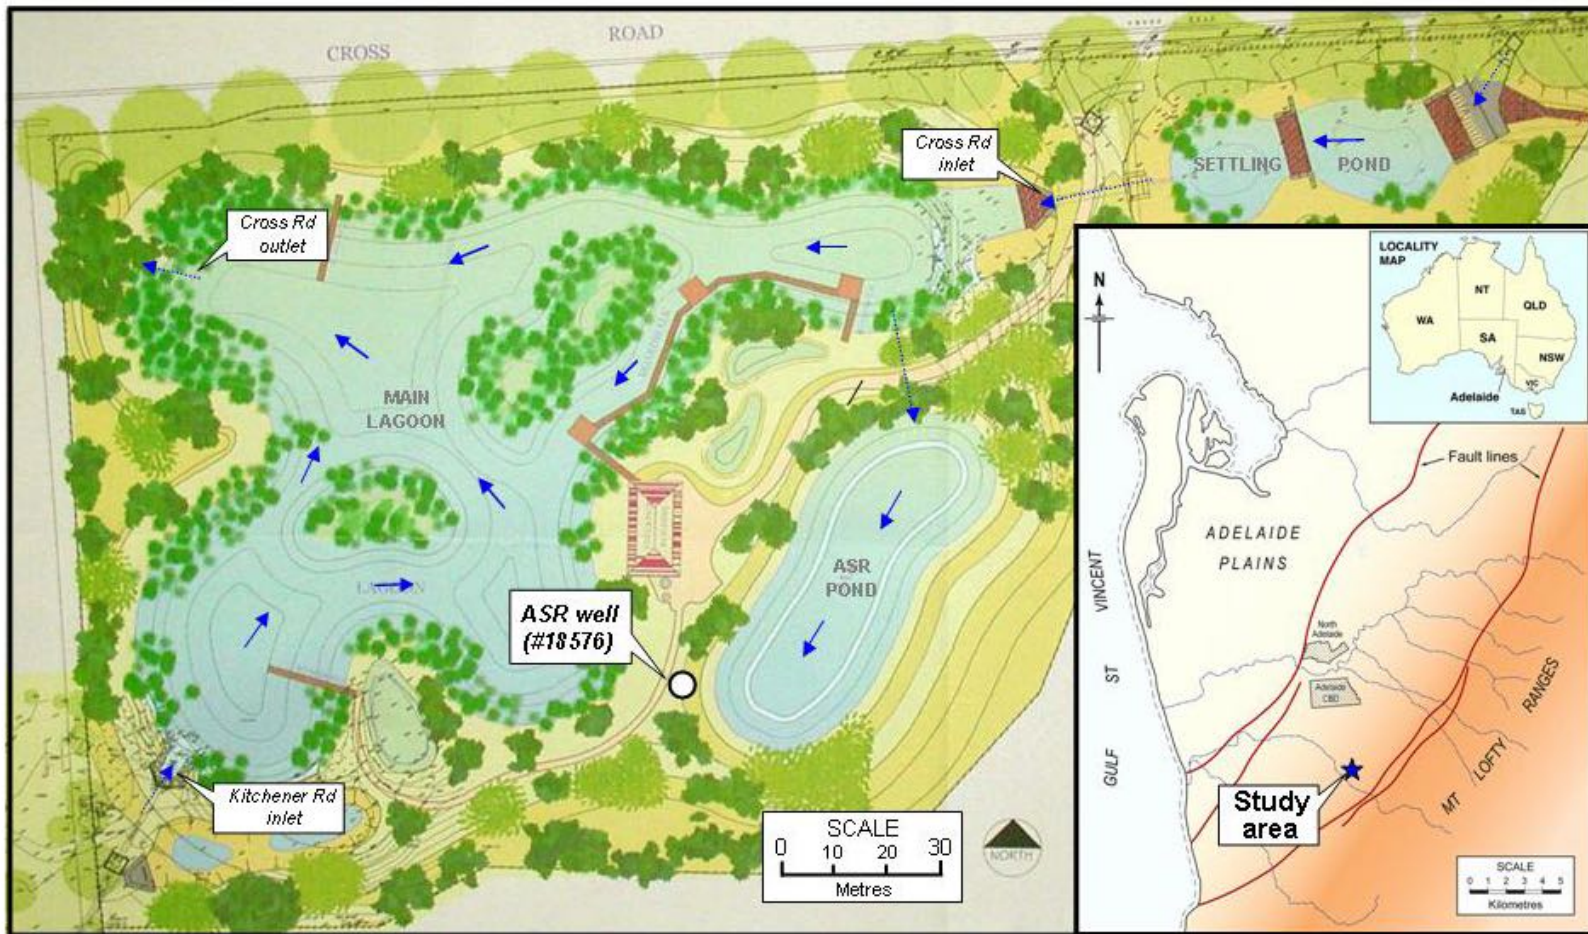
Figure 3. Site map showing location of the ASR well in relation to the holding pond (source of regional map: Bob Schuster, CSIRO). The arrows indicate the inferred direction of flow during stormwater inflow and well injection (from Lin et al., 2006). Note the pre-settling pond was established in 2003; several years after the conclusion of this study.

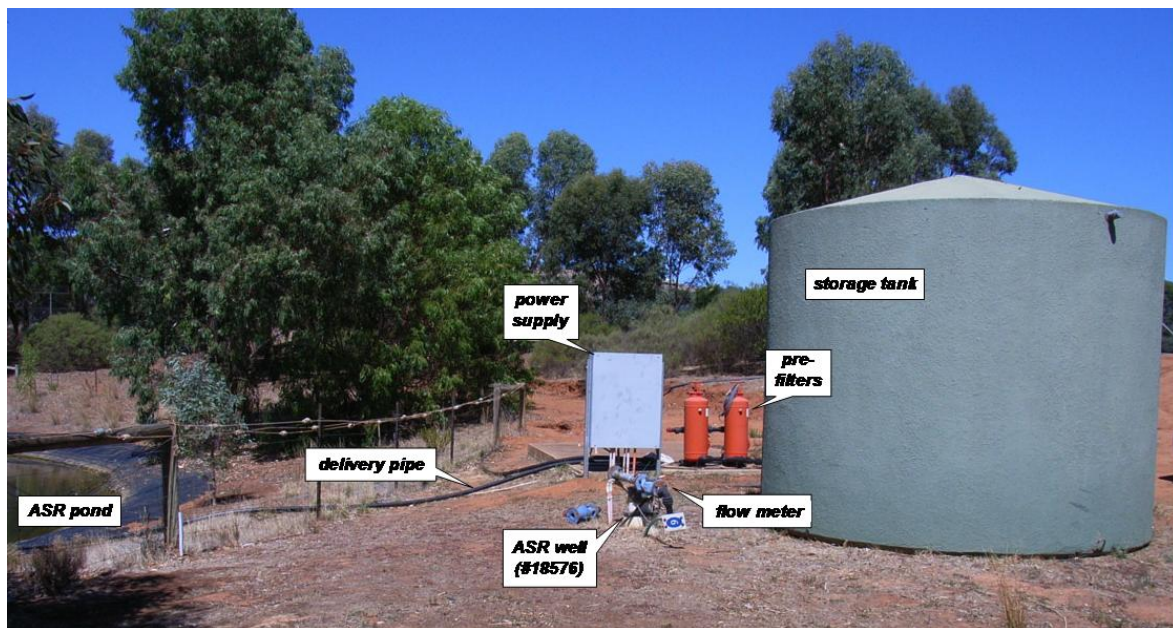
Figure 4. Study site at Urrbrae, South Australia indicating the main components of the ASR system

The components of the ASR system include the ASR well fitted with a submersible pump (Calpeda MXS 204) positioned at 80 m depth, an 8 m<sup>3</sup> ferro-cement storage tank, two rapid sand media filters (Yamit 600 series), on-line cumulative flow meter, manual flow control valves, electrical control system and cement footing for the sand filter and proposed irrigation pumps (Figure 4).

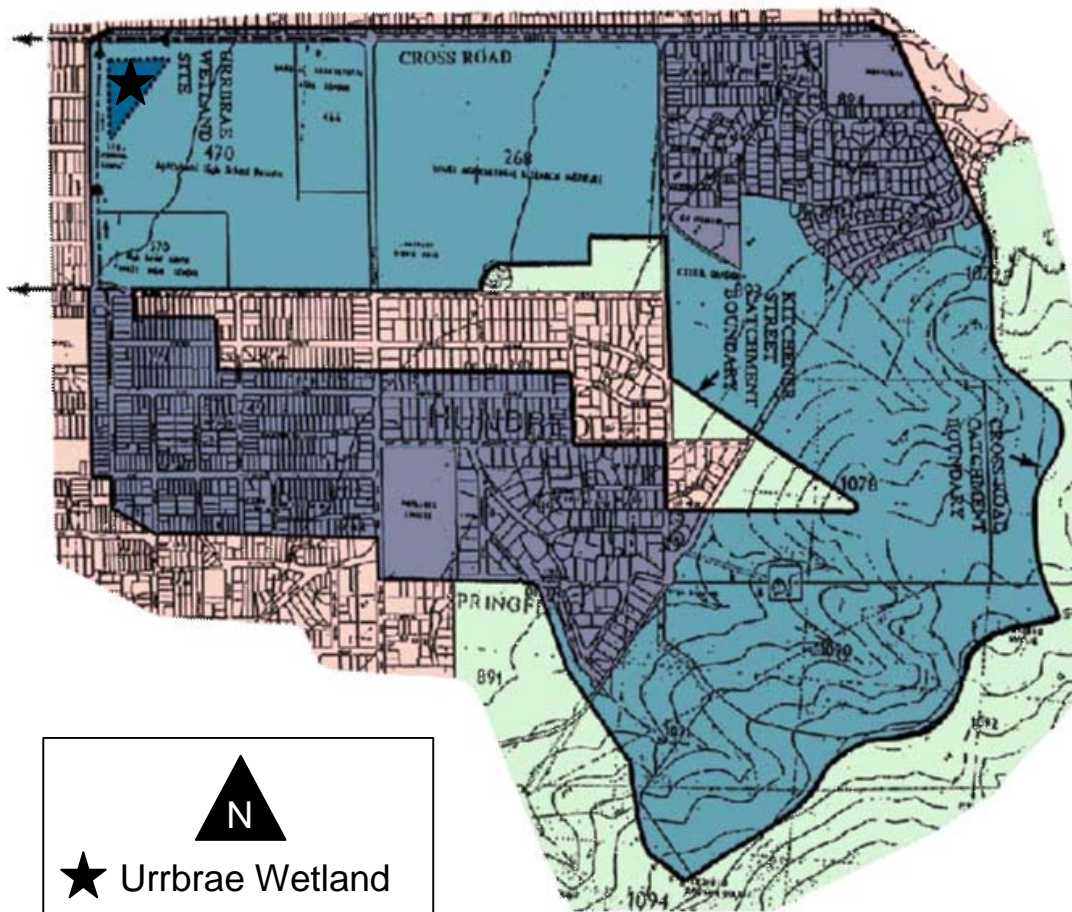
Figure 5. Surface water catchment for the Urrbrae Wetland comprising of the Cross Road and Kitchener Street sub-catchments (from Hodson, 1999)

The 375 hectare (Ha) catchment is comprised of two sub-catchments (Cross Road and Kitchener Street). Each sub-catchment takes in the margins of the Mount Lofty Ranges and adjacent Adelaide Plains (Figure 5). The catchment contains a mix of landuses including agriculture (mainly non-irrigated), residential, agricultural education and research facilities. The catchment contains virtually no industry and little development of commercial property (Hodson, 1999).

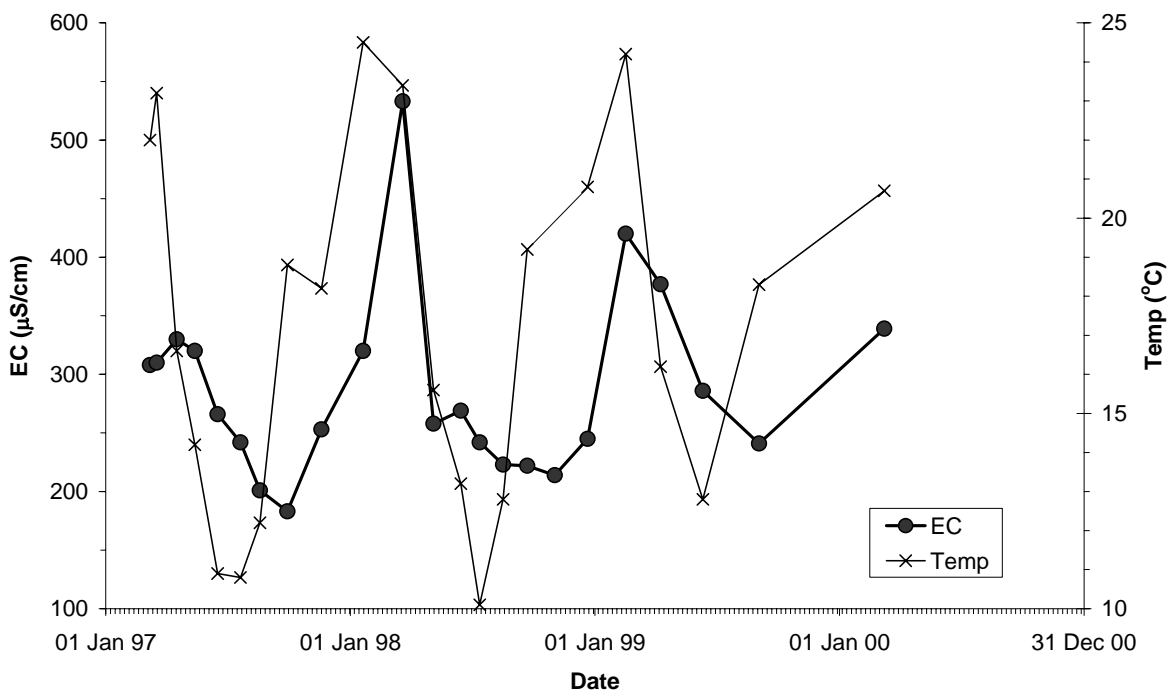
Figure 6. Electrical conductivity (EC) and temperature variations in holding pond between March 1997 and March 2000

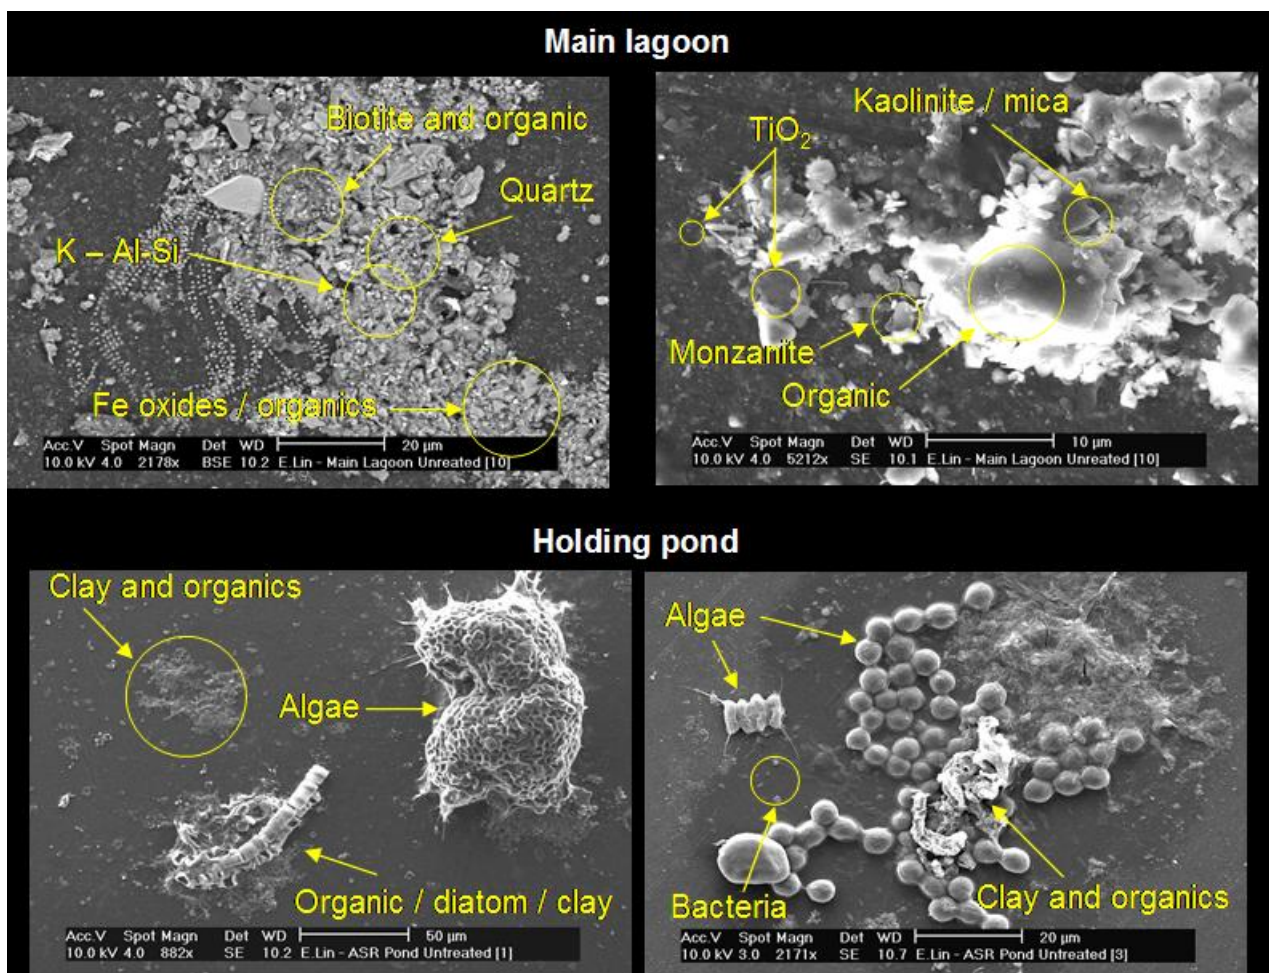
Scanning electron microscopy (SEM) images reported by Lin et al., (2006) reveal mostly inorganic and organic particle assemblages containing large organisms, some smaller organic remnants, diatoms, and bacteria in the main lagoon (Figure 7). Particle sizes range from 10 to 100  $\mu\text{m}$ . Energy Dispersive X-ray (EDX) spectra indicated aluminium-silicates, iron-oxides and organics. The holding pond water contains a diverse assortment of discrete particles (mostly macro-organisms) and complex organic and inorganic particle assemblages (or flocs) bound by organic mucilage (Figure 7). Indicative particle sizes range from 50 to 300  $\mu\text{m}$ . Macro-organisms included algae, diatoms, amoebas, fungi and bacteria. Minerals included clay minerals, quartz, and iron-oxides. The abundant amorphous mucilage was reflected in EDX spectra by the high C, O, P, S and K, while aluminium-silicate peaks were associated with the minerals. Macro-organisms were much more common (some algae were observed) and flocs were more uniformly coated with mucilage indicating different biological population or environmental conditions. SEM images previously reported by Massmann et al., (1999) show similar characteristics.

Figure 7. SEM micrographs showing typical particles in main lagoon during stormwater inflow on 19 Oct. 2005 (top row) and holding pond water from 17 Oct. 2005 (bottom row) (from Lin et al., 2006).

SEM imaging of the backwash water revealed that all of the particles were significantly smaller than the injected particles, with dimensions less than 5 to 10 µm (Figure 9). Lin *et al.*, (2006) demonstrated that the passage of the Urrbrae Wetland water through a roughing filter pre-treatment system also reduced the effective size of particles in the treated water. The majority of particles evident in Figure 9 are inorganic, whereas a much higher organic content was present in the injectant (Figure 7).

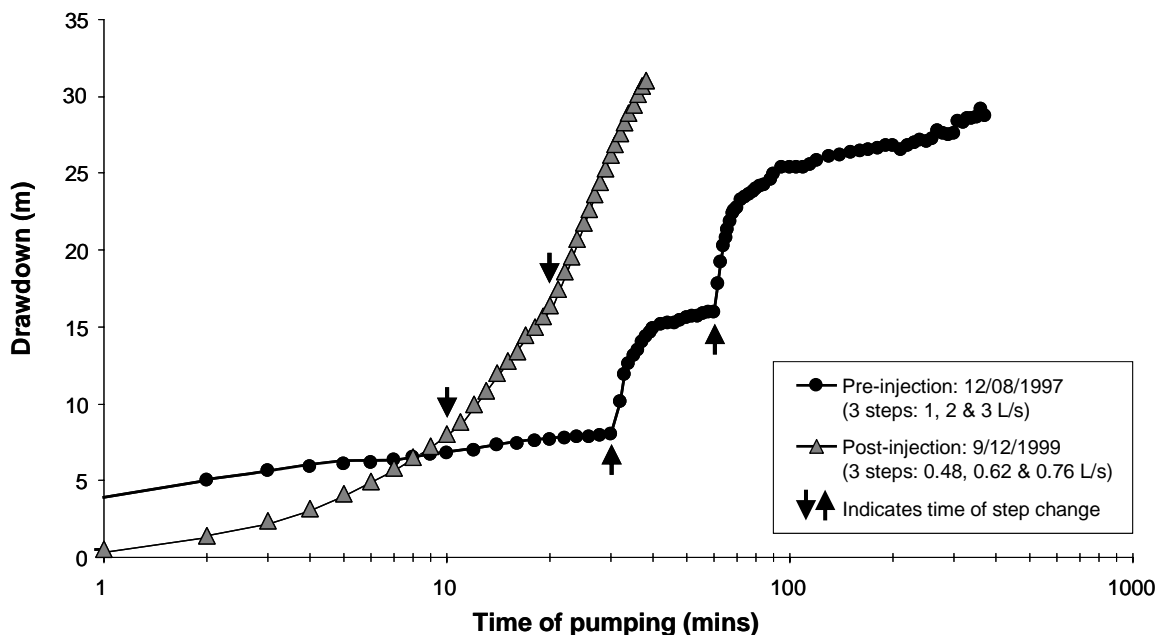
The severity of clogging is indicated by the results of pumping tests conducted before and after injection (Figure 8). This figure shows, for example, that post-injection a 28 m drawdown was achieved 9 times faster with pumping rates 2-4 times lower than pre-injection.

Figure 8. Semi-log plot of drawdown in ASR well versus time of pumping for pre- and post- injection pumping tests

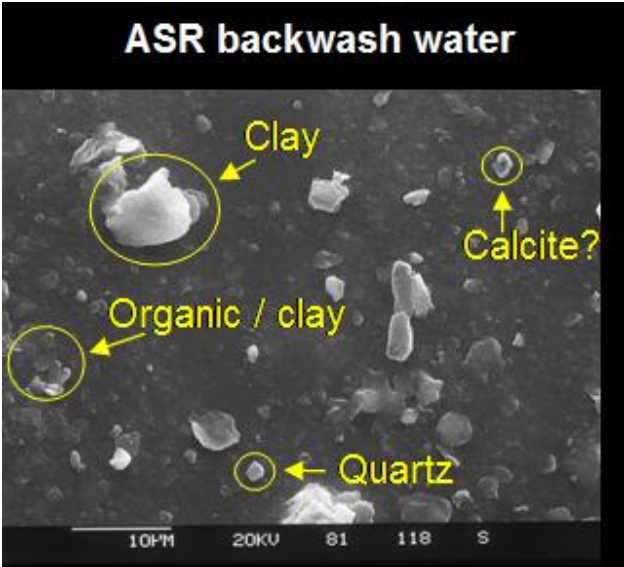
Figure 9. SEM micrographs showing particles in backwash water from ASR well on 10 Dec. 1999

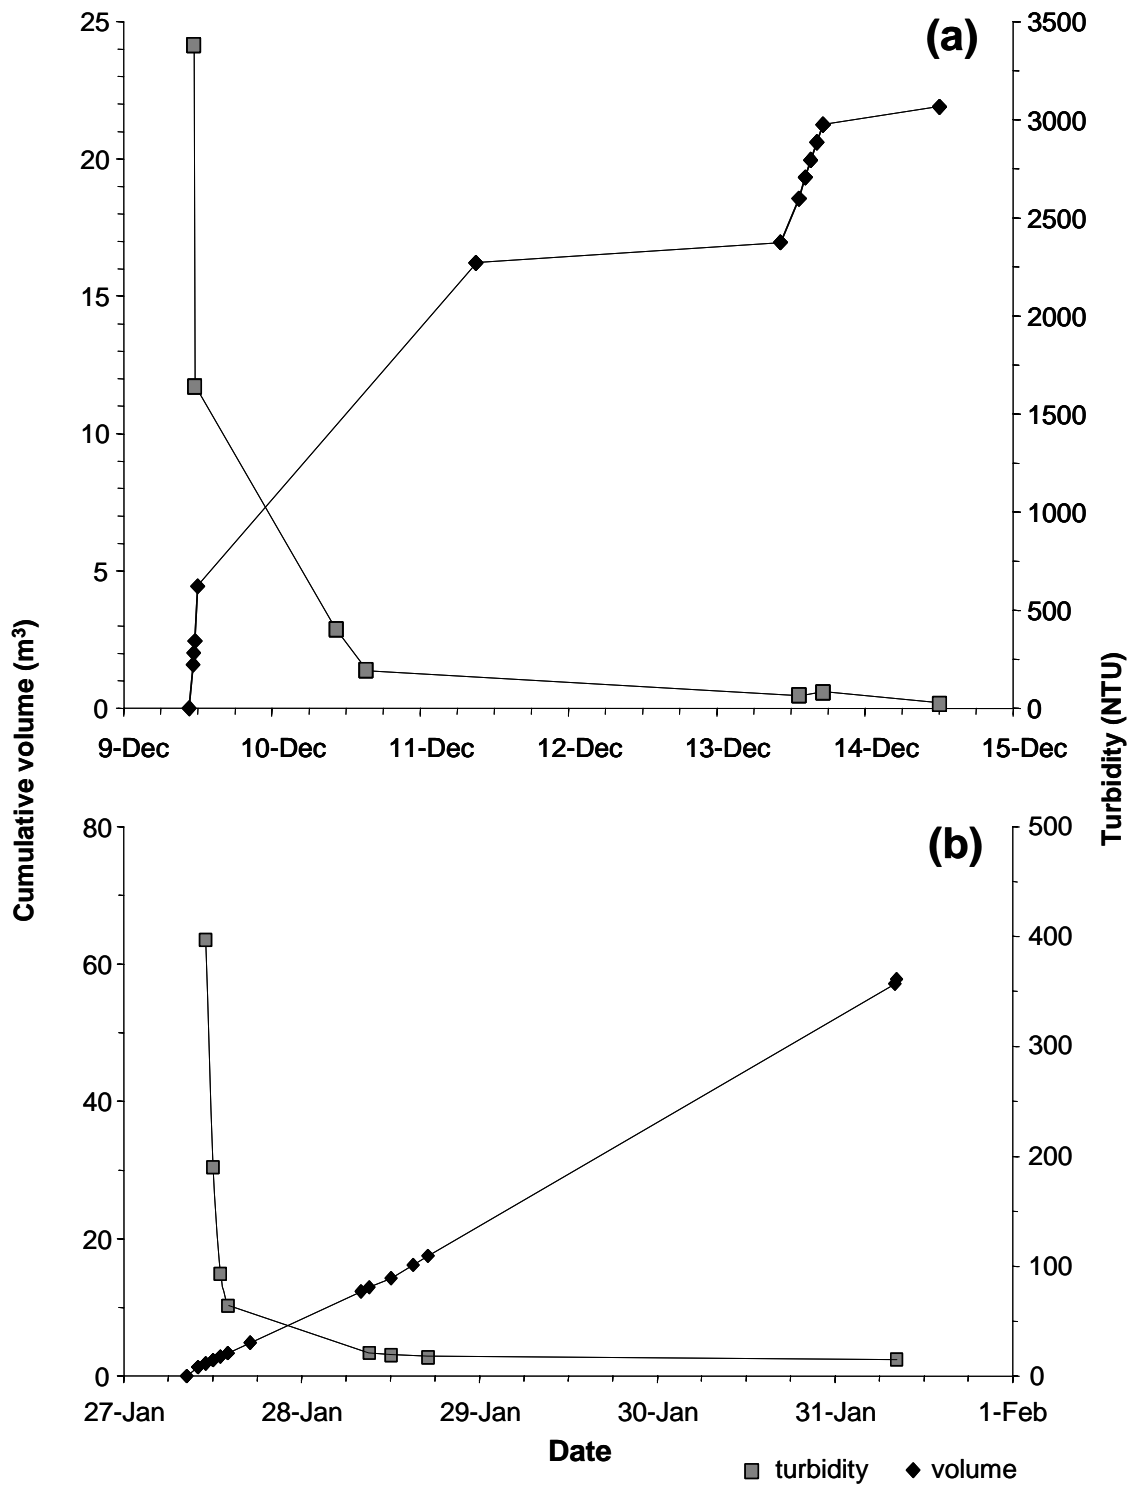
As Figure 10a shows, the turbidity of the recovered water initially peaked at 3500 NTU and declined exponentially to a final value of 21 NTU after 22 m<sup>3</sup> had been pumped. The final turbidity was similar to the average injectant turbidity (Table 1). There was no visual evidence of oil residue in the backwash waters. Recurrent pumping and the demonstrated removal of at least some of the clogging agents from around the well failed to produce a measurable improvement in well efficiency. The specific capacity remained unchanged at 3-5 m<sup>3</sup>/d/m, far lower than the pre-injection values of 11-13 m<sup>3</sup>/d/m (Figure 11). The evidence seemed to suggest that only a small fraction of the most easily-dislodged clogging agents had been recovered from around the well-screens.

During pumping the initial peak in turbidity was 400 NTU and declined exponentially to reach a final value of 15 NTU (Figure 10b). Surprisingly, this peak value was almost an order of magnitude lower than the highest concentration measured in December 1999. Once again, pump testing on 1 Feb. and 8 Mar. 2000 revealed little or no improvement in the specific capacity of the well (Figure 11).

Figure 10. Changes in turbidity and the cumulative volume of water pumped during redevelopment events. The upper plot (a) is before rehabilitation in December 1999; the lower plot (b) is after well chlorination in January 2000.

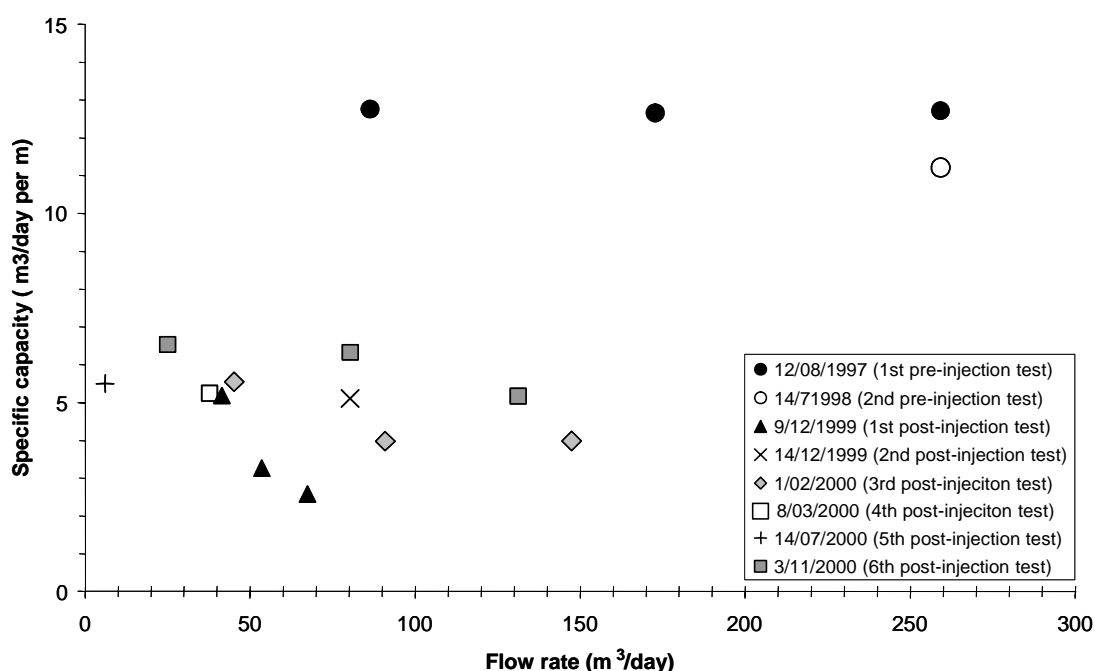
Figure 11. Plot of specific capacity (at t=10mins) versus pumping rate at different stages of the trial

Pump testing in July and November 2000 clearly showed that there was a slight improvement in well performance as compared to the situation in December 1999 situation, but still well below the initial conditions (Figure 11).

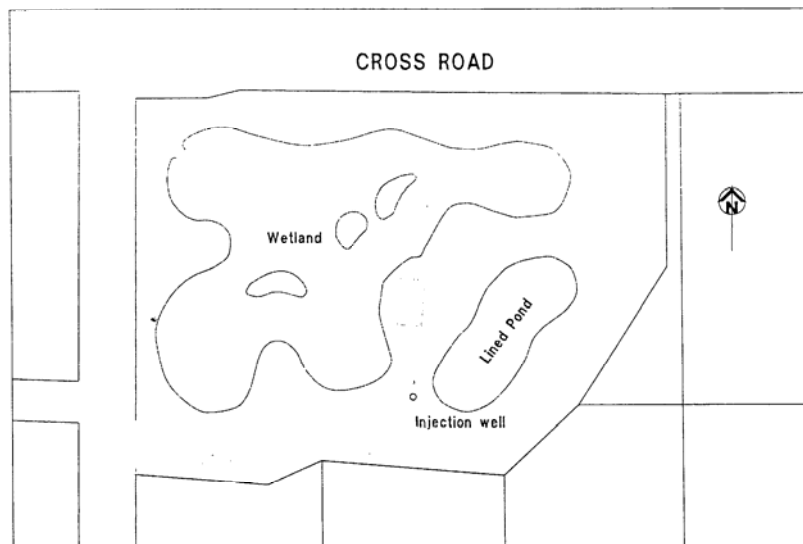
A suitable location for the trial injection well was found in the south west corner of the lined pond enclosure. This site, shown on Figure 1 was selected since it was adjacent to the likely source of injection water and within a short distance of the necessary power cables.

Figure 1 Injection Well Location
