# The Maintenance and Repair of Architectural Cast Iron

## Preservation Briefs

## 27

### John G. Waite, AIA, Historical Overview by Margot Gayle

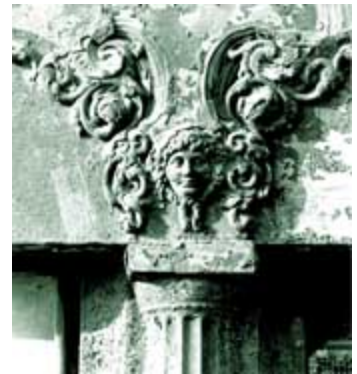
Cast iron feature in need of cleaning and painting.  
Photo: Courtesy, New York Landmarks Conservancy.

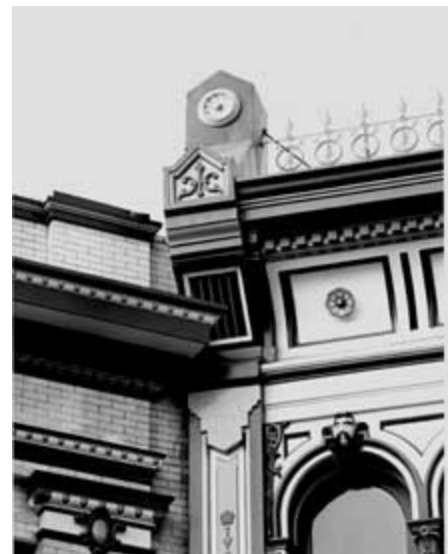
This shows a detail of a polychromed cast-iron facade in Petaluma, California, 1886 (O'Connell and Lewis, Architectural Iron Works, San Francisco). Photo: Don Meacham.

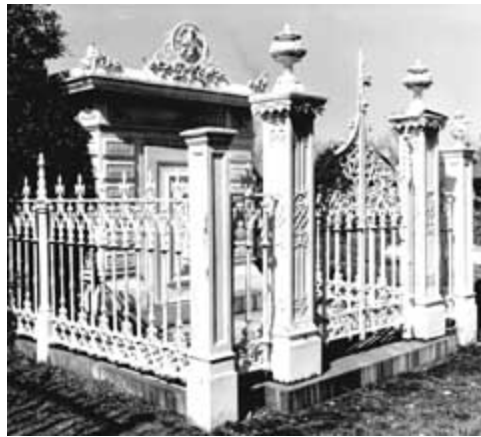
The Slatter Family Tomb in Mobile, Alabama, consisting of a cast-iron mausoleum and fence, exhibits the wide range of uses of the material in the 19th century. Photo: Jack E. Boucher, HABS Collection.

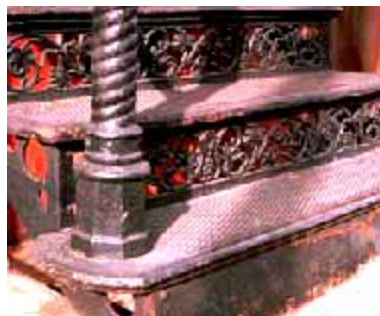
The risers on these cast iron steps feature a highly decorative pattern. Photo: NPS files.

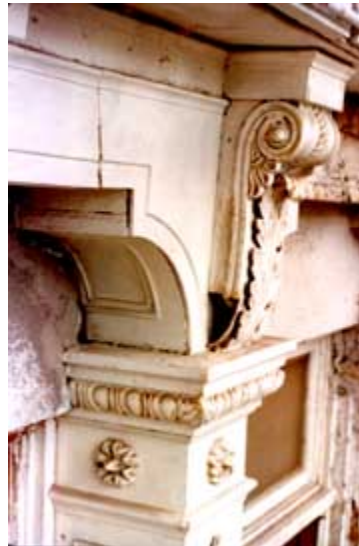
Structural crack, gaps at joints between components, and a large opening where part of the console bracket is missing are the problems evident in this cast-iron assembly. Photo: Ford, Powell & Carson.

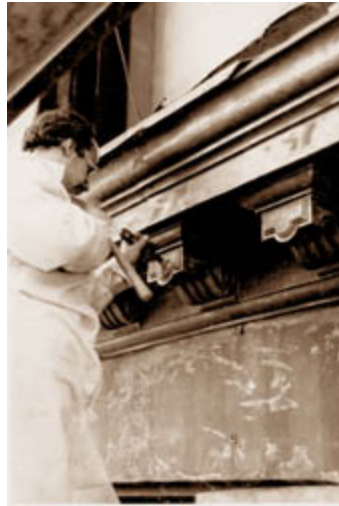
Where chemical paint stripping is involved, careful planning of the sequence of work and inspection by an architect or conservator to ensure strict compliance with the contract documents is important to minimize the risk of problems. Photo: Raymond M. Pepi, Building Conservation Associates.

Chemical paint removal using alkaline compounds, such as methylene chloride or potassium hydroxide, can be an effective alternative to abrasive blasting for removal of heavy paint buildup. These agents are often available as slow-acting gels or pastes. Because they can cause burns, protective clothing and eye protection must be worn. Chemicals applied to a non-watertight facade can seep through crevices and holes, resulting in damage to the building's interior finishes and corrosion to the backside of the iron components. If not thoroughly neutralized, residual traces of cleaning compounds on the surface of the iron can cause paint failures in the future. For these reasons, field application of alkaline paint removers and acidic cleaners is not generally recommended.

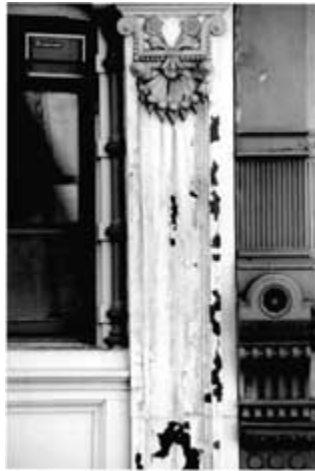
On this building, a strong alkaline paint remover was used, and apparently was not adequately rinsed or neutralized. Over a period of months, the newly applied paint began to peel and streaks of rust appeared on the iron. Photo: Kim Lovejoy.

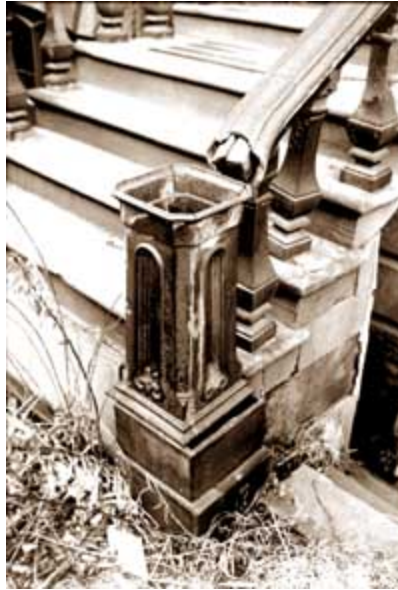
In an effort to repair the stair railing, concrete was poured around the wood spacer inside the railing ceiling. Water penetrated the railing and reacted with the concrete to accelerate the corrosion of the iron. Photo: John G. Waite.

The internal voids of balusters, newel posts, statuary, and other elements should not be filled with concrete; it is an inappropriate treatment that causes further problems. As the concrete cures, it shrinks, leaving a space between the concrete and cast iron. Water penetrating this space does not evaporate quickly, thus promoting further rusting. The corrosion of the iron is further accelerated by the alkaline nature of concrete. Where cast-iron elements have been previously filled with concrete, they need to be taken apart, the concrete and rust removed, and the interior surfaces primed and painted before the elements are reassembled.

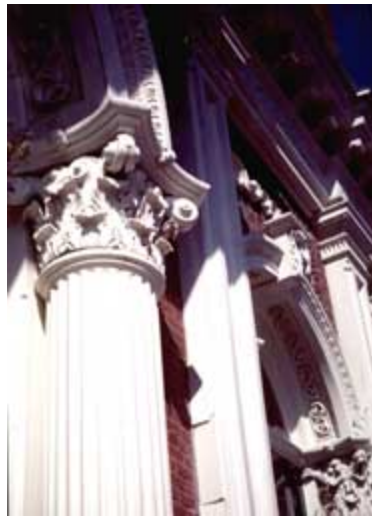
Fiberglass columns and aluminum capitals were installed to replicate the ornamental features on the east facade of the New Market Theater in Portland, Oregon. Photo: William J. Hawkins, III.

Reinforced polyester, commonly known as fiberglass, is often used as a lightweight substitute for historic materials, including cast iron, wood, and stone. In its most common form, fiberglass is a thin, rigid, laminate shell formed by pouring a polyester resin into a mold and then adding fiberglass for reinforcement. Like epoxies, fiberglass is non-corrosive, but is susceptible to ultraviolet degradation. Because of its rather flimsy nature, it cannot be used as a substitute for structural elements, cannot be assembled like cast iron and usually requires a separate anchorage system. It is unsuitable for locations where it is susceptible to damage by impact, and is also flammable.

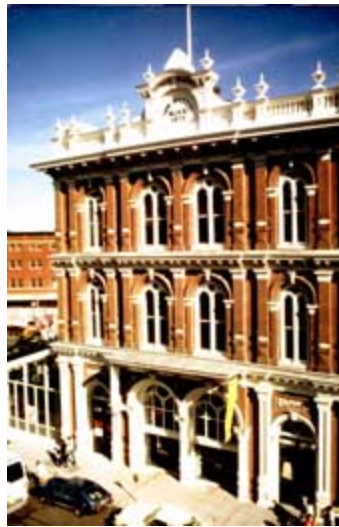
The west facade of the New Market Theater retains its original cast iron features. Photo: George McMath.

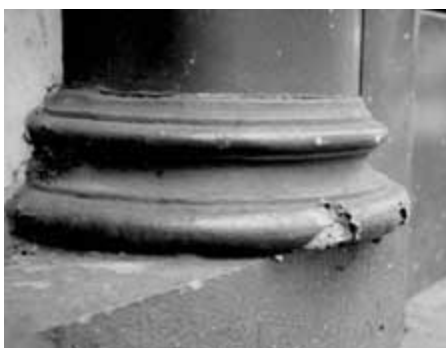
This lightweight fiberglass column at street level sustained damage from impact within a few years of installation. Photo: Building Conservation Associates.
