WIND SPEED–DAMAGE CORRELATION IN HURRICANE KATRINA

WIND SPEED-DAMAGE CORRELATION IN HURRICANE KATRINA

Timothy P. Marshall*
Haag Engineering Co.
Dallas, Texas

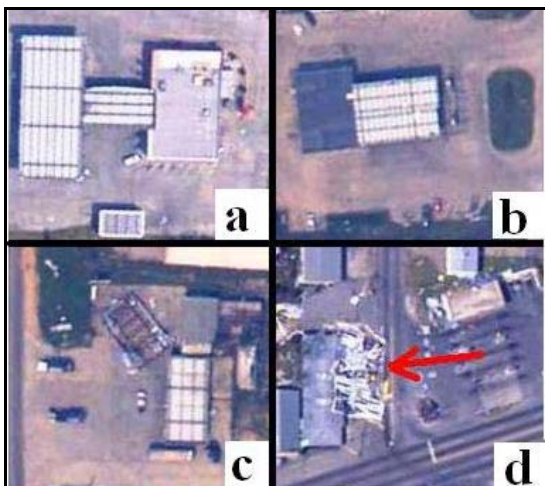
Figure 3. Various DODs to gas station canopies in the study area: a) no visible damage, b) removal of some roof panels (DOD 3), c) collapse of canopy (DOD 5), and transport of canopy across the street as shown by the red arrow (DOD 6).

However, an isolated increase in the DOD does not necessarily mean an isolated increase in wind speed. Note the collapsed canopy with loss of its metal panels in Fig. 3c adjacent to a relatively undamaged canopy. Flaws in the construction of the canopy or poor attachment/anchoring can better explain such sharp gradations in the damage rather than a rapid change in wind speed. Therefore, it is important to examine adjacent items when trying to determine a failure wind speed. Also, a site inspection may be required to better determine a failure wind speed.

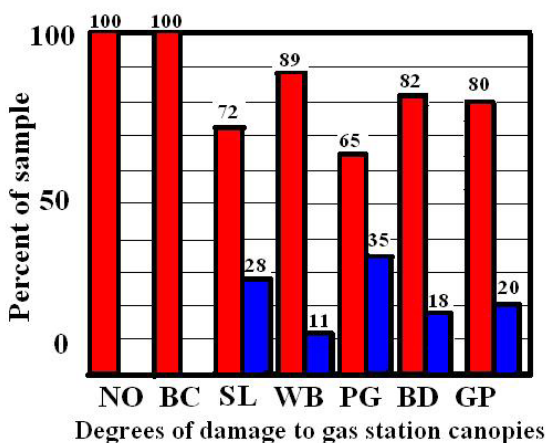
Fig. 4 shows the DODs for each of the seven geographic zones in this study area. Not surprisingly, canopies that lost metal panels occurred from Slidell, LA eastward, where the strongest winds occurred. A higher percentage of gas station canopies experienced a loss of metal panels in the Pass Christian-Gulfport, MS area with 35 percent of the canopies experiencing some damage. Overall, the frequency of gas station canopies losing panels in the study area was 1 in 10 and the frequency for collapse or displacement of canopies was 1 in 33.

Figure 4. Normalized percentage of wind damage to gas station canopies in the seven geographic zones. Red bars are DOD 2 or less whereas blue bars are DOD 3 or more.

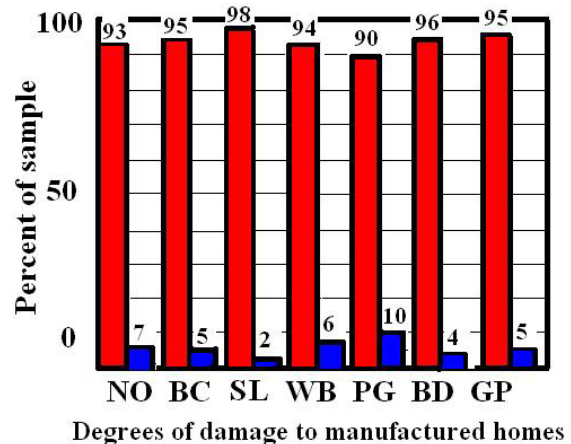
Fig. 7 depicts the DODs within the seven geographic zones. Overall, there was not much difference in the degree of wind damage to manufactured homes across the study area. Only slightly more wind damage occurred to manufactured homes from Waveland to Gulfport, MS, where the strongest winds occurred.

Figure 7. Normalized percentage of wind damage to manufactured homes in the seven geographic zones. Red bars indicate the percentage of DOD 2 or less whereas blue bars indicate the percentage of DOD 4 or more.

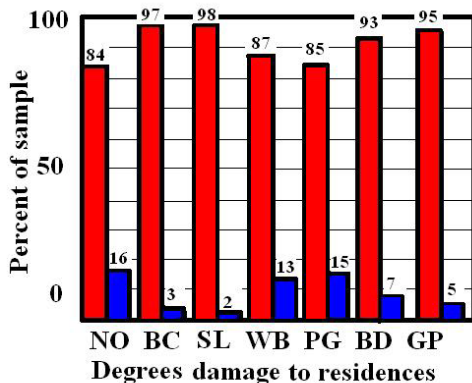
Fig. 10 depicts the DODs to residences within the seven geographic zones. Overall, there was not much difference in the degree of wind damage to residences across the study area. Slightly more wind damage did occur from Waveland to Gulfport, MS as expected since this area experienced the strongest winds. However, the DODs to residences were just as great in eastern New Orleans, LA as in the hardest hit areas in Mississippi. We suspect that the exposure of residences to northerly winds across Lake Pontchartrain accounted for higher degree of wind damage to roofs there.

Figure 10. Normalized percentage of wind damage to residences for the seven geographic zones in the study area. Red bars are DOD 2 or less whereas blue bars are DOD 4 or more.

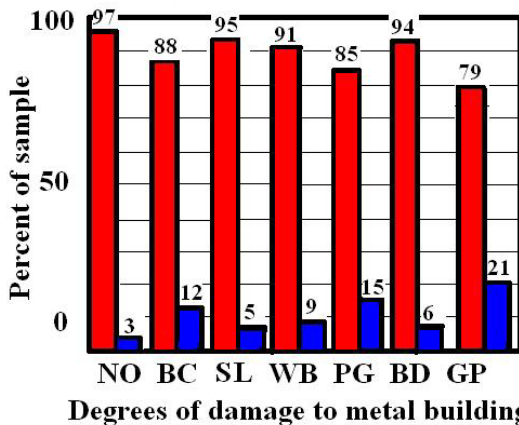
Fig. 13 depicts the DODs to metal buildings within the seven geographic zones. Interestingly, more wind damage occurred to the older metal buildings at the Ingalls shipyard in Pascagoula, MS than in other areas. However, the greatest numbers of damaged metal buildings were in Gulfport, MS but due to the heavy concentration of undamaged buildings, the overall percentages of building damage averaged out.

Figure 13. Normalized percentage of wind damage to metal buildings for the seven geographic zones in the study area. Red bars are DOD 2 or less whereas blue bars are DOD 3 or more.

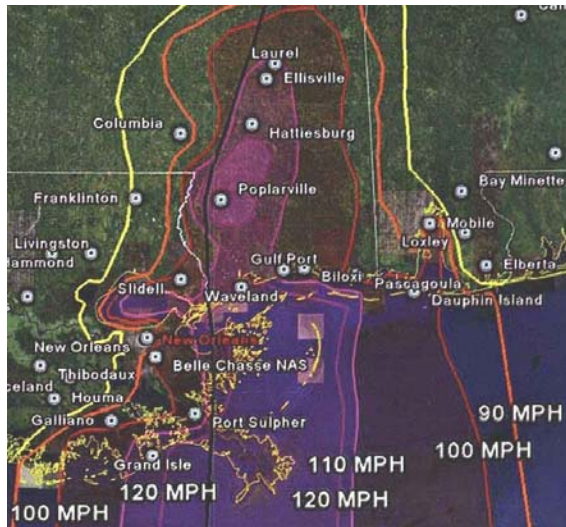
Overall, the wind values in this study agreed quite well with the maximum wind speeds estimated by NOAA and FEMA (Figs. 14 and 15). However, since most buildings were in Exposure B not C, and were well below 10 m (33 ft.), the vast majority of structures in hardest hit areas did not experience the strongest winds.

Figure 14. Estimated maximum wind gusts (in miles per hour) for Louisiana, Mississippi, and Alabama during Hurricane Katrina by NOAA (2005a).

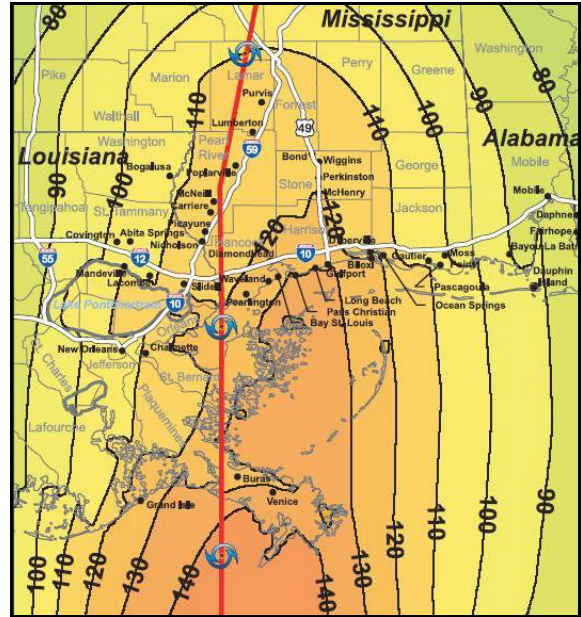
Figure 15. Estimated maximum three-second wind gusts (in miles per hour) for Louisiana, Mississippi, and Alabama for Hurricane Katrina at 10 m (33 ft.) above the ground in Exposure C by FEMA (2006).
