# Hurricane Laura Damage Survey

Timothy P. Marshall<sup>1</sup>  
Haag Engineering Company

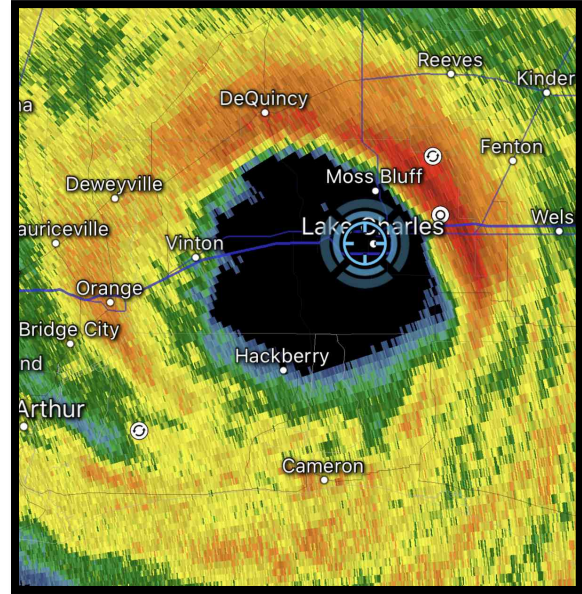
**Figure 1.** The eye of Hurricane Laura over Lake Charles, LA around 0730 UTC. The author was on top of a parking garage within the blue circle. Image from RadarScope.
