MILLS NOS. 5, 6 and 8 Suffolk Manufacturing Company (Wannalancit Office and Technology Center)

Lowell, Massachusetts

WINDOWS NUMBER 13

Aluminum Replacement Windows with Sealed Insulating Glass and Trapezoidal Muntin Grids

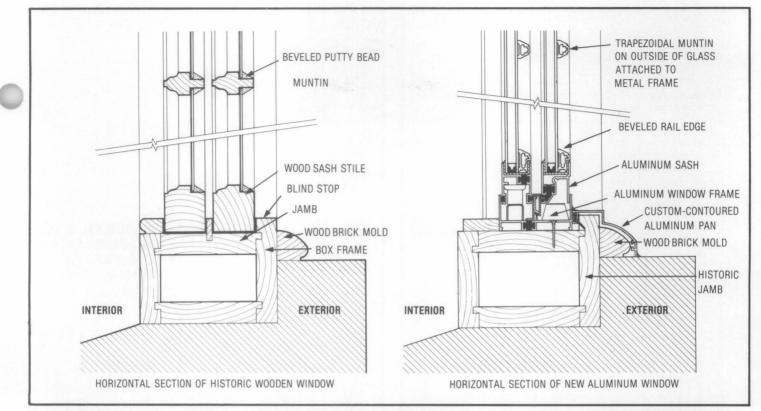
The historic wooden frames were retained and used as a structural subframe on which to fasten the new aluminum trim and frame members. A custom extruded aluminum pan was used that fitted snugly around the exposed face of the original frame and maintained the face width and depth of the casing at both jamb and head. The original wooden brick molding (which covers the joint between the masonry and the window frame) was fitted with a customextruded aluminum pan (see figure 3).

Figure 3. Horizontal section of both the original wooden window and the replacement aluminum window. Drawings: Penelope Watson
