# HISTORIC STRUCTURE REPORT

SOUTHWEST REGION HEADQUARTERS BUILDING  
SANTA FE, NEW MEXICO

A Historic Structure Report

Southwest Cultural Resources Center Professional Paper No. 6  
U.S. Department of the Interior  
National Park Service  
Santa Fe, New Mexico  
March 1985

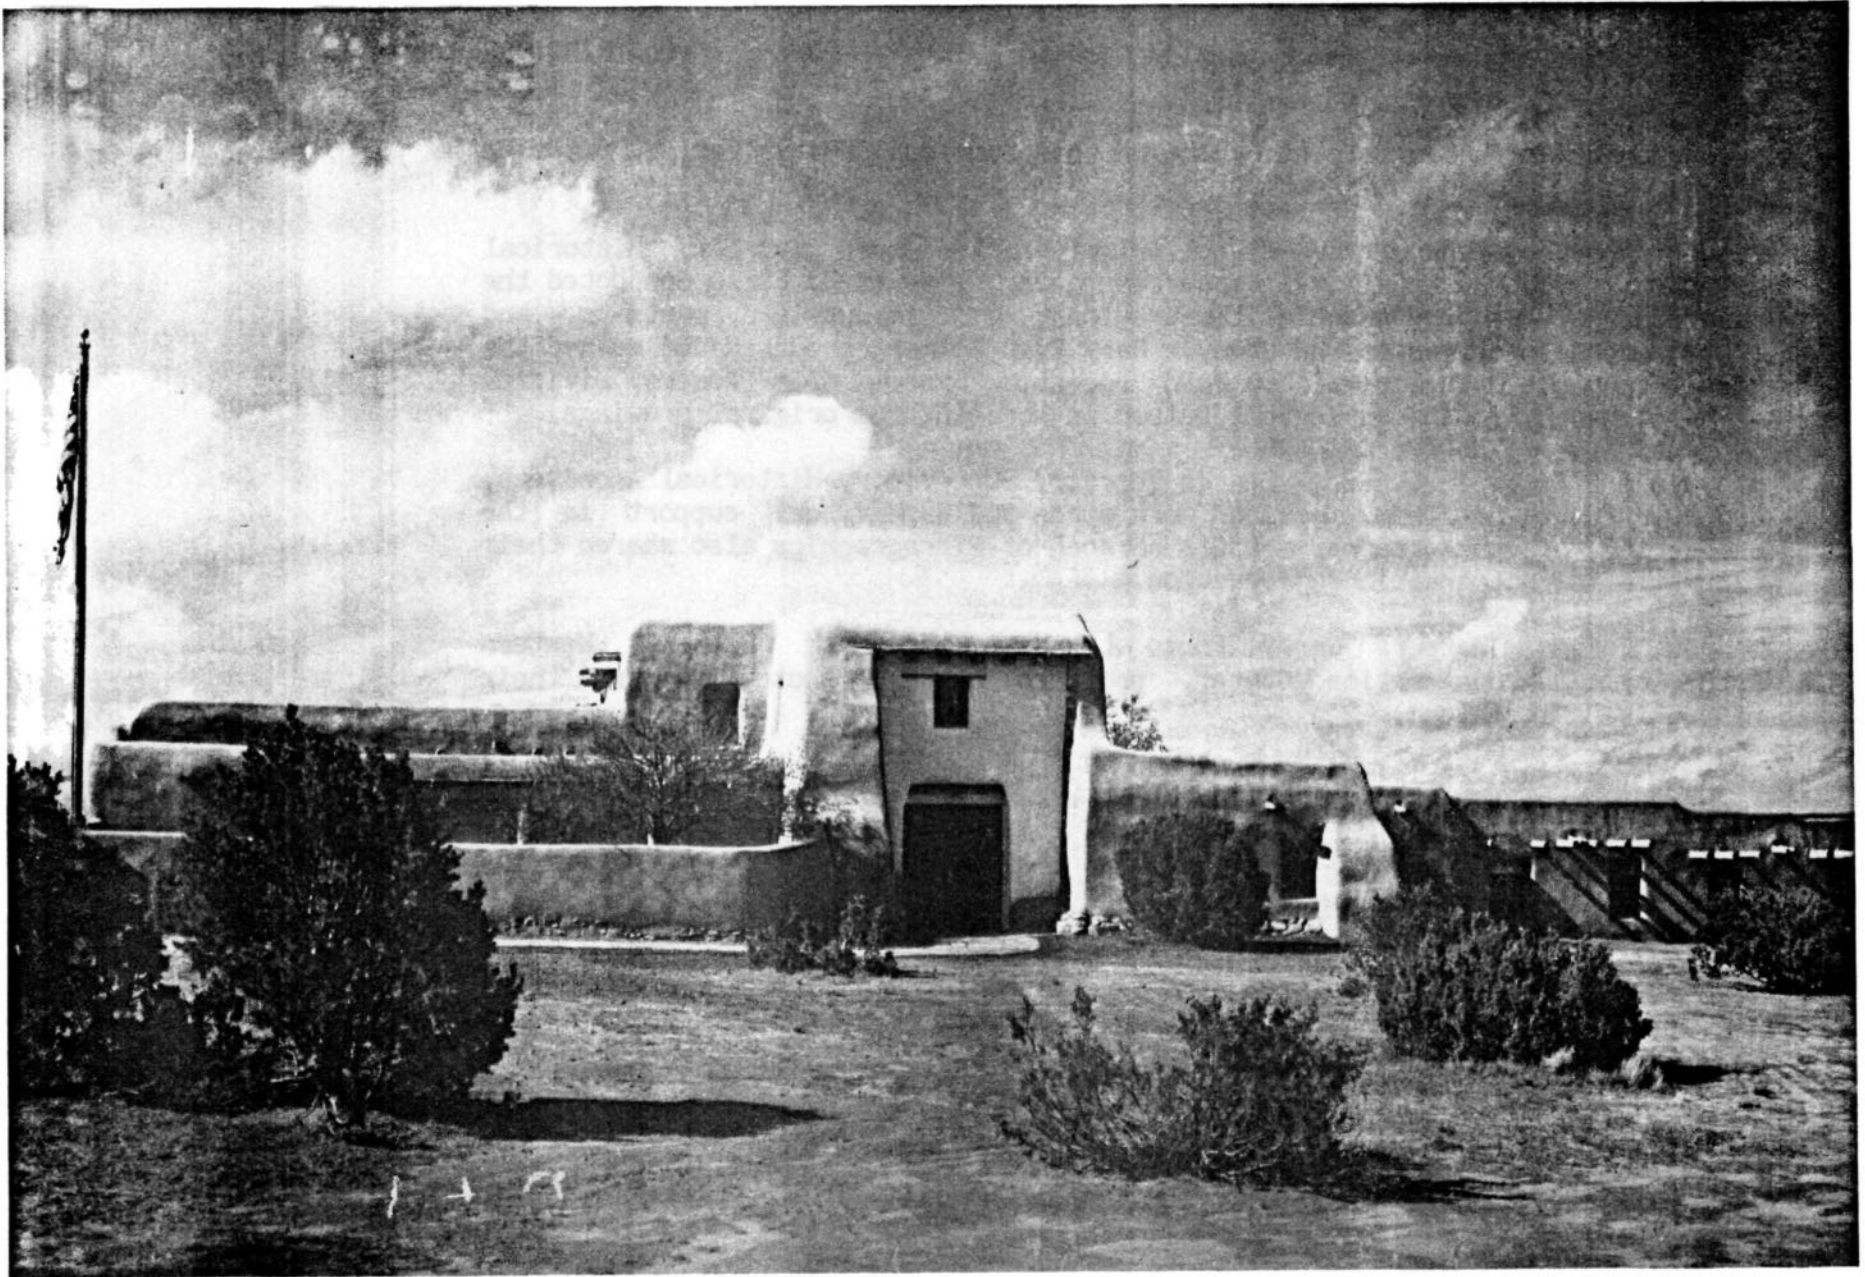
Figure 1.

The north front of Region III headquarters, July 29, 1939.

The Southwest Regional Office building, National Park Service in Santa Fe, New Mexico, is thought to be the largest adobe office building in the United States. The 24,000 square foot building, now listed on the National Register of Historic Places, is located on Old Santa Fe Trail off Camino del Monte Sol in the foothills of the Sangre de Cristo Mountains ("Park Service Moves," Santa Fe New Mexican, July 1, 1939), (Figure 1).

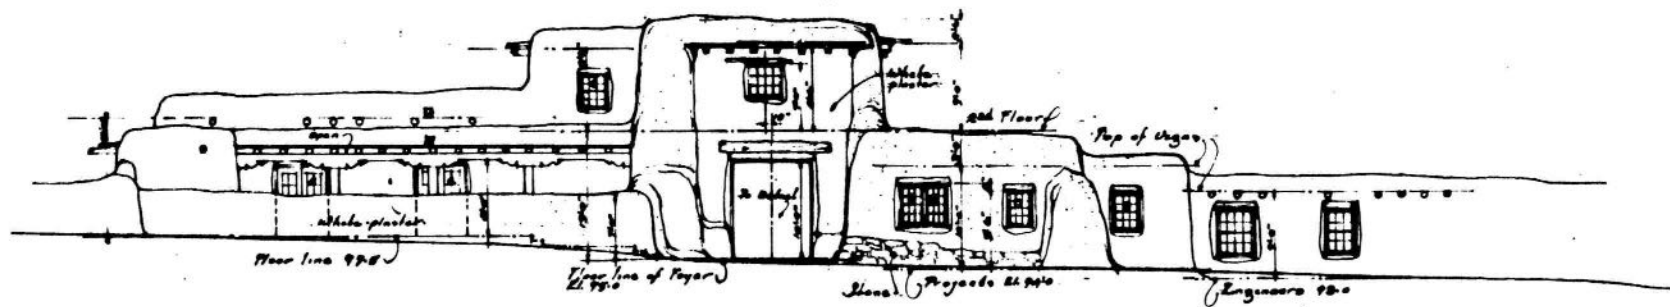
Figure 6.

NORTH ELEVATION REVISED  
 Entrance Motif Revised Feb. 18, 1930  
 Scale 1/8" = 1'-0"

Elevation showing the final entrance motif and exposed stone foundation.

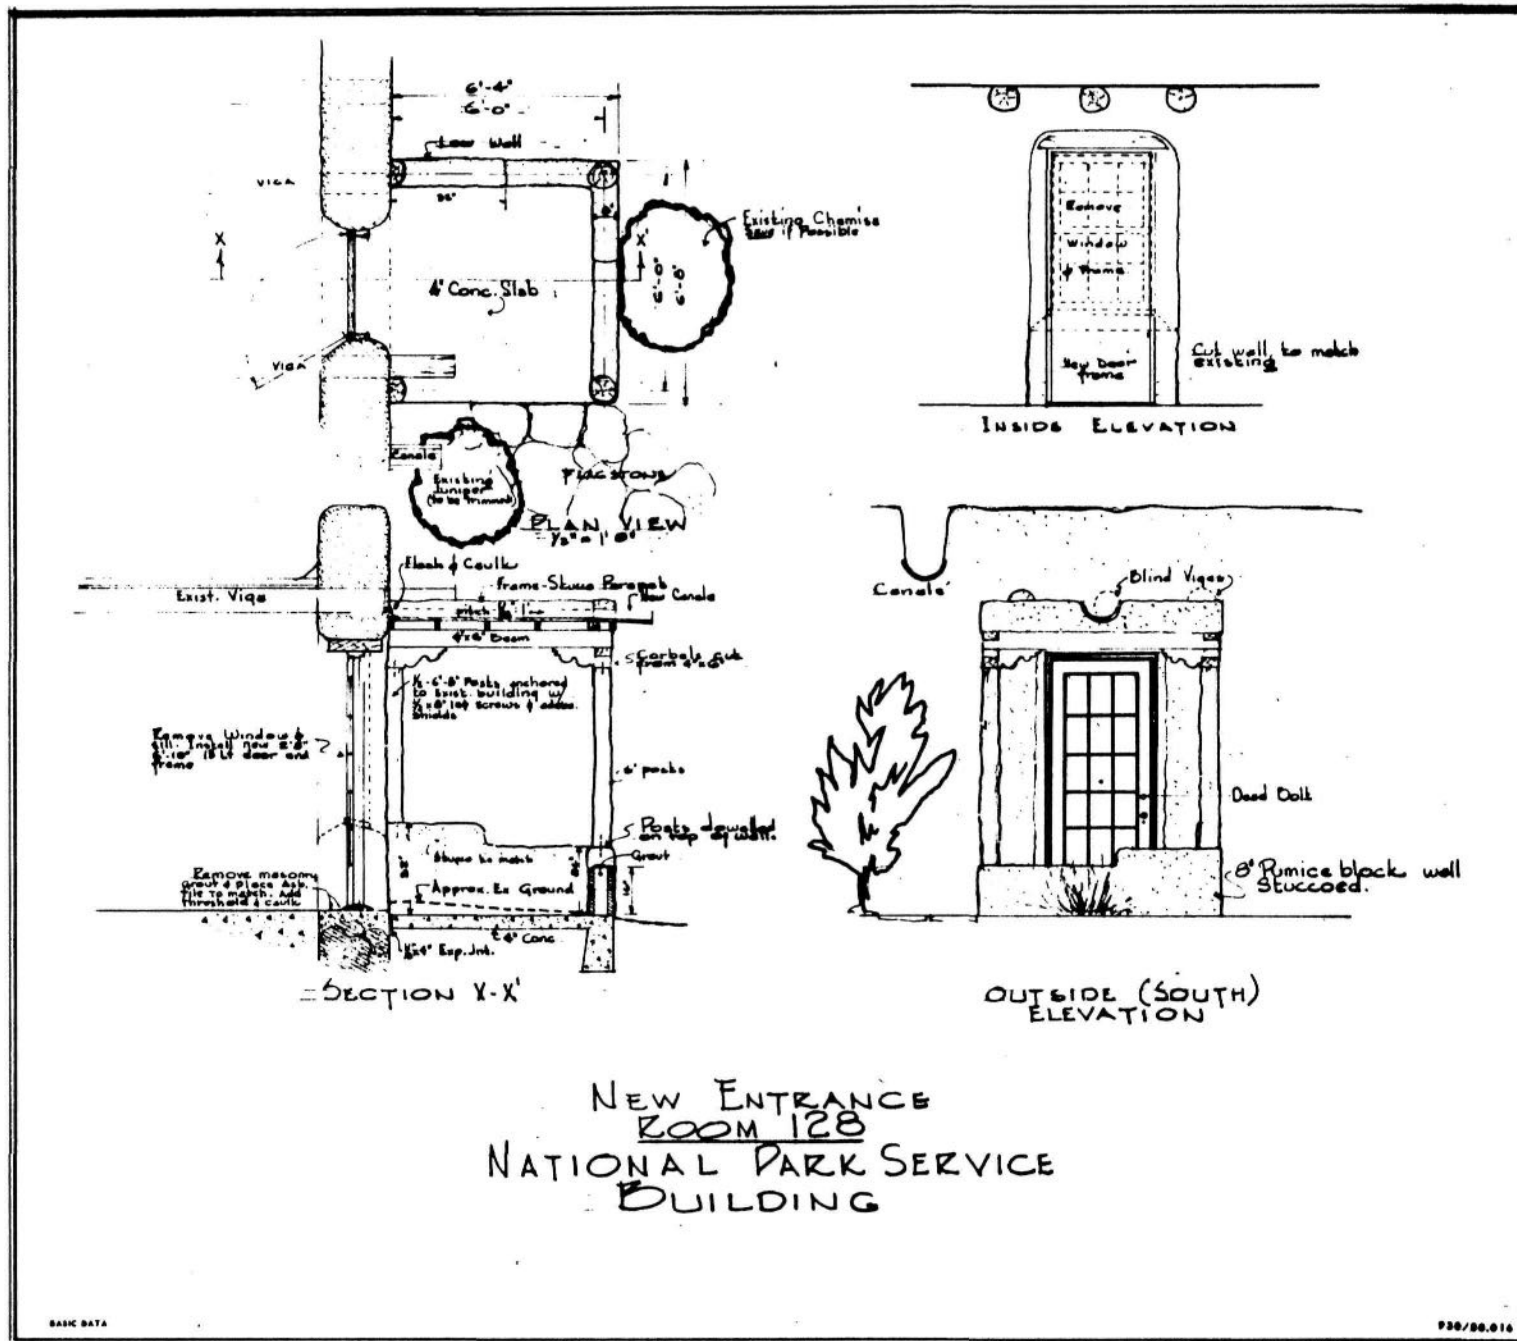
Figure 7.

A new entrance to Room 128 was added to the south side of the building by removing a window and cutting the wall.

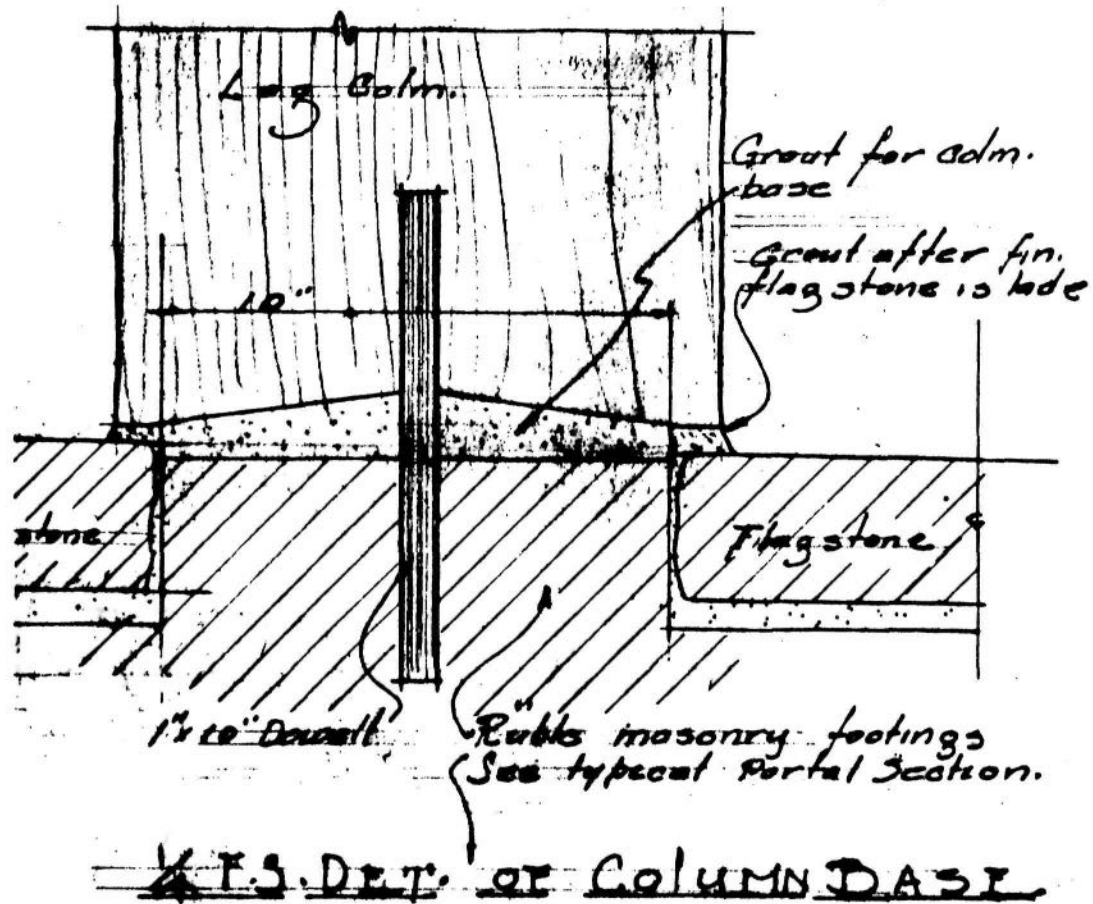
Figure 9.

Detail column base showing how a 10-inch dowel was used to attach the column to its base.

The log portal columns surrounding the patio are attached to rubble masonry footings with a 1-inch by 10-inch dowel used to attach the column to its base. As originally constructed, the column bases were grouted to prevent rotting after the final flagstone was laid (Figure 9).

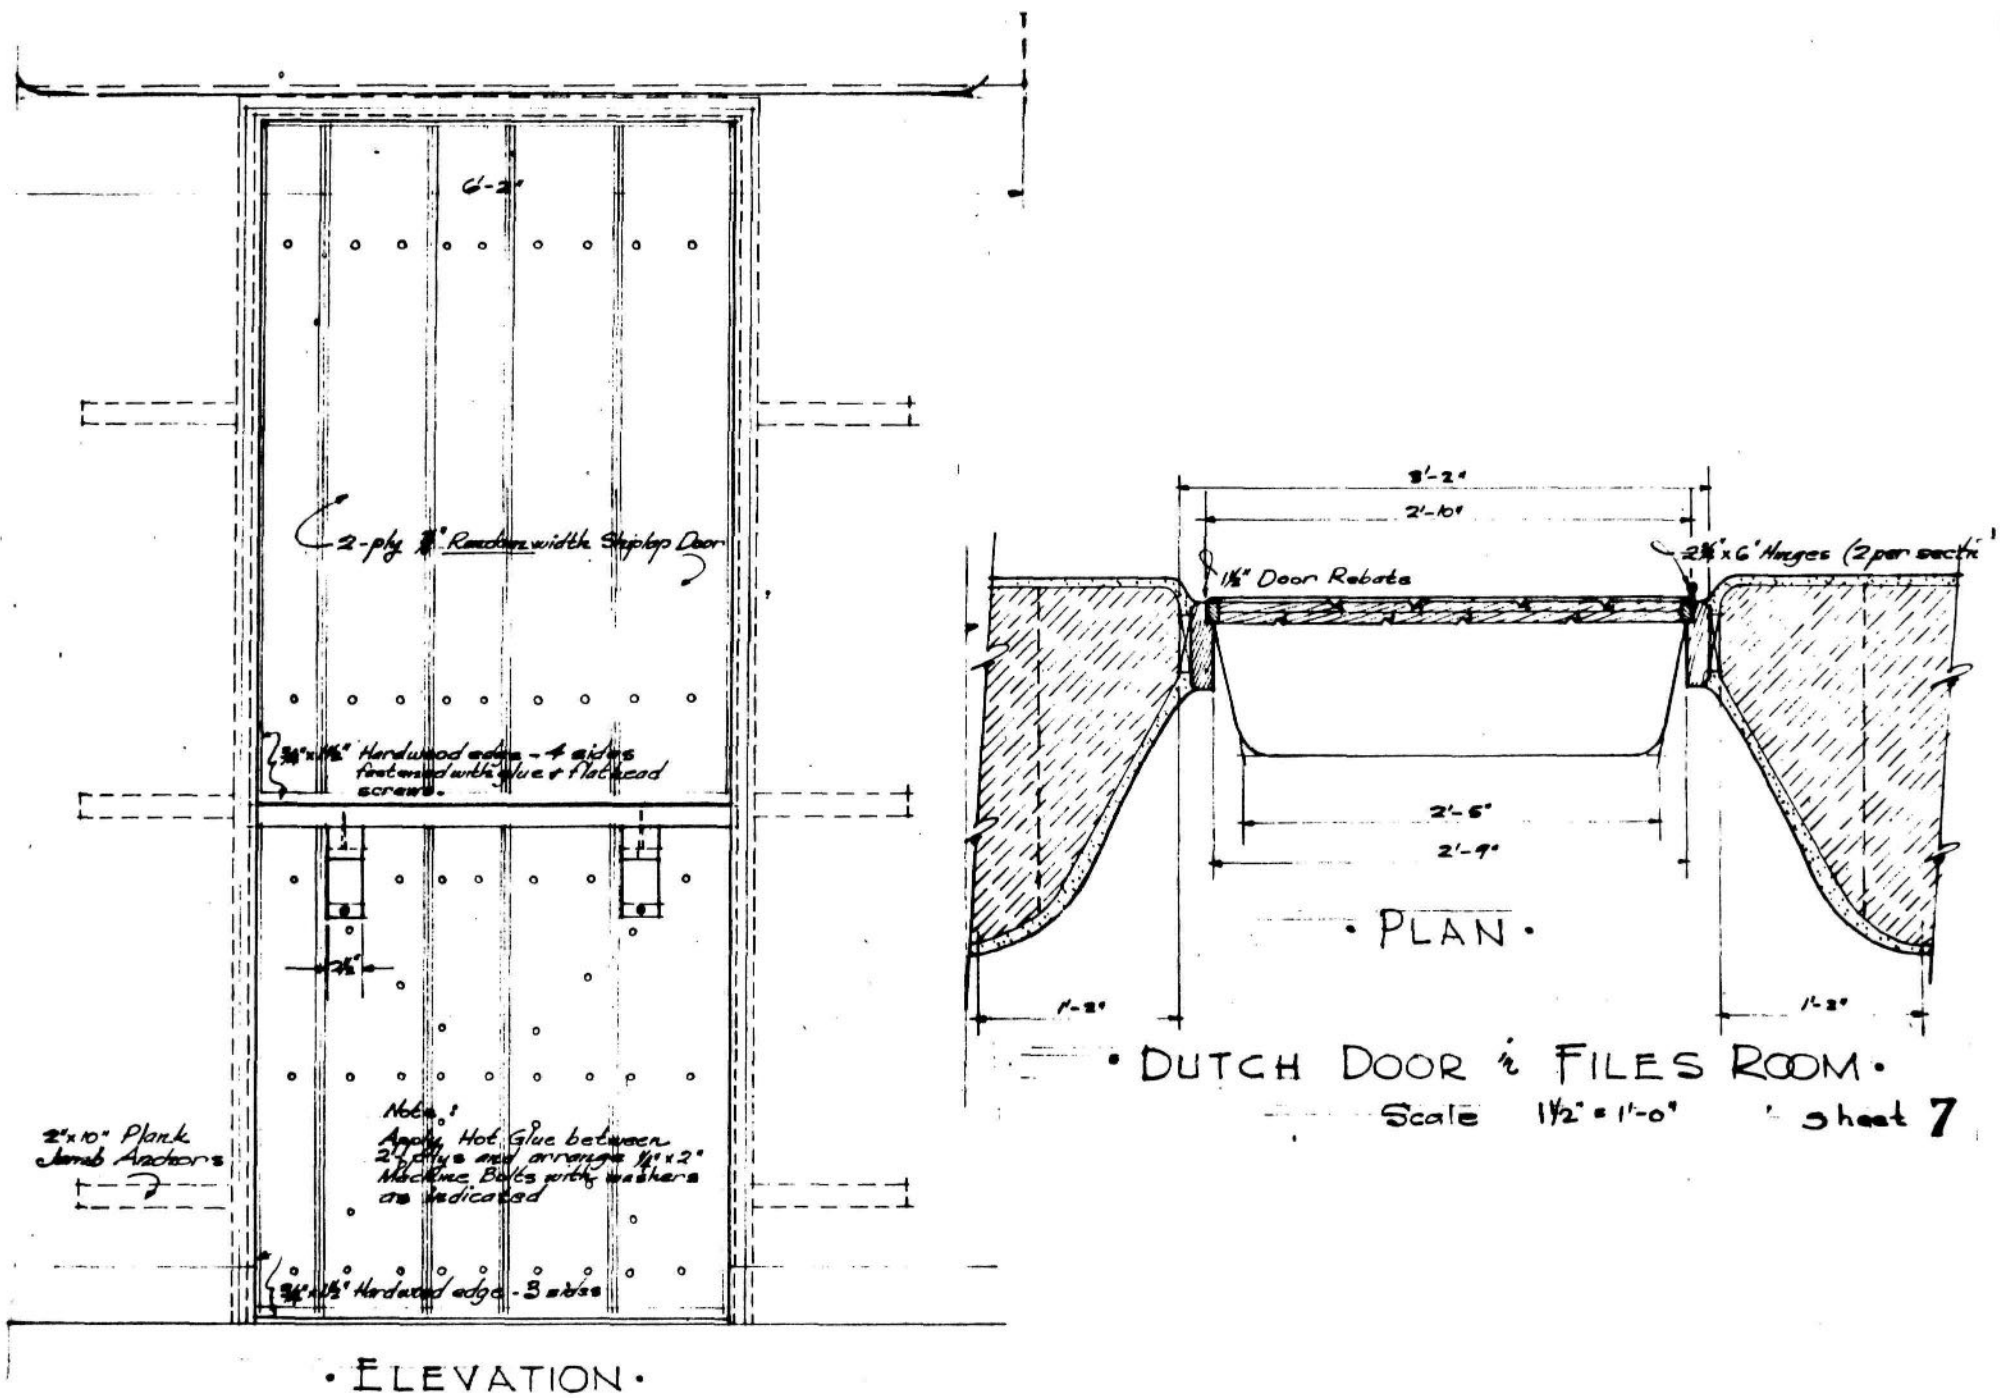
Figure 12.

A Dutch style door, built on the job for the files room, now stands locked and rarely used.

The headquarters building displays a wide variety of door and window types, most of which were constructed on site of either fir or white pine. One unique door, a Dutch door leading into the files room, was built of 2-ply, 7/8-inch random width shiplap. The two plies of shiplap were attached with hot glue and then connected with machine bolts. A shelf on the lower door projected 11 inches and stood 3 feet 4 inches above the floor. This shelf was later removed. Four butt hinges measuring 2-3/4 inches by 6 inches were made to attach the door to the frame. The Dutch door, still in place, is currently locked and rarely used (Figure 12).

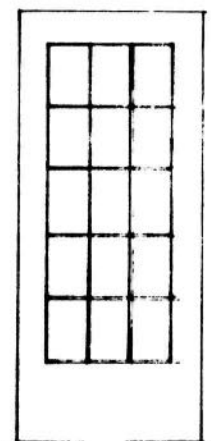
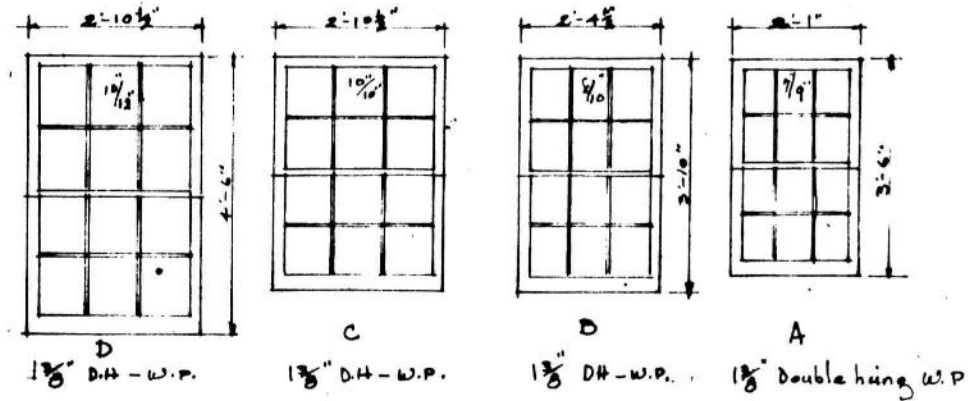
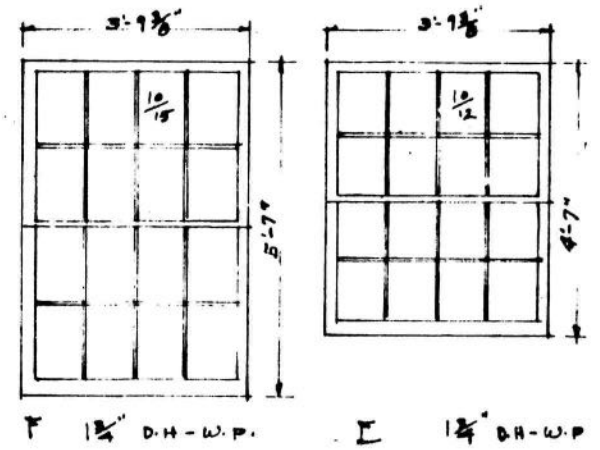
Figure 14.

J Steel sash - Pivoted - BASEMENT

Door and window schedules show all windows as double hung with check rails. Both window frames and doors were constructed of white pine.

All window sashes, double hung with check rails (window stops), were built of standard stock and sizes. Many of the casements have rabbeted meeting rails, and were built out of white pine and glazed with DS "A" glass. Basement windows were constructed of a pivoted type steel casement (Figure 14).

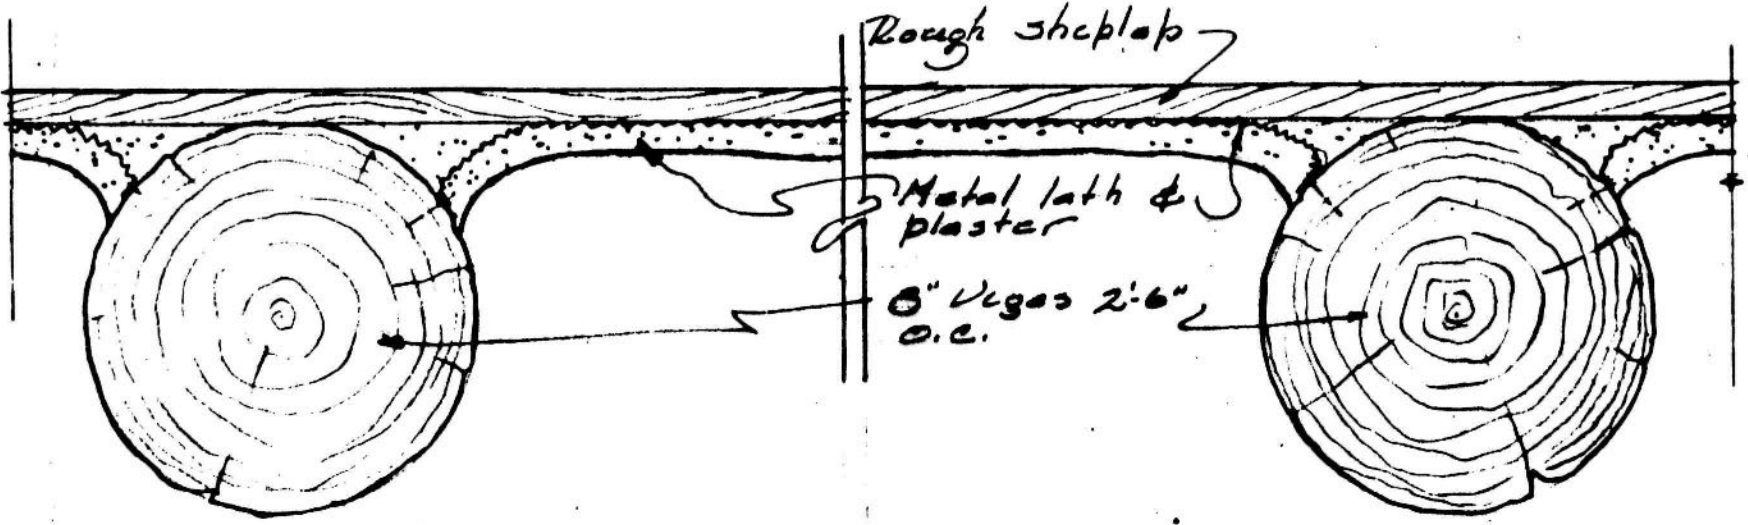
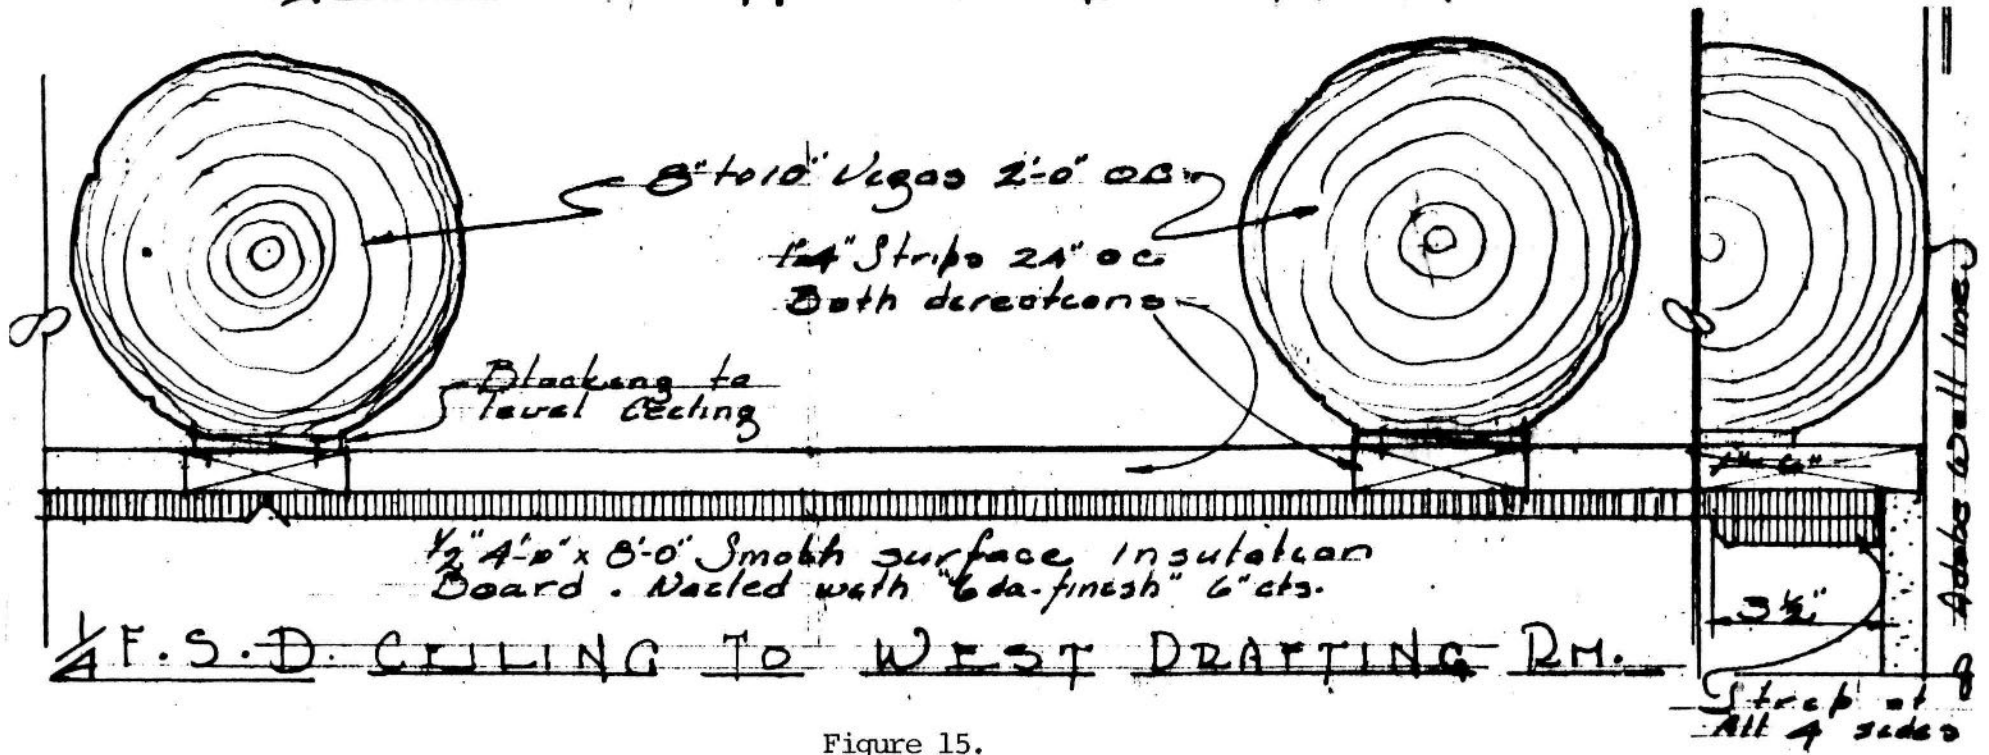
Figure 15.

1/2 F.S.D. CEILING TO EAST DRAFTING R.M.

1/4 F.S.D. CEILING TO WEST DRAFTING R.M.

The ceilings throughout the building show a variety of construction techniques and styles evident in Spanish-Pueblo architecture. Ceilings in the east drafting room, and the offices bordering the patio, have exposed vigas ranging from 8 inches to 10 inches in diameter. The current drafting room on the west side of the building has 8 to 10 inch unexposed vigas, 2 feet on center. Under each viga is blocking, to which is attached a ceiling made of 1/2 inch smooth surface insulation board. The east drafting room was originally located just east of the present drafting room and is currently used as a personnel office (Figure 15).

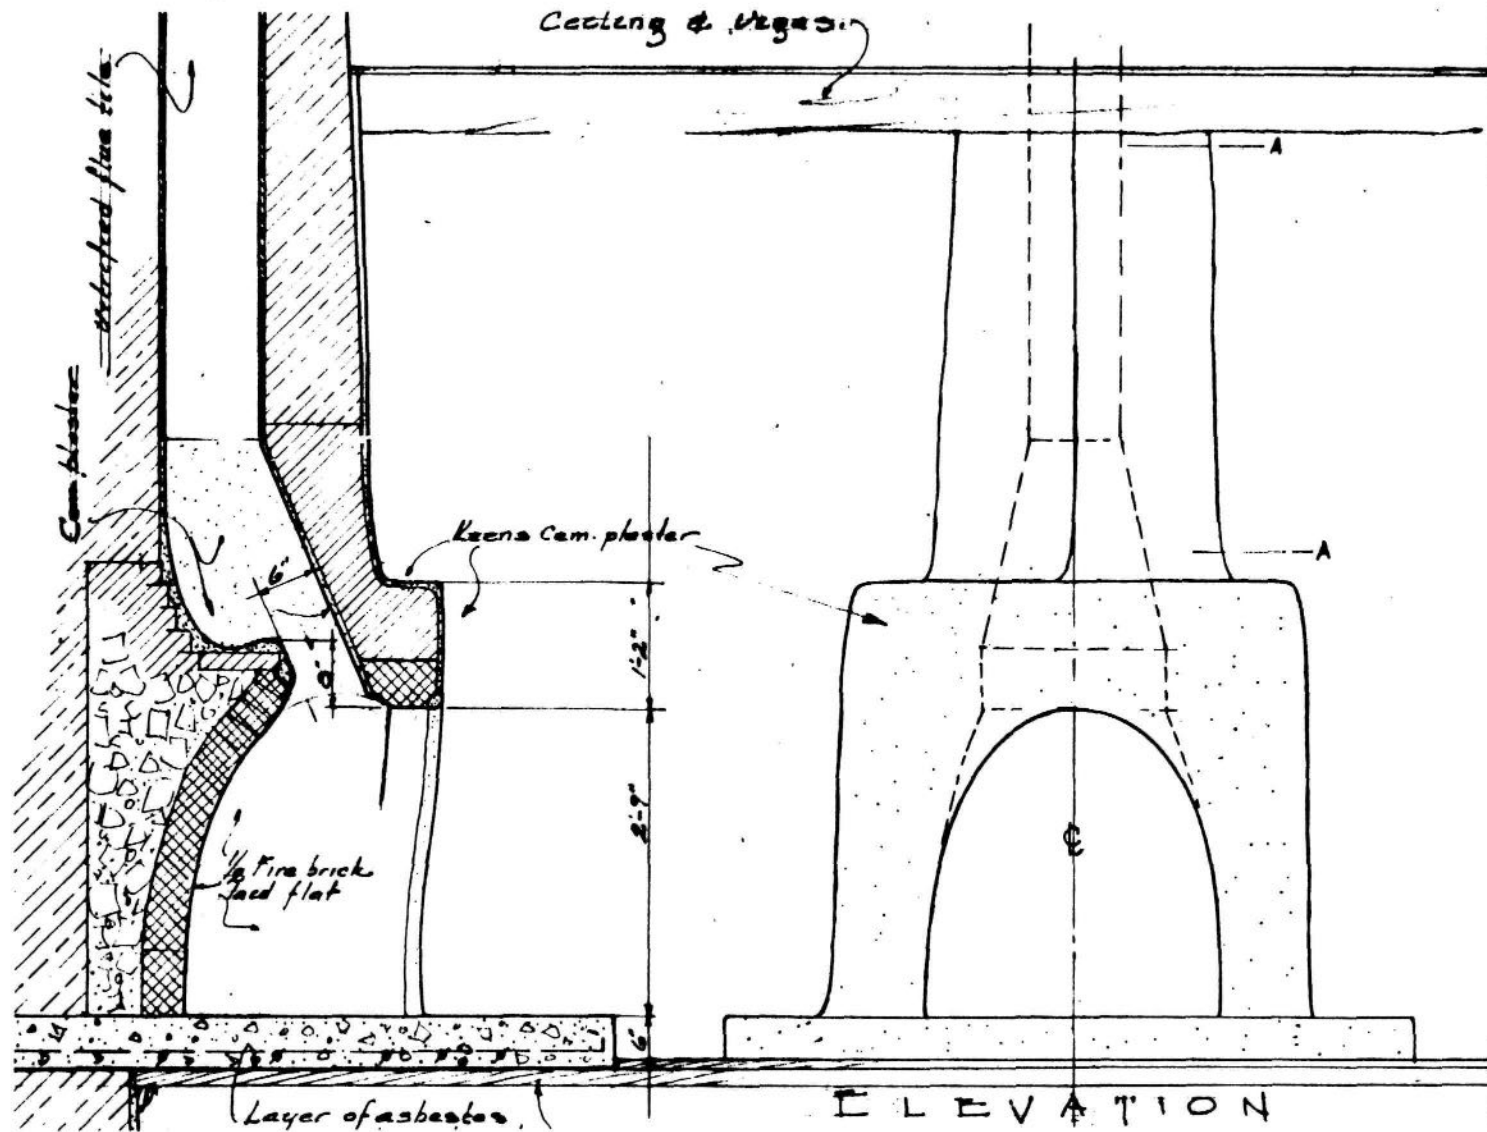
Figure 17.

A typical "beehive" fireplace with a battered chimney seen in the second floor offices.

Since the building was opened in 1939, a number of Regional Directors from Herbert Maier and Hilory Tolson to Robert Kerr, current Regional Director, have occupied the same office. Located on the north side of the building, the office measures 23 feet 6 inches long by 18 feet wide. It came complete with a fireplace, one of four on the second floor. All fireplaces were built on concrete slabs, and so that they would be identical, the openings were constructed from templates. Designed in the traditional "behive" shape, the fireplaces were constructed of fire brick, covered with cement plaster, and whitewashed. Each fireplace has a 2-foot 6-inch opening, with chimney breasts battered up to the ceiling (Figure 17).

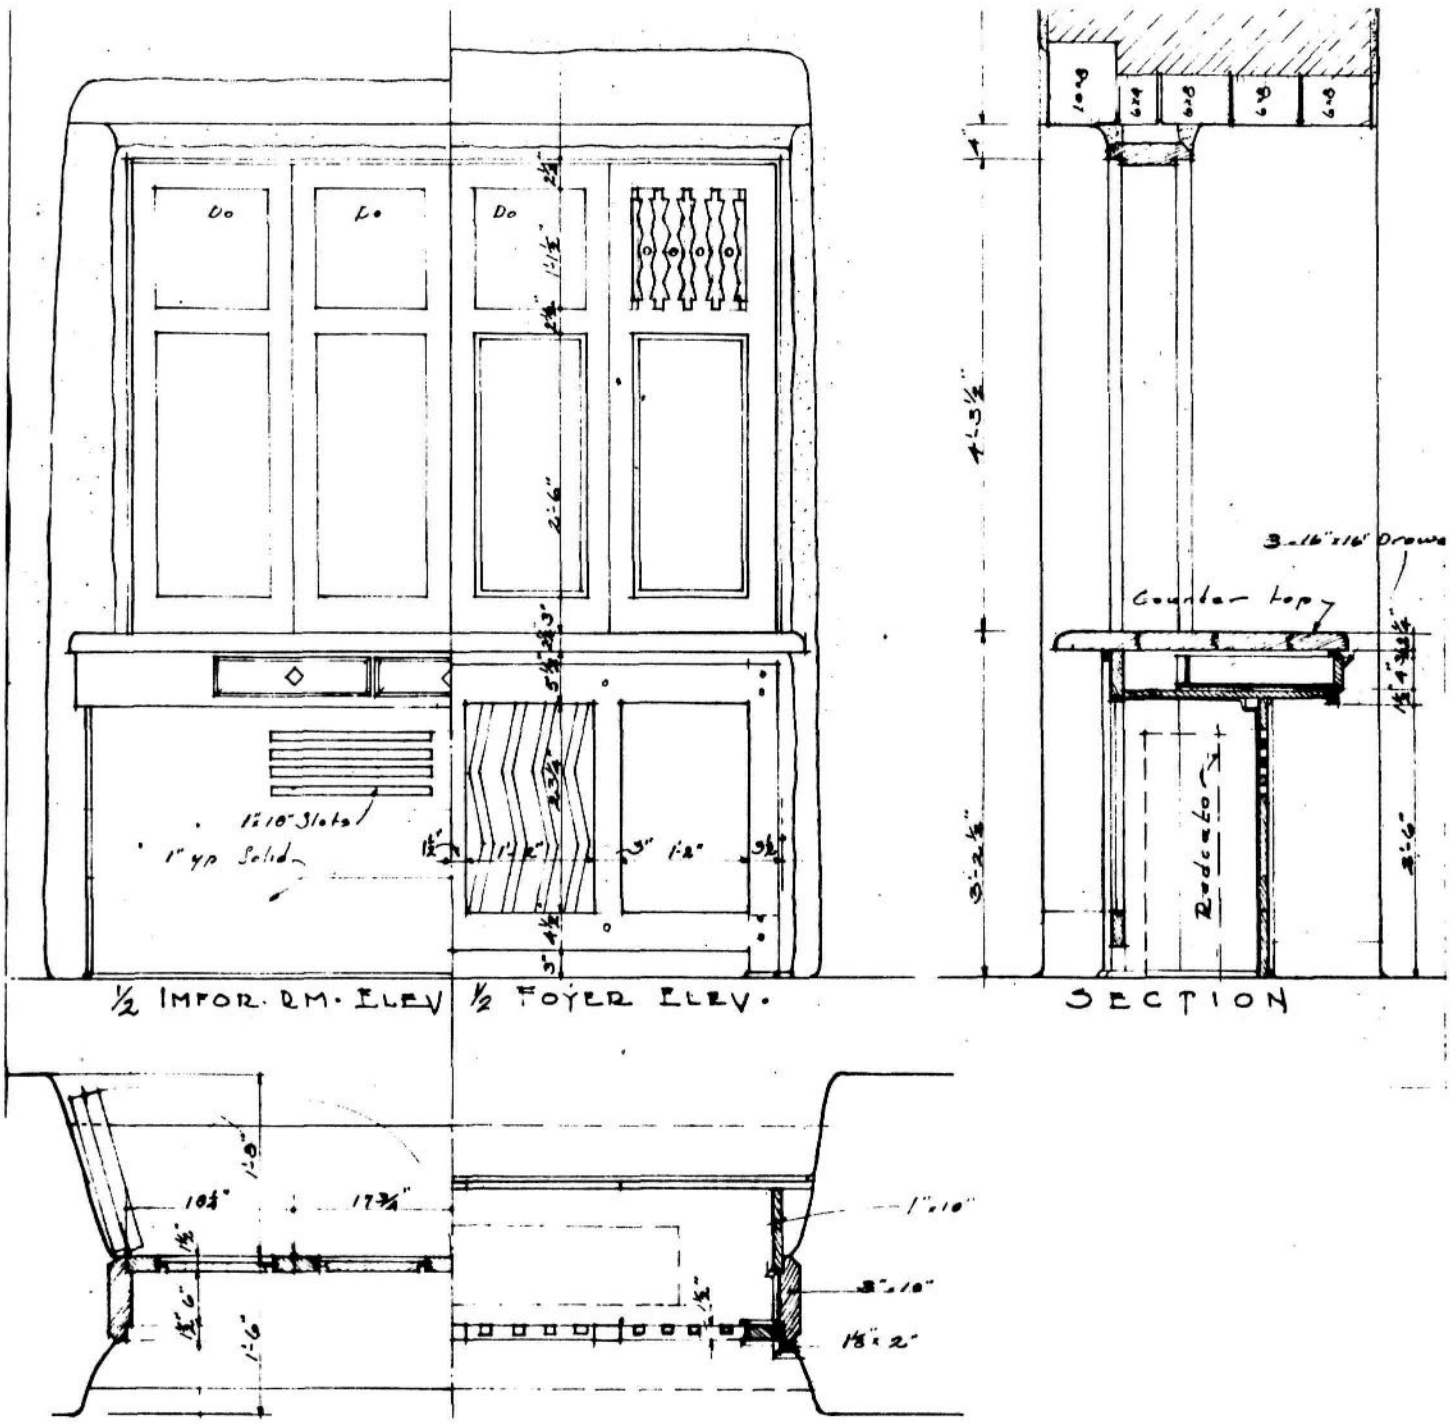
Figure 18.

Radiators from steam heat were often incorporated into the walls as shown here under the information counter.

The original boiler was gas-fired, made of sectional steel, and was complete with an automatic control. The boiler was large enough to supply radiation throughout the building. Steam heated radiators were either free standing or incorporated into the walls (under a window or behind a wall as in the information counter, Figure 18). All steam mains and hot water lines were run in two pipe tunnels at a slope of 1 inch in every 20 feet. The pipe tunnels still run under the building, one about 45 feet north from the boiler room and the other under the east portal of the large patio. The lines were suspended free of end walls and insulated. Air traps and value drains were installed at the end of each return line. Steam and return vents were of black iron (Figure 19).

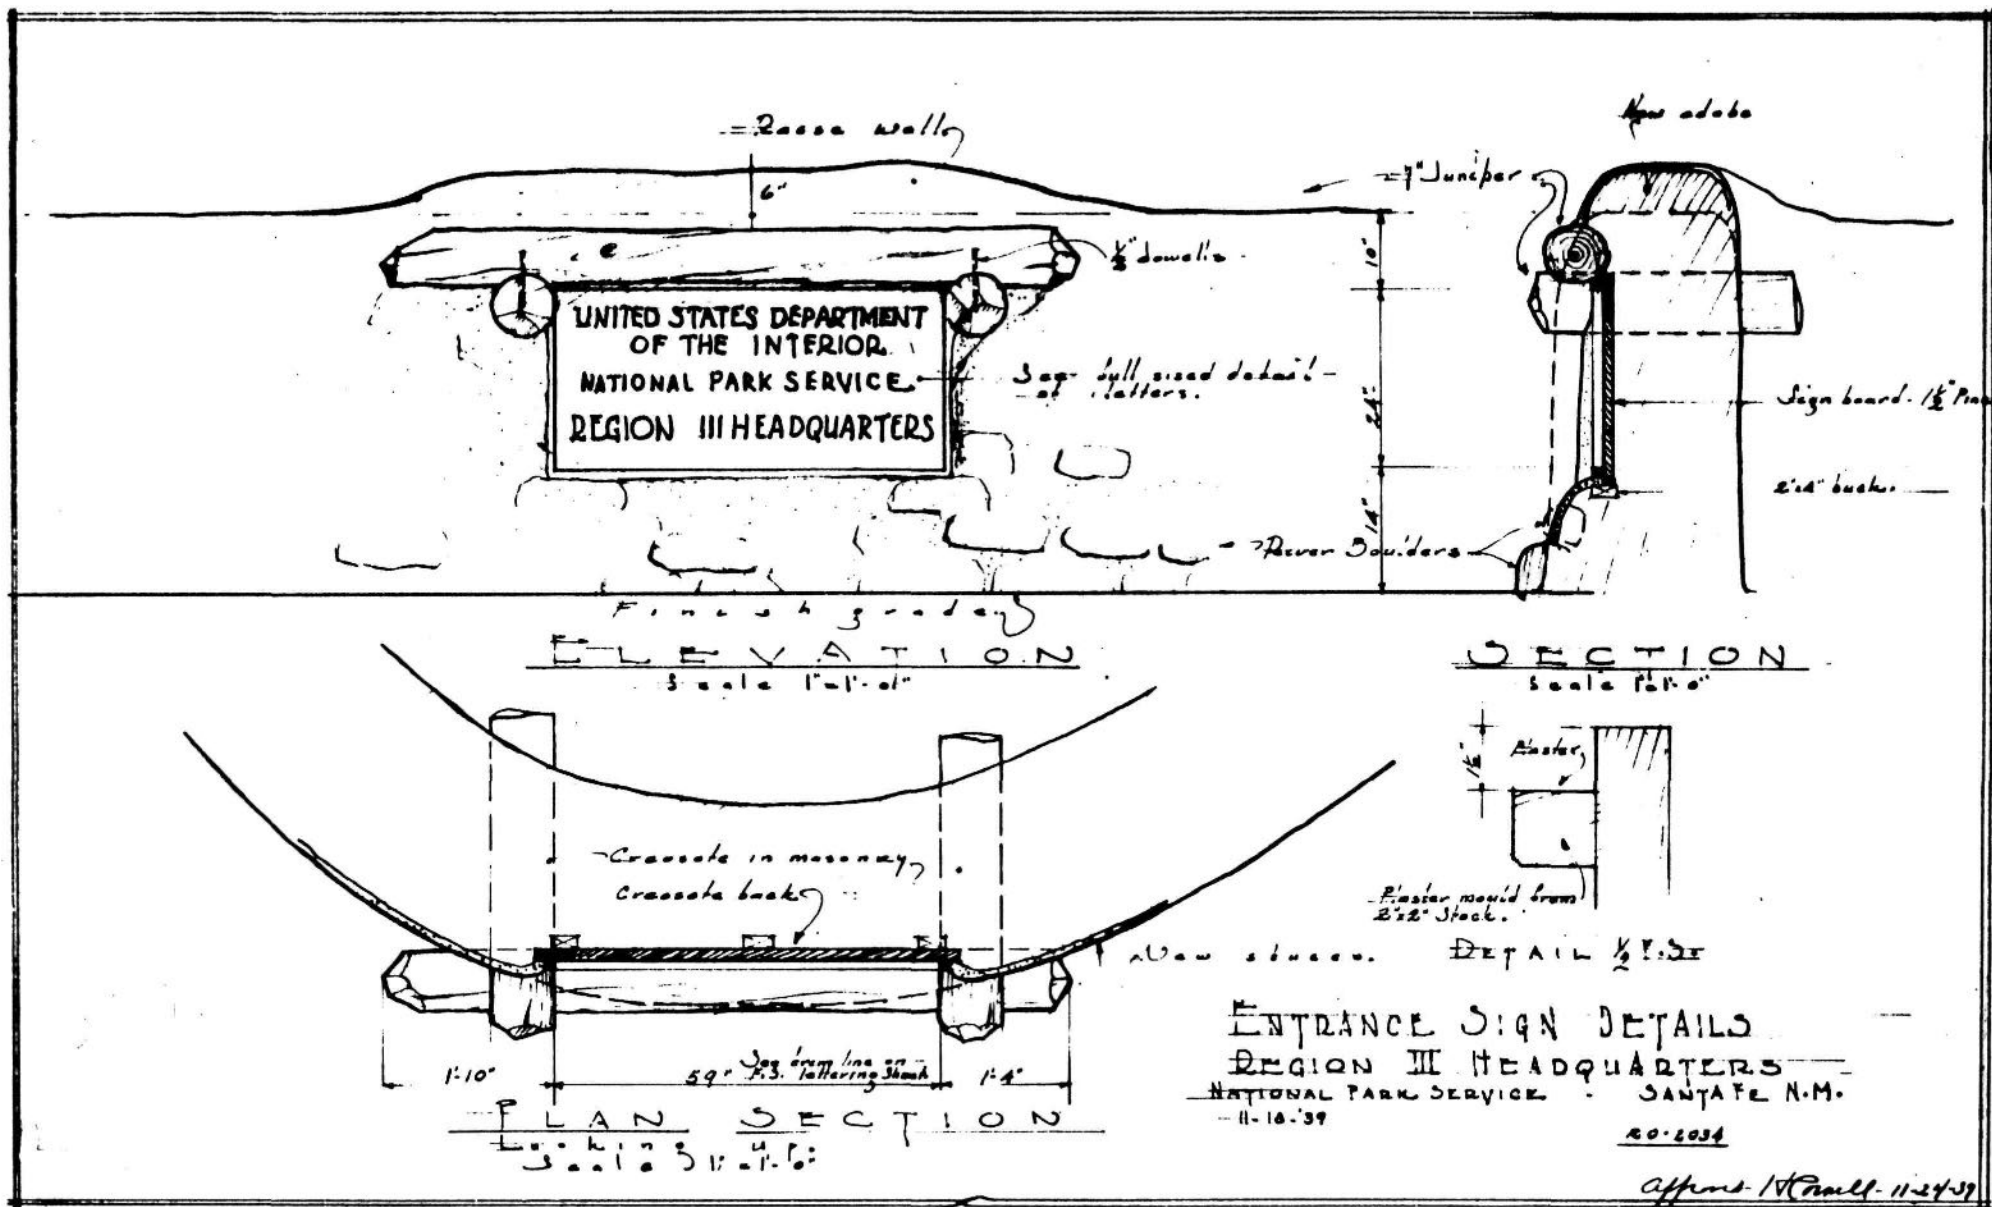
Figure 22.

Entrance sign details show that the sign was built directly into the adobe confining wall.

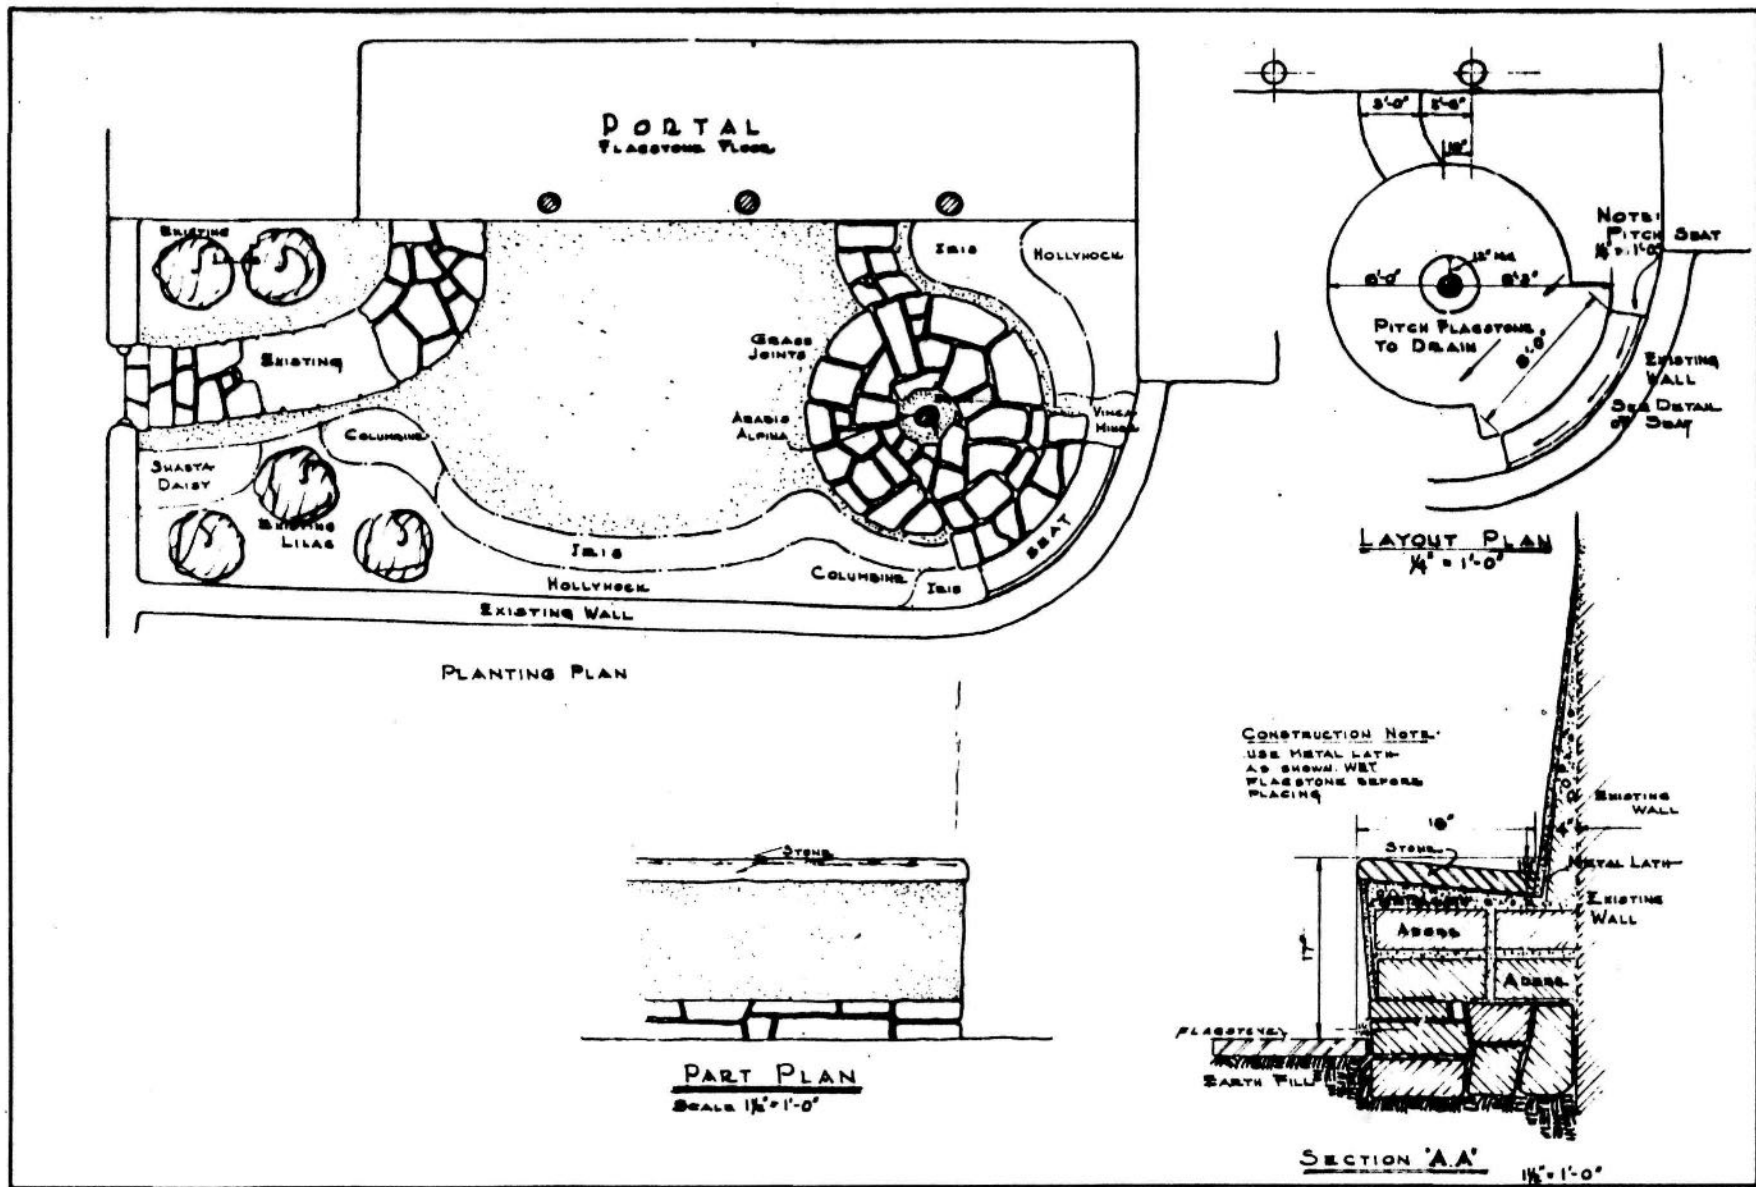
Figure 26.

Conference room patio plan showing the original landscaping, flagstone walks and an adobe banco.

The conference room patio on the northeast corner of the building became a real landscape work of art. Figure 26 shows the conference room patio landscaping as originally planned by Cornell and Kell. Planted within the patio walls were lilac, shasta daisies, iris, hollyhock, columbine, and an apricot tree with a 4-inch trunk. Surrounding the tree was a 14-foot circular catch basin pitched to collect rain water. The catch basin and walk in the patio were both constructed of flagstone, with grass planted in the cracks. Also built in the patio was an adobe banco with a stone seat. Next to a flagstone sidewalk, just over the conference room patio wall, periwinkle, pinons and more junipers were planted (Figure 27).
