# HISTORIC STRUCTURE REPORT

SOUTHWEST REGION HEADQUARTERS BUILDING  
SANTA FE, NEW MEXICO

A Historic Structure Report

Southwest Cultural Resources Center Professional Paper No. 6  
U.S. Department of the Interior  
National Park Service  
Santa Fe, New Mexico  
March 1985

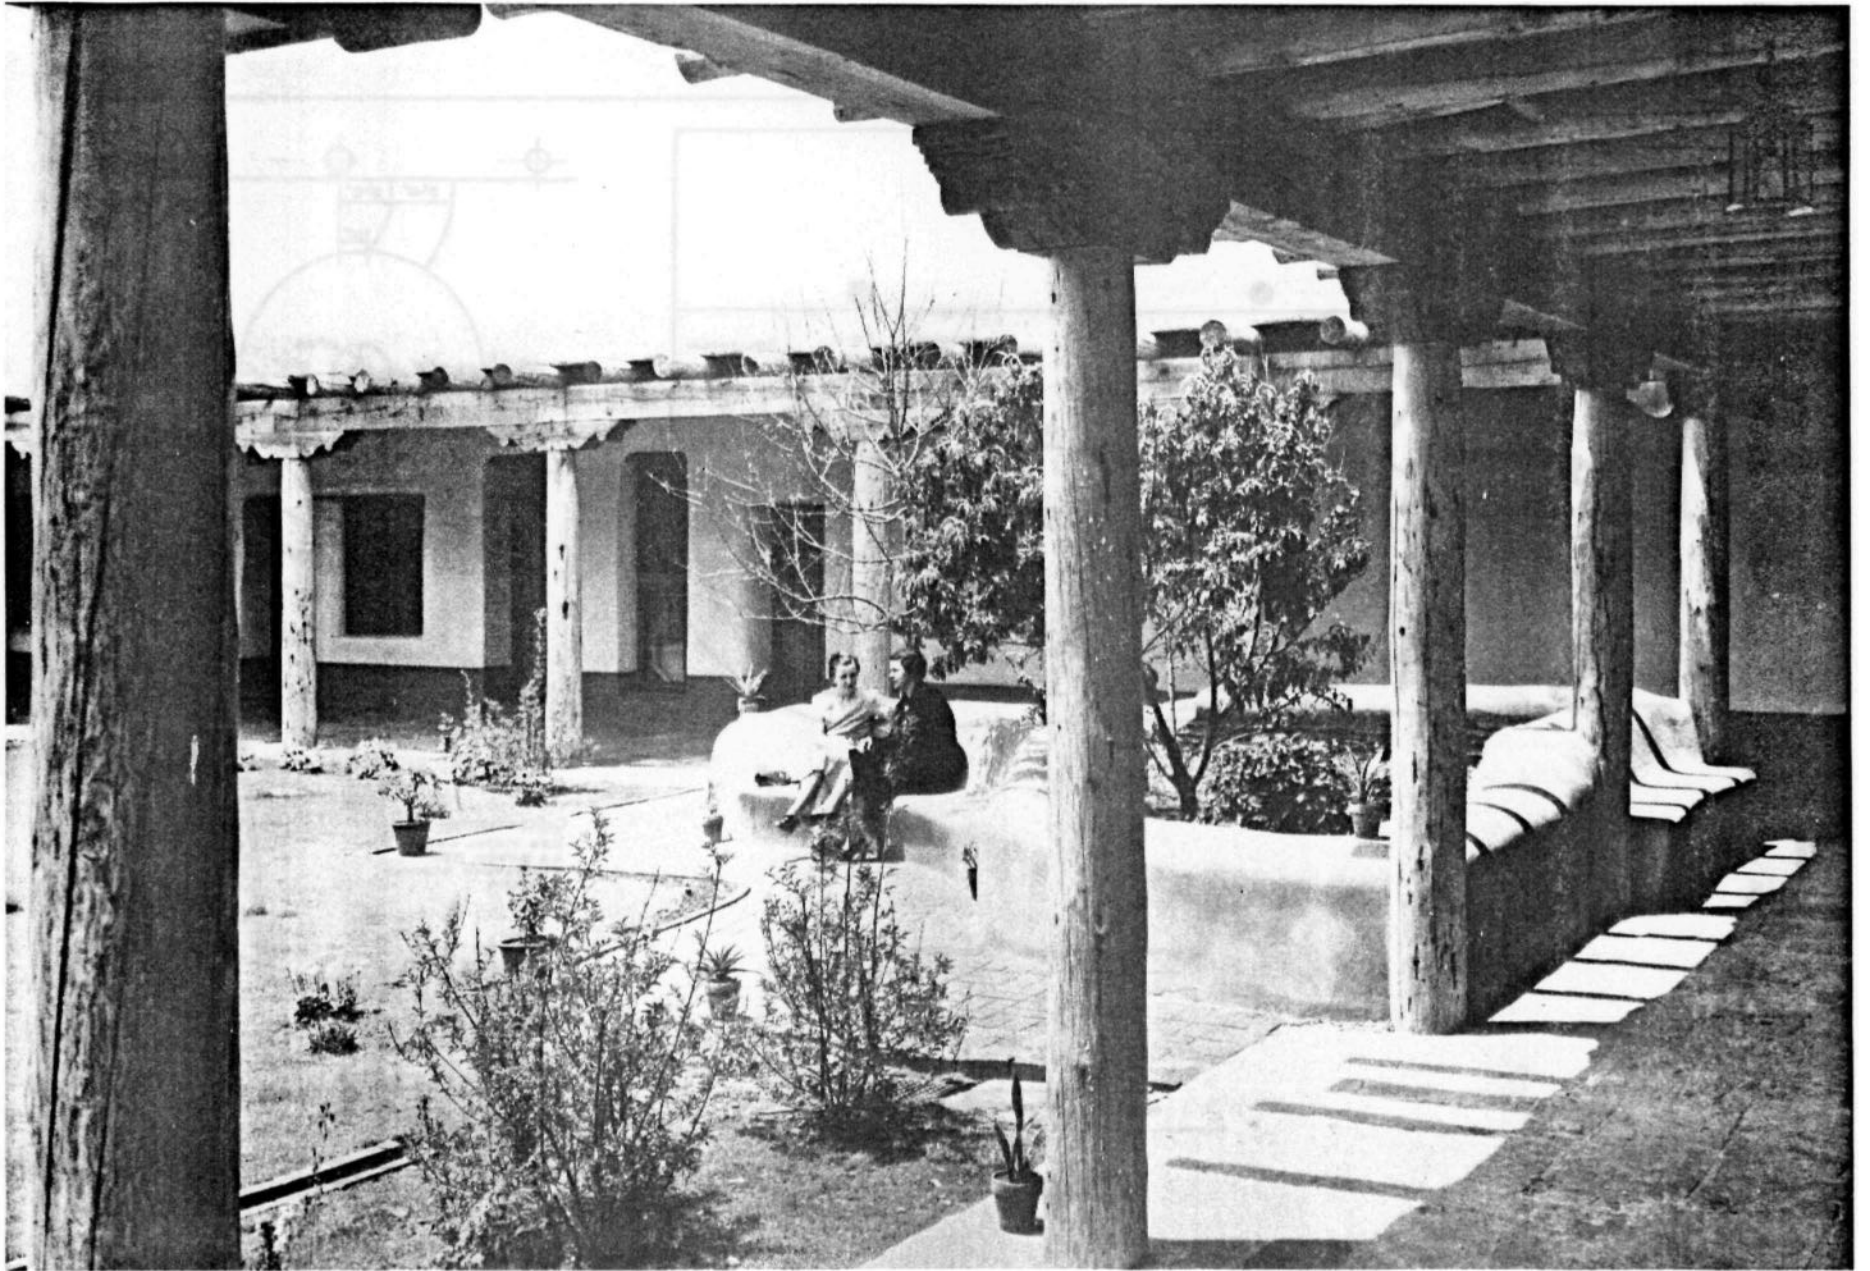
Figure 27.

Fine example of an adobe banco.

The conference room patio on the northeast corner of the building became a real landscape work of art. Figure 26 shows the conference room patio landscaping as originally planned by Cornell and Kell. Planted within the patio walls were lilac, shasta daisies, iris, hollyhock, columbine, and an apricot tree with a 4-inch trunk. Surrounding the tree was a 14-foot circular catch basin pitched to collect rain water. The catch basin and walk in the patio were both constructed of flagstone, with grass planted in the cracks. Also built in the patio was an adobe banco with a stone seat. Next to a flagstone sidewalk, just over the conference room patio wall, periwinkle, pinons and more junipers were planted (Figure 27).

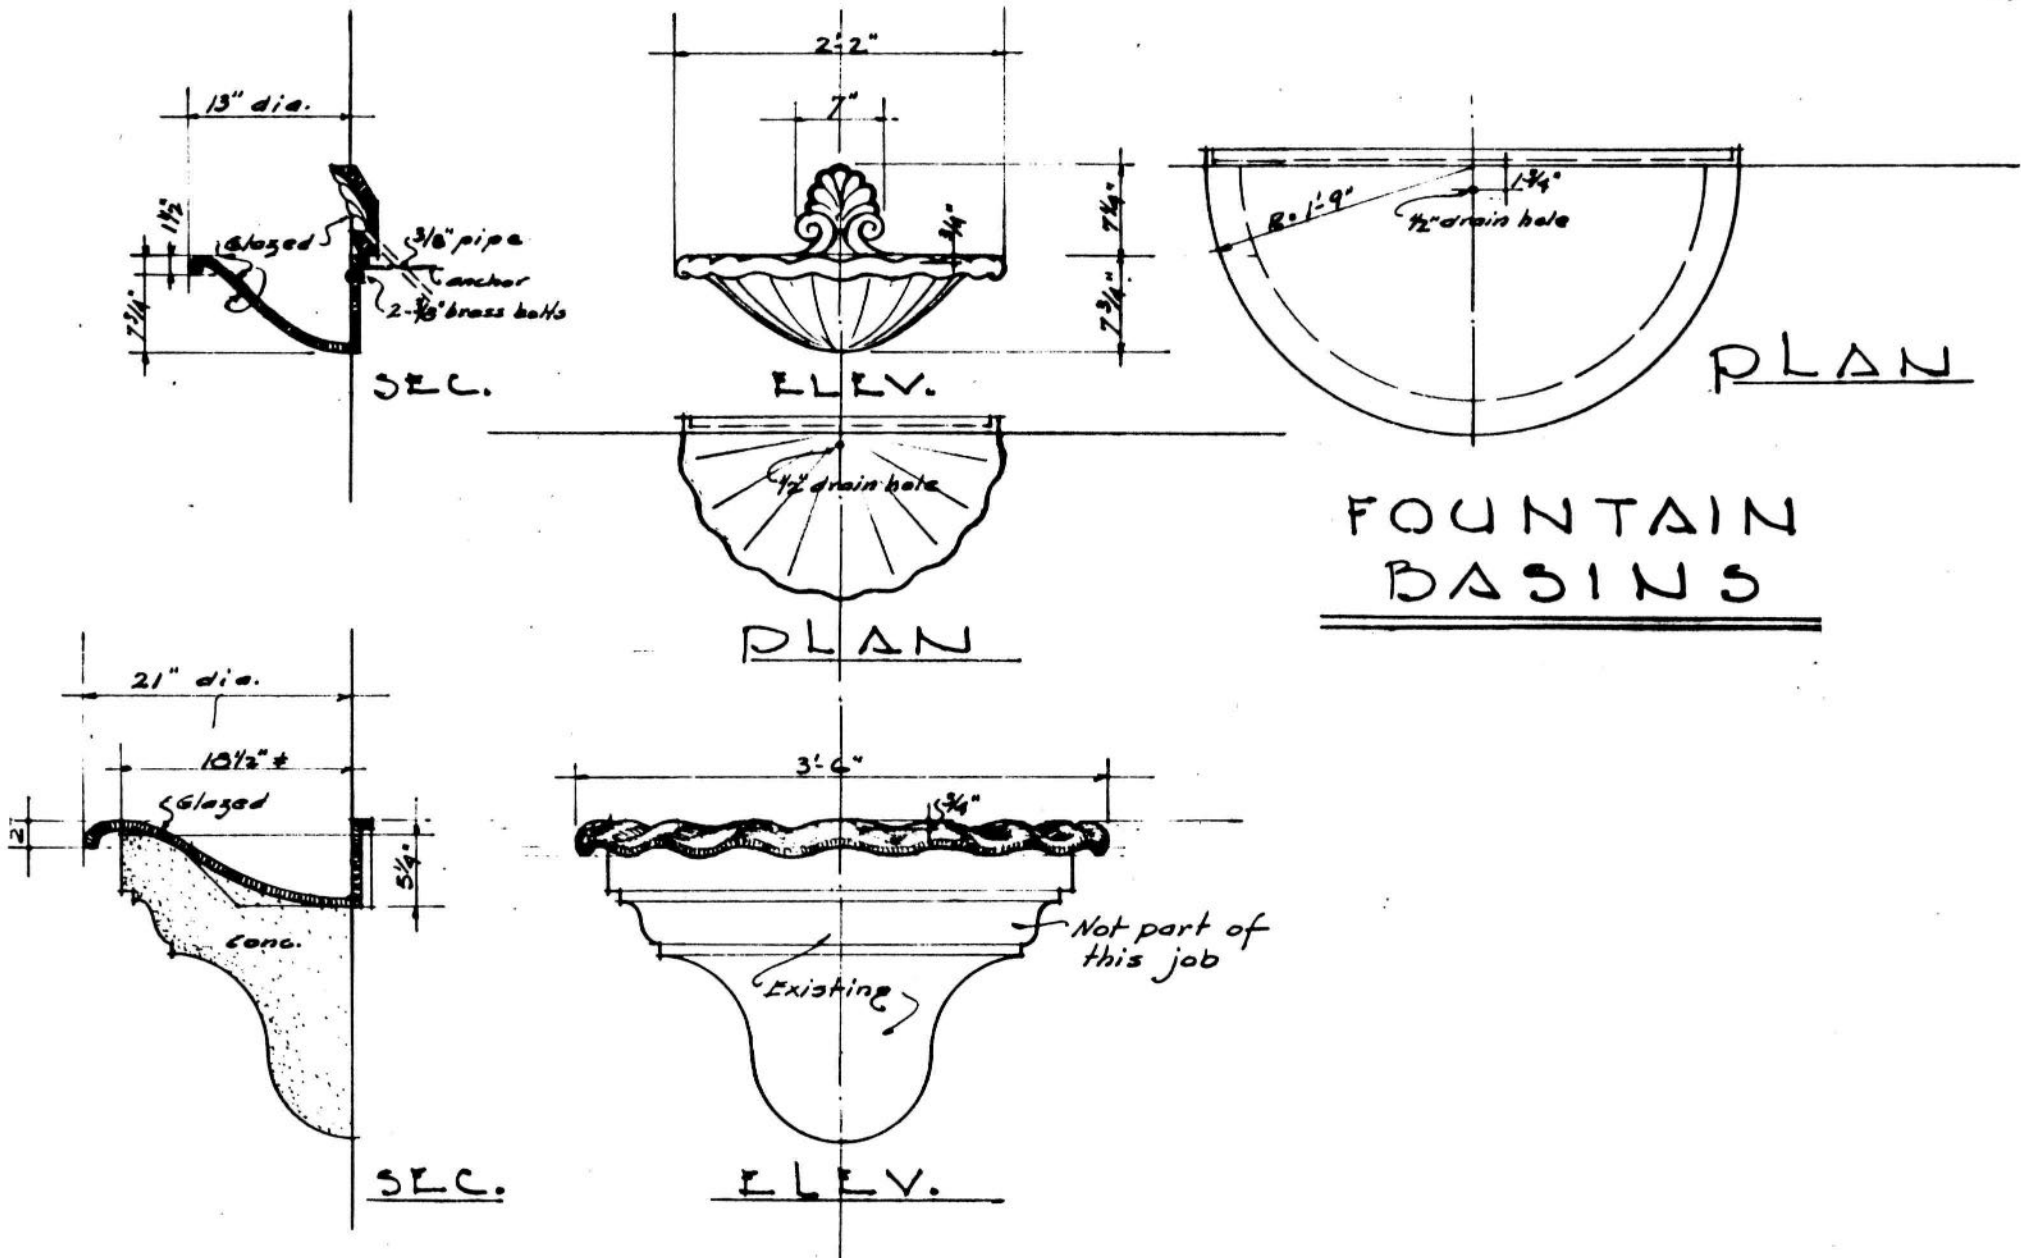
Figure 29.

Fountain basin as originally designed with a decorative glazed rim.

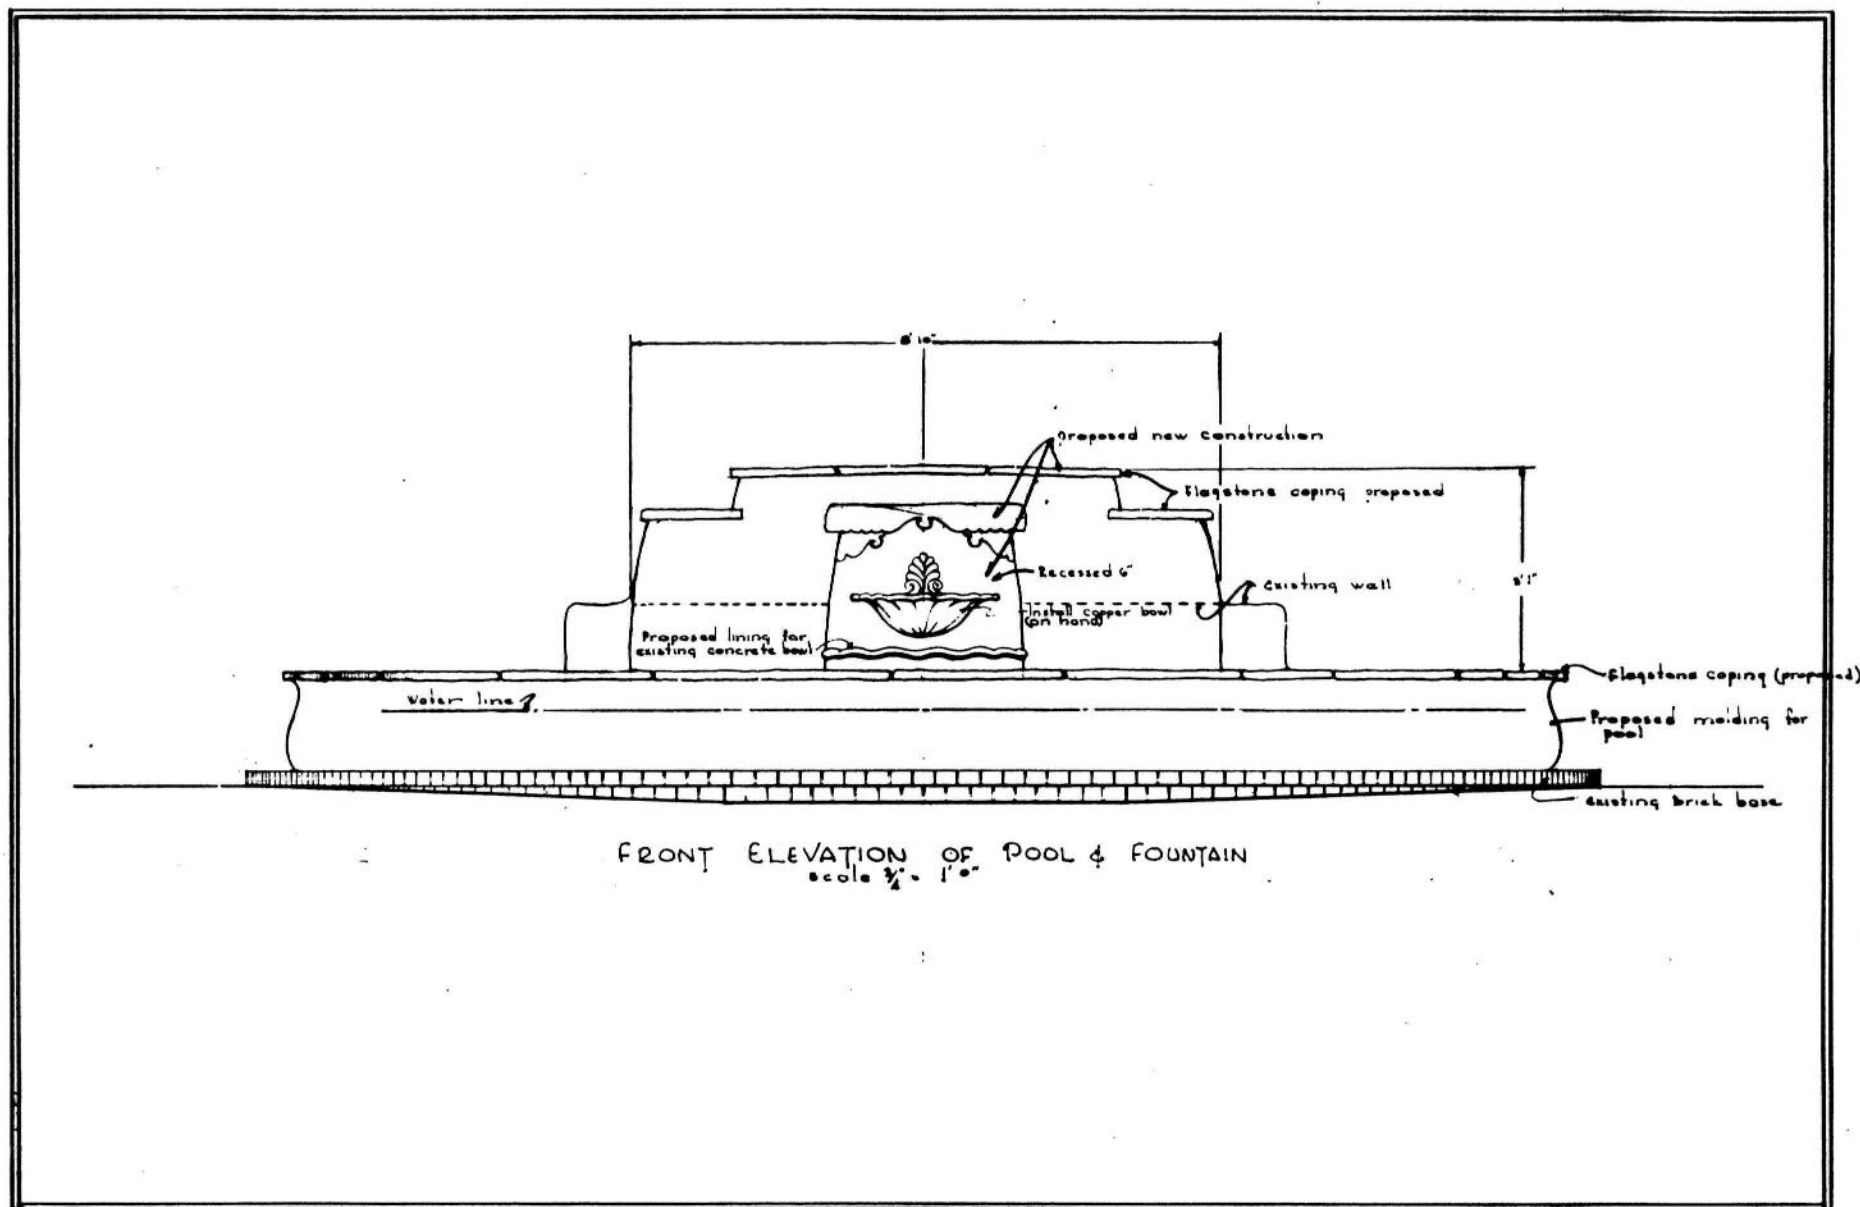
Figure 31.

The 944 gallon pool and fountain was originally designed with a flagstone coping and a glazed rim basin.

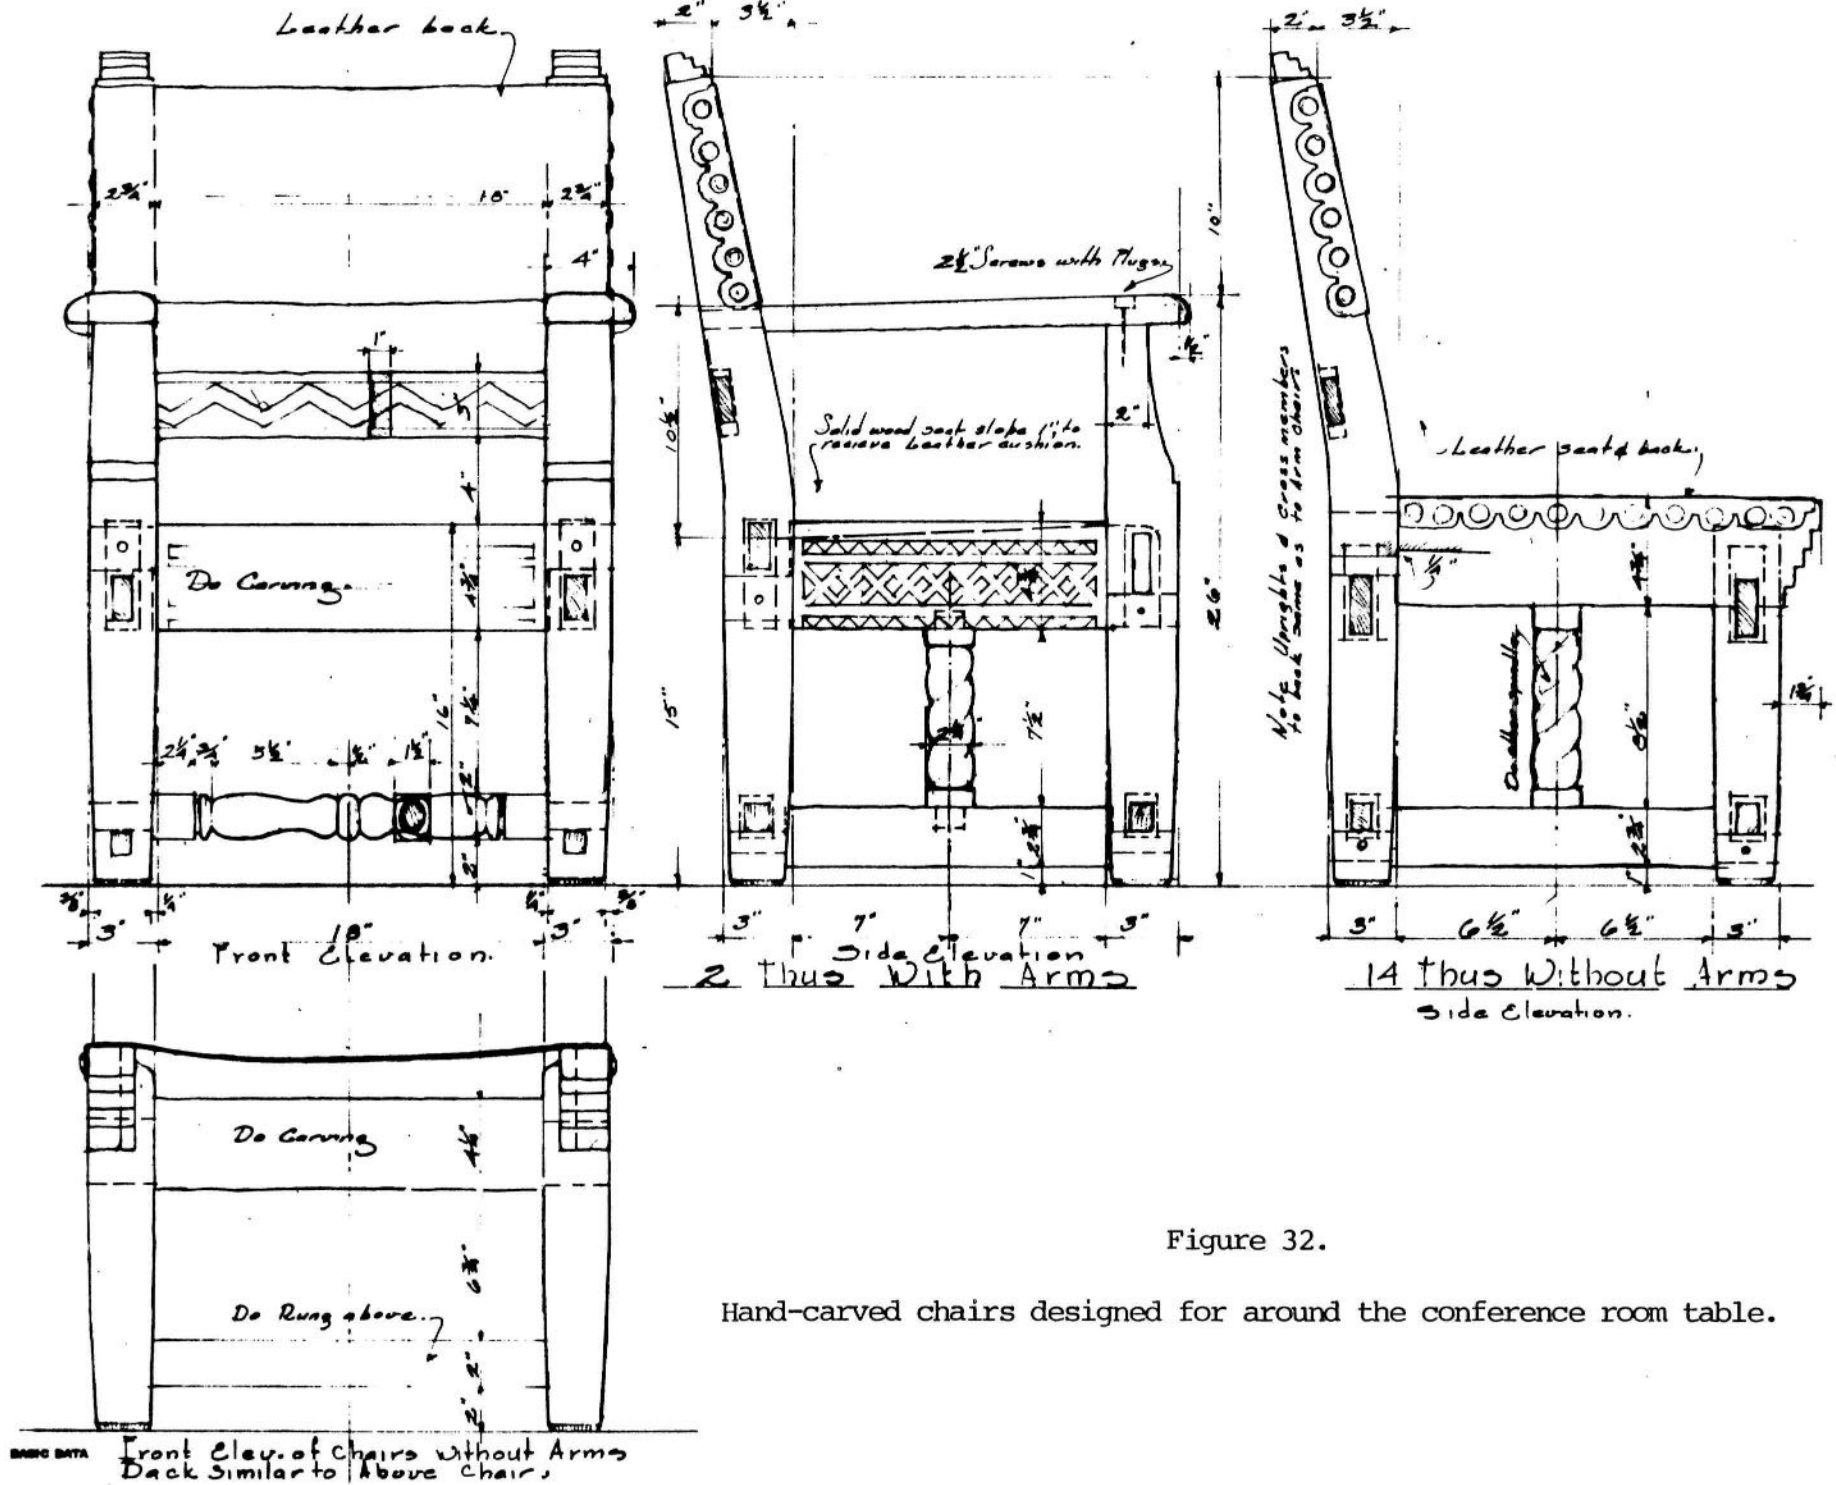
Figure 32.

Hand-carved chairs designed for around the conference room table.

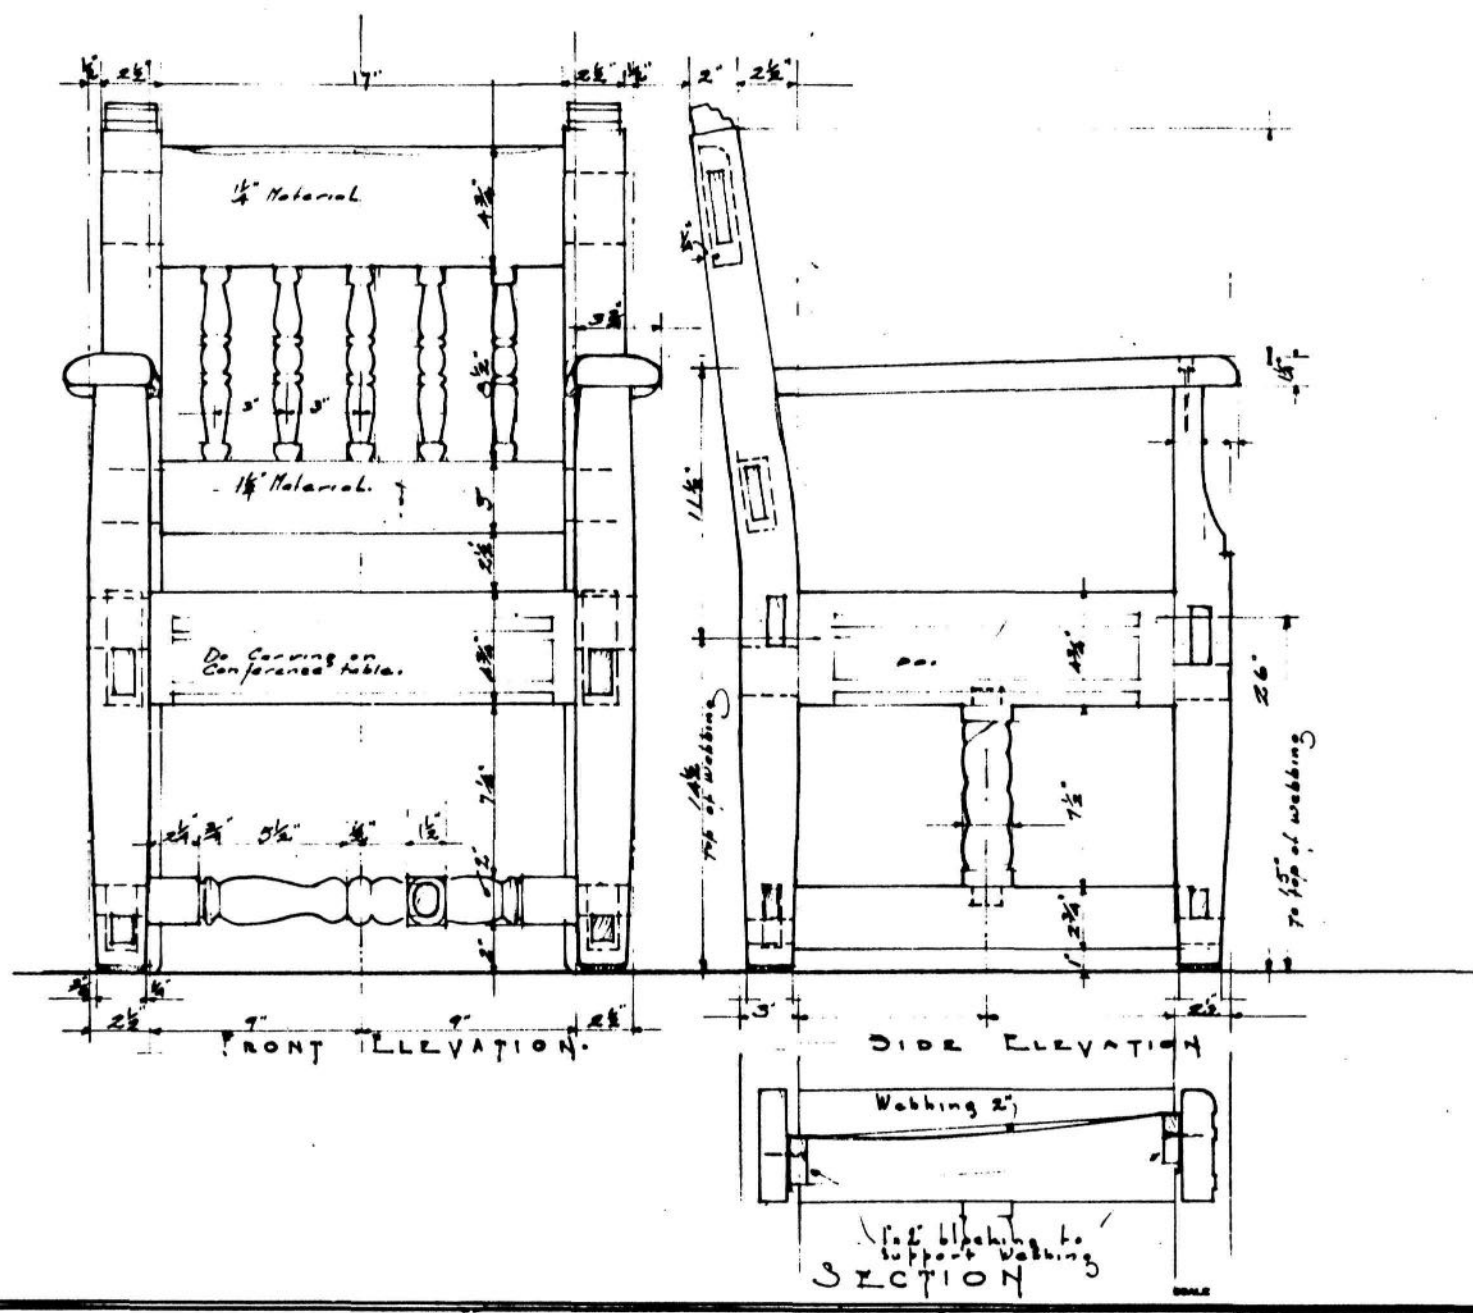
Figure 33.

Conference room chairs designed with arms for around the table.

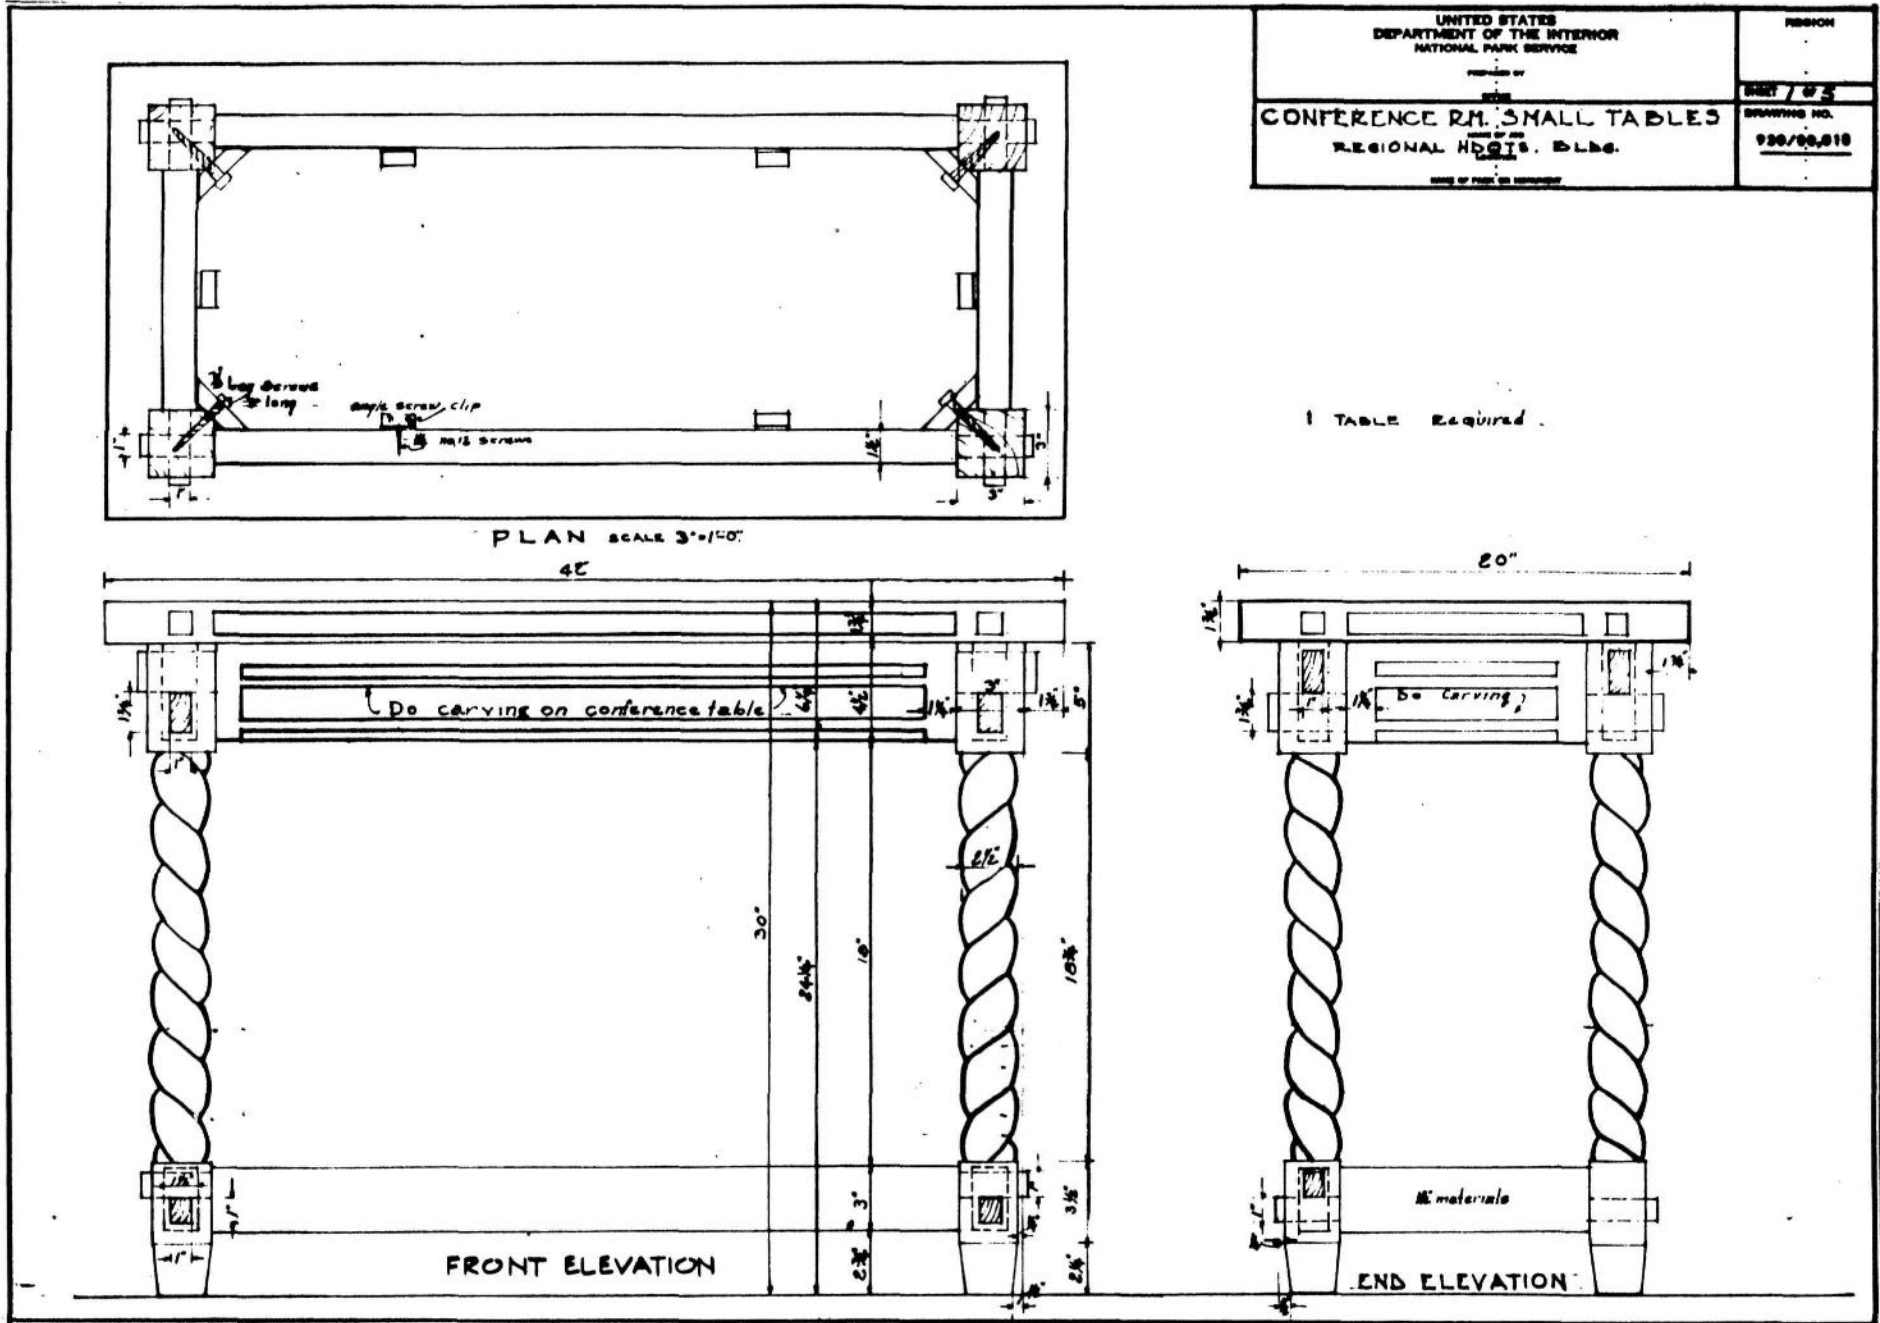
Figure 34.

Small hand-carved table designed to match other conference room furnishings.

A small table measuring 30 inches high by 20 inches wide, by 42 inches long was built to match the other conference room furnishings. The table is of a similar design and construction as the chairs, with intricate spindle design carving on the legs, and geometric Spanish designs carved into the rungs and stringers. Dowels, screws, and mortise and tenon joints were used as fasteners. Large lag screws were used to secure the legs, with 45-degree angle

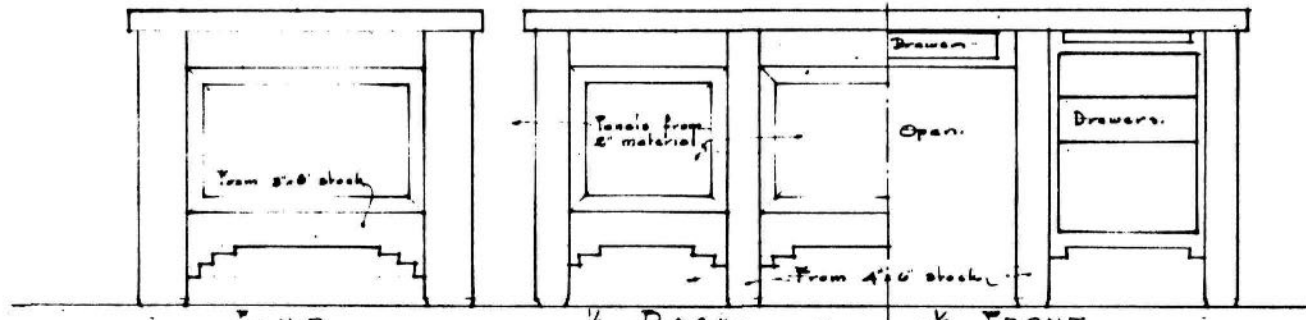
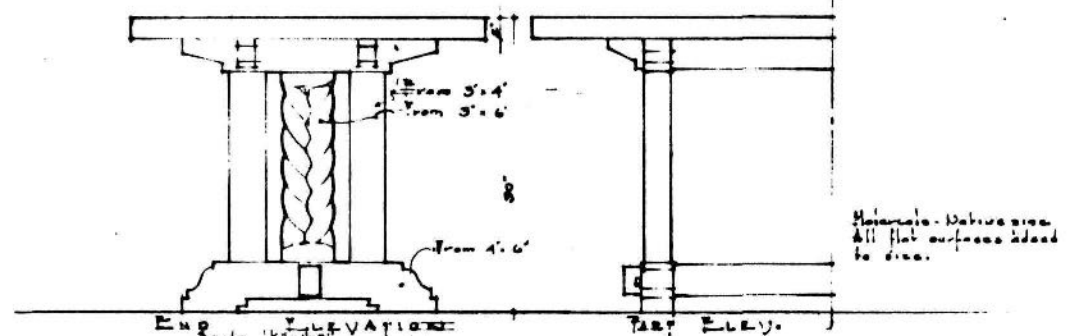
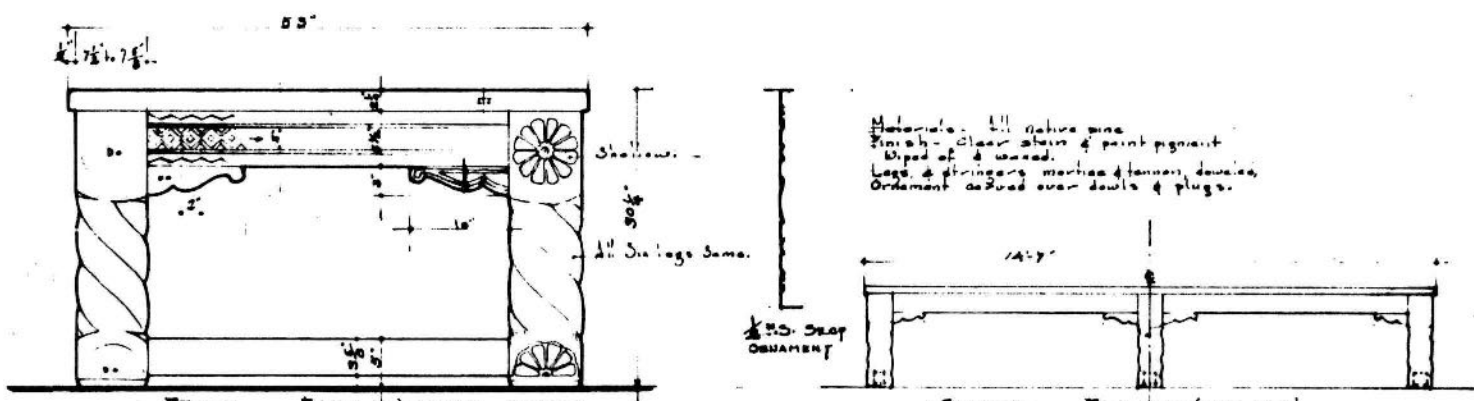
Figure 35.

END                      1/2 BACK                      1/2 FRONT  
 Material: Native pine - Mortise & Tenon, doweled - All surfaces look added to size & finish.  
**DETAILS OF LARGE DESK**

END ELEVATION                      SIDE ELEV.  
 Scale 1/2" = 1'-0"  
**DETAILS OF TABLE - NOT MEASURED**

END ELEVATION                      SIDE ELEVATION  
 Scale 1/2" = 1'-0"                      Scale 1/2" = 1'-0"  
**DETAIL - TABLE CONFERENCE ROOM REGION III HEADQUARTERS**

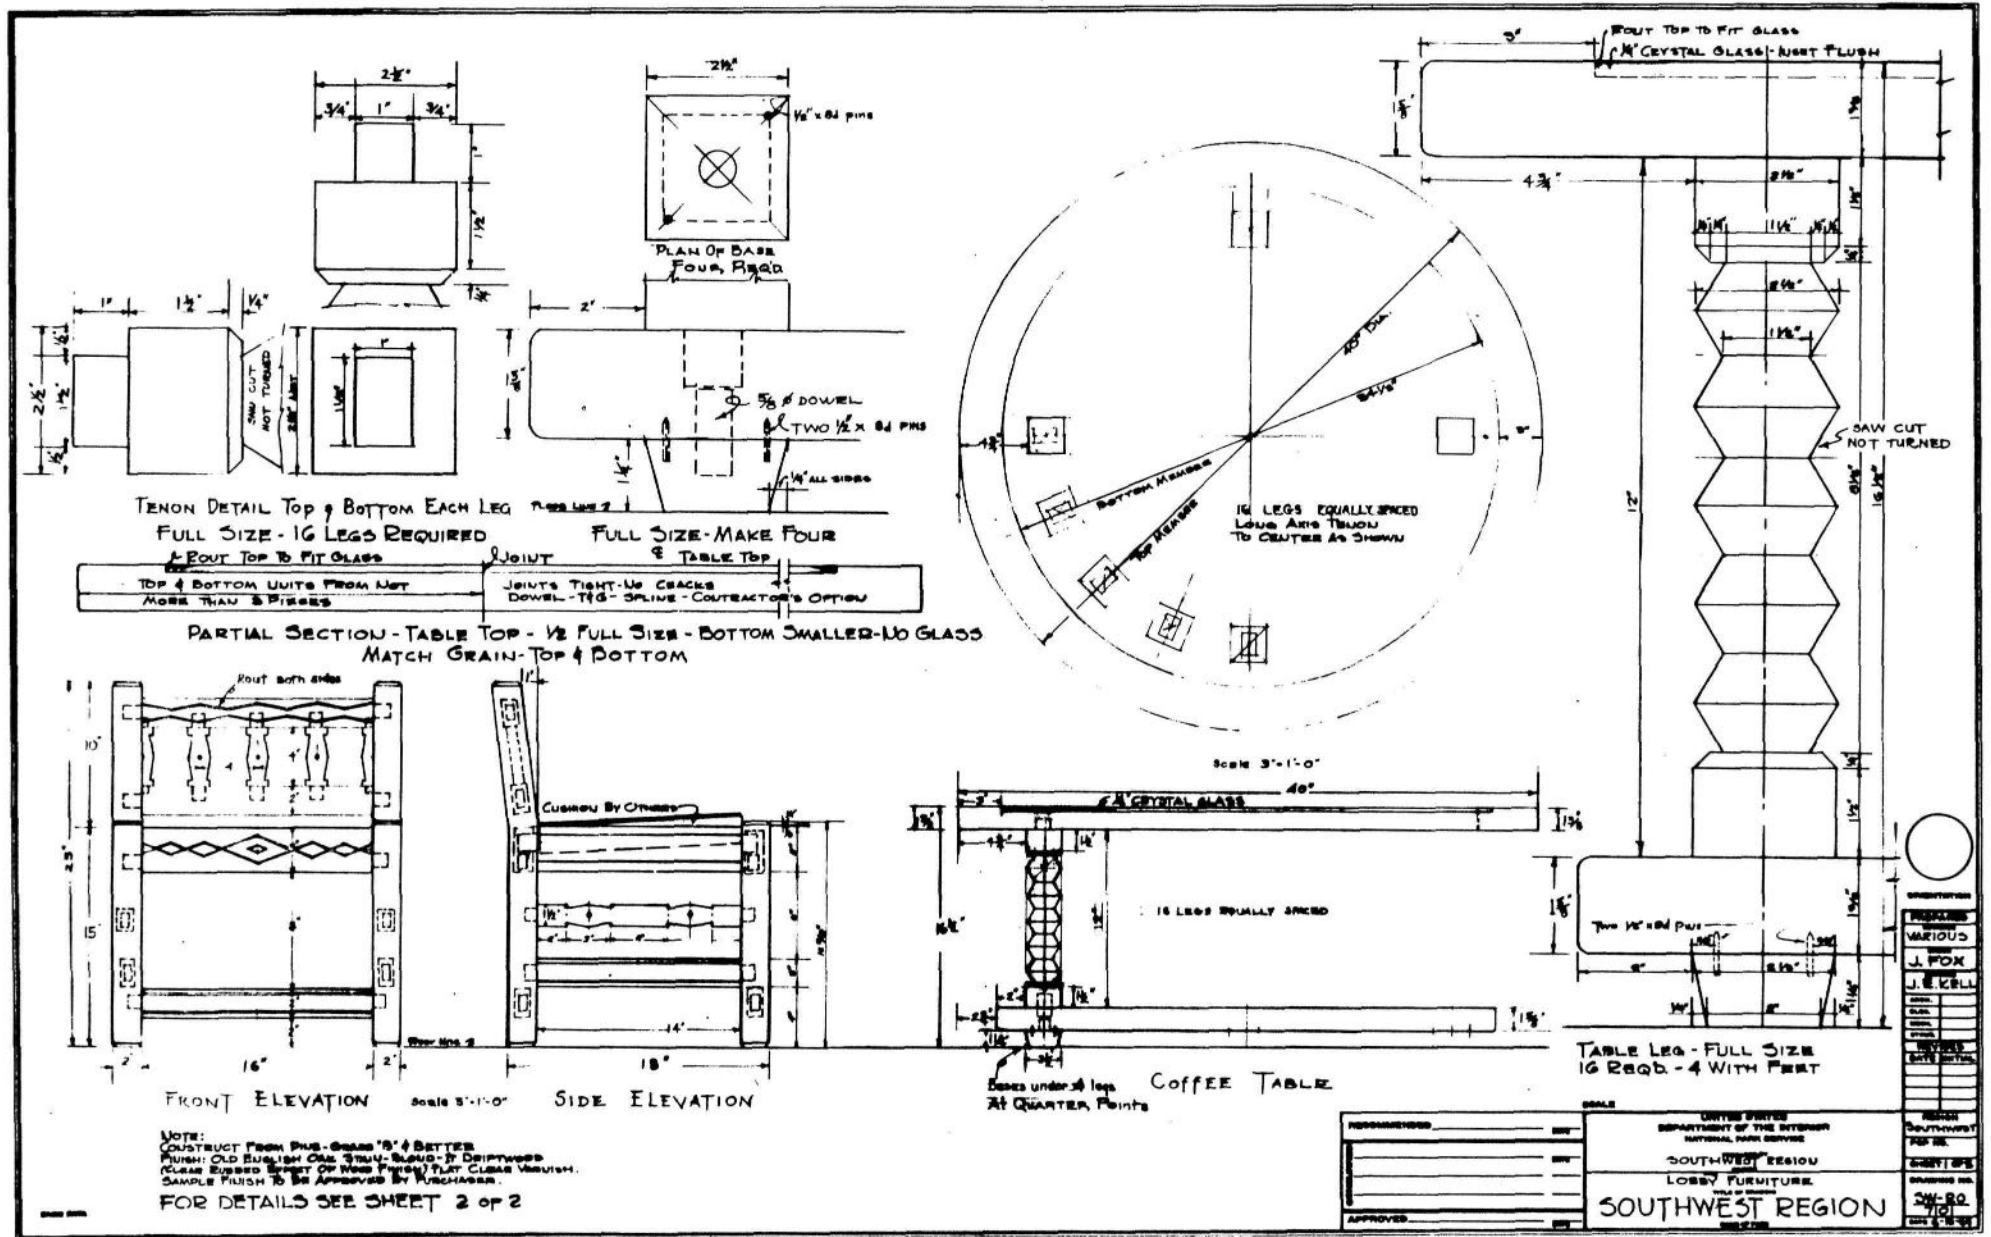
Figure 36.

Coffee table for foyer designed to reflect the hand-carved Spanish style seen in the original furniture.

In 1964 new furniture was built for the building's lobby. A small round coffee table with matching chairs was designed by "various" people in the Region (see title block on drawing). The table measures approximately 16-1/2 inches tall and 40 inches in diameter. It was constructed of grade "B" pine. The table has a lower shelf 1-1/4 inches up from the floor, with 16 legs equally spaced between the bottom shelf and the table top. Unlike the carved legs on the conference room table, the coffee table legs were saw cut, not turned or hand-carved. The table top has a 1/4-inch piece of glass inset 3 inches from

the side and 1/4 inch into the top. Mortise and tenon joints from the 16 legs are exposed on top (Figure 36).

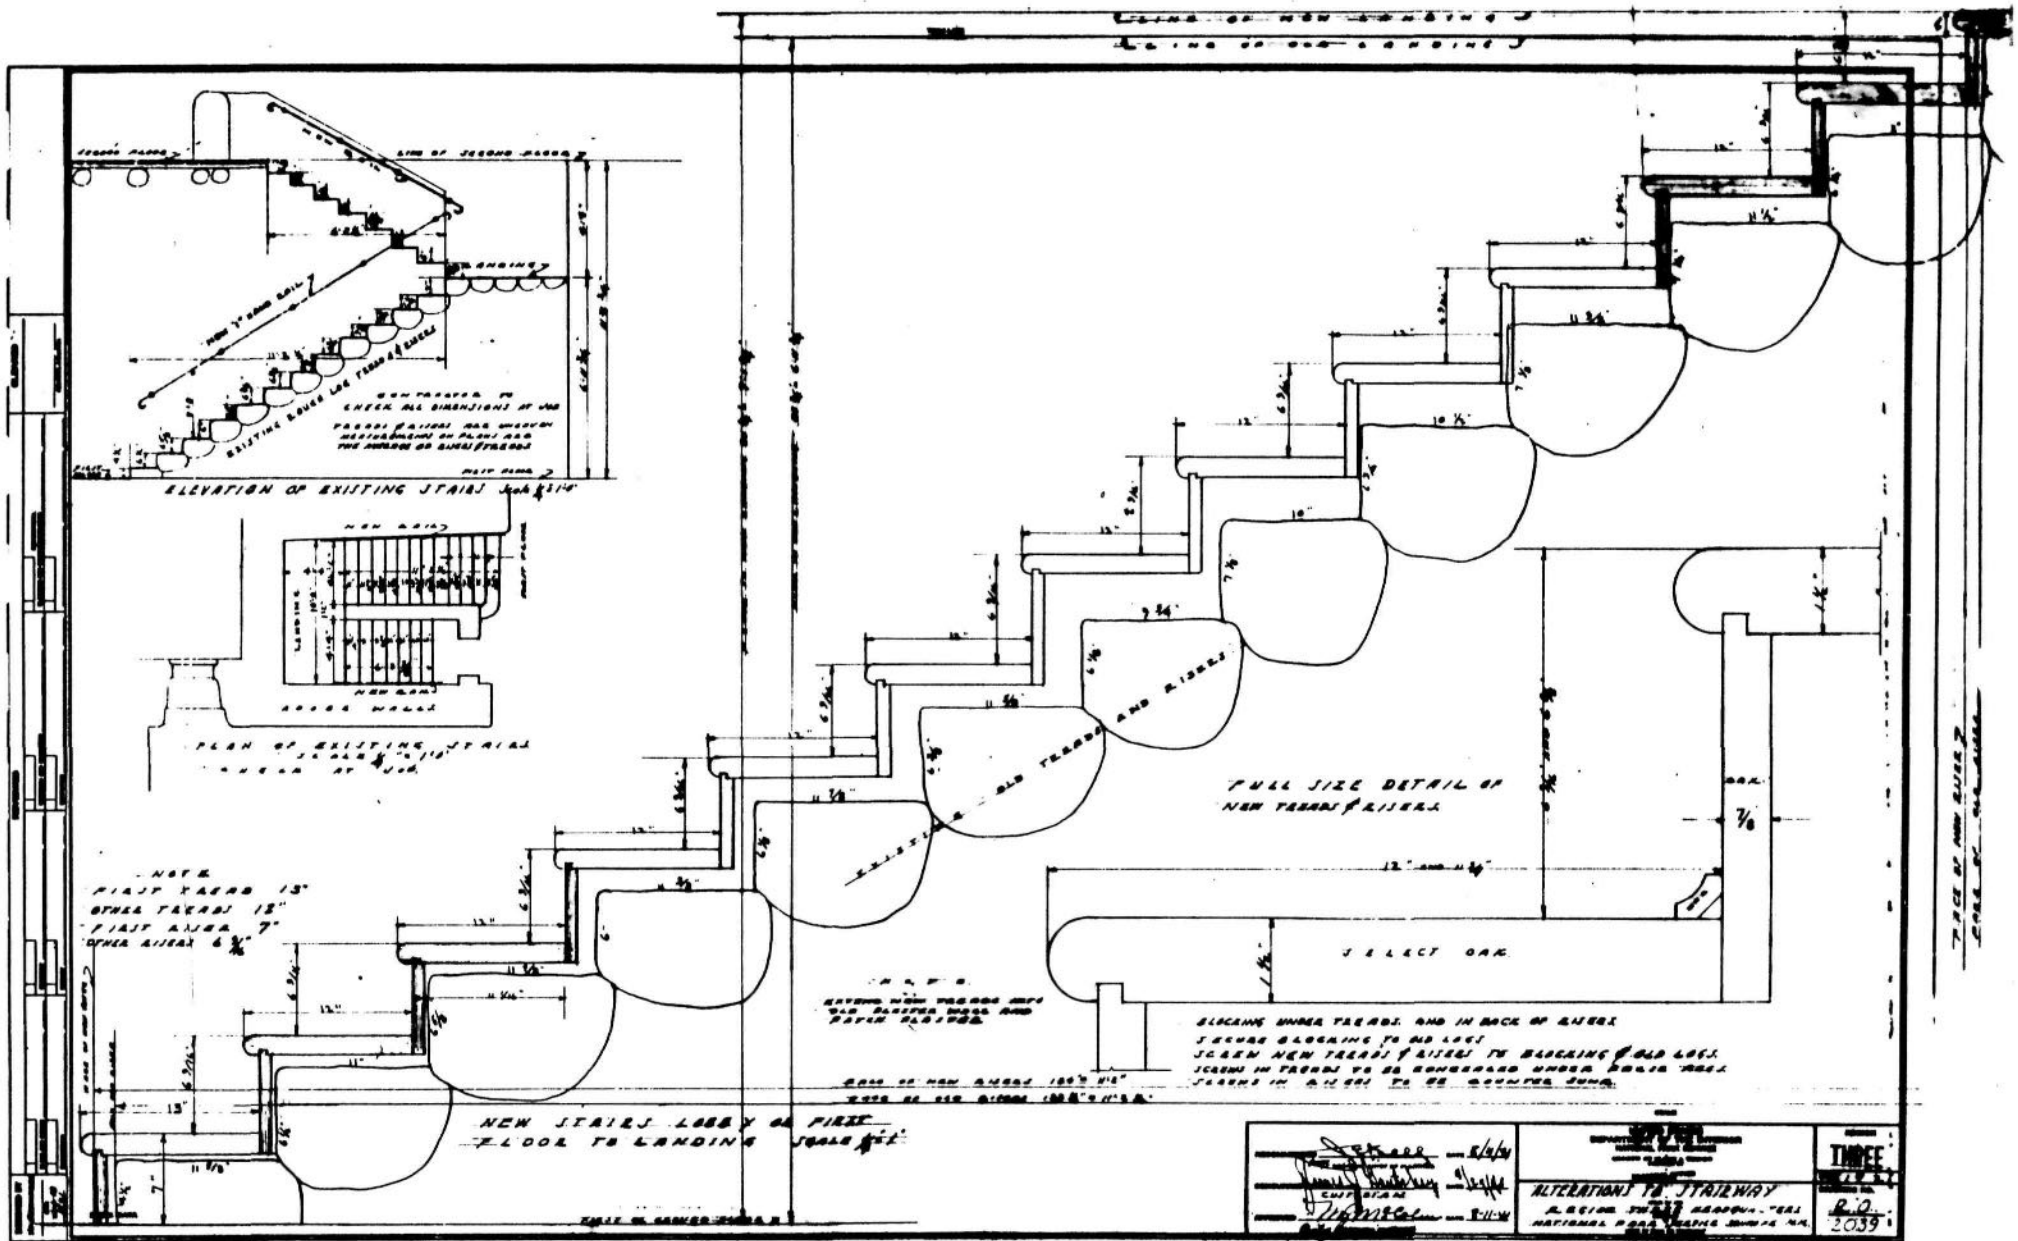
Figure 42.

Original log stair to the second level modified in 1941 with new oak treads and risers.

The building had only been opened a year when employees began to complain about tripping on the log stairs. After careful measuring, it was discovered that the logs were uneven. To rectify the situation, new treads and risers were constructed over the original log stairs. The new treads and risers were constructed of oak and were screwed down to leveling blocks which had previously been attached to the logs. When remodeling neared completion, the plaster walls were patched and the screws concealed under false pegs. The stair exists today as it was remodeled in 1941. All of the new treads measure 12 inches except the first which measures 13 inches, and all of the risers measure 6-7/16 inches except the first which measures 7 inches (Figure 42).

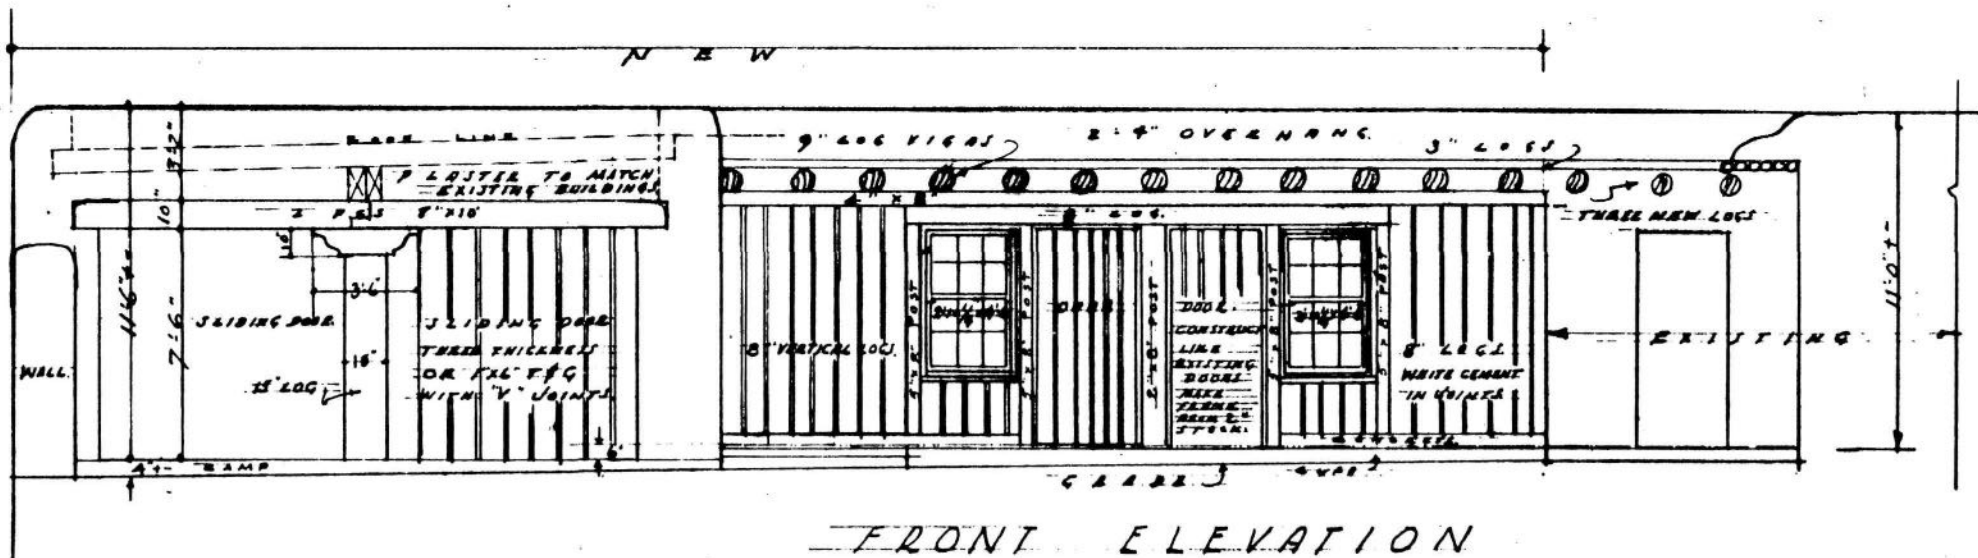
Figure 44.

The front elevation of the service building was constructed of 7-inch exposed vertical logs with chinking in between. This method of log construction is most common in the small towns to the north of Mountainair, New Mexico.

doors were built of tongue and groove V-joint stock. The north wall of the file rooms was constructed of 8-foot exposed vertical logs, 7 inches in diameter, with a 7-inch viga acting as a lintel above. The addition was finished after the final application of cement chinking between the logs and three coats of cement plaster over the exterior and interior adobe walls (Figures 44 and 45).
