# HISTORIC STRUCTURE REPORT

SOUTHWEST REGION HEADQUARTERS BUILDING  
SANTA FE, NEW MEXICO

A Historic Structure Report

Southwest Cultural Resources Center Professional Paper No. 6  
U.S. Department of the Interior  
National Park Service  
Santa Fe, New Mexico  
March 1985

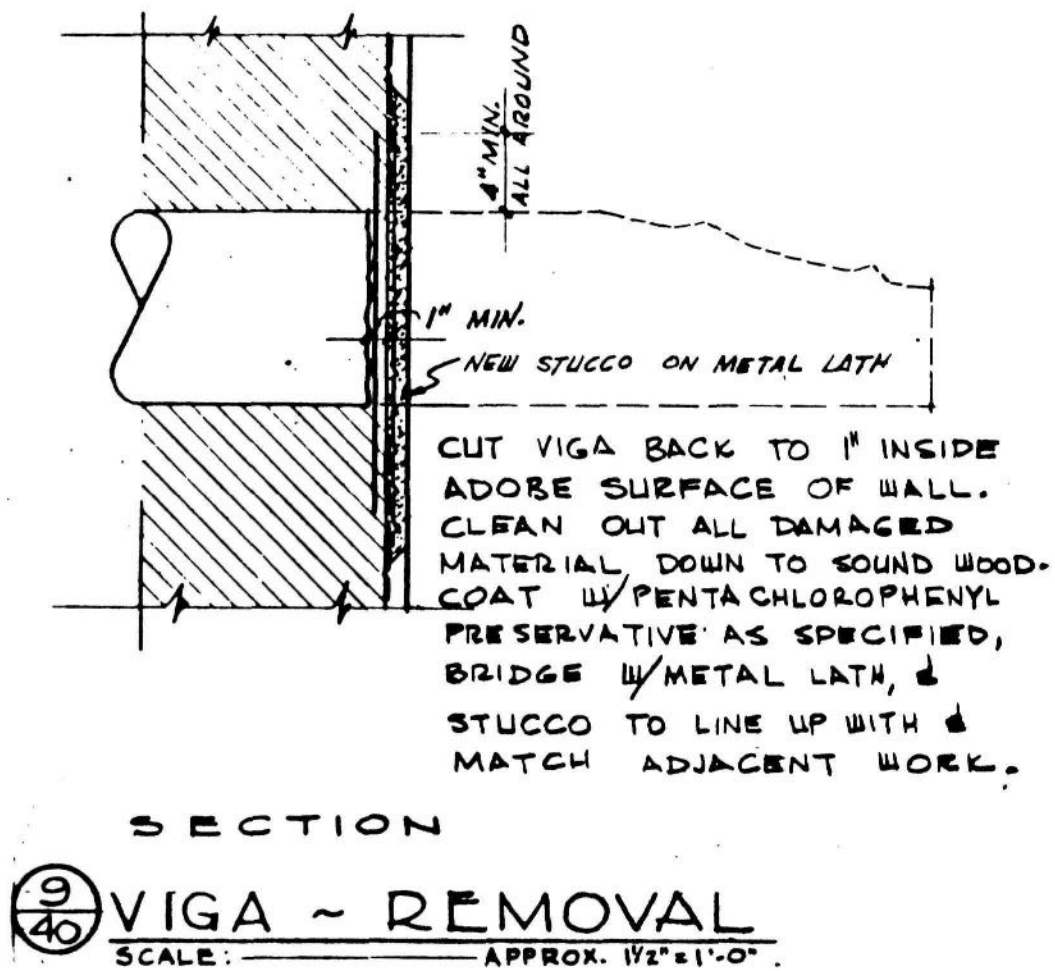
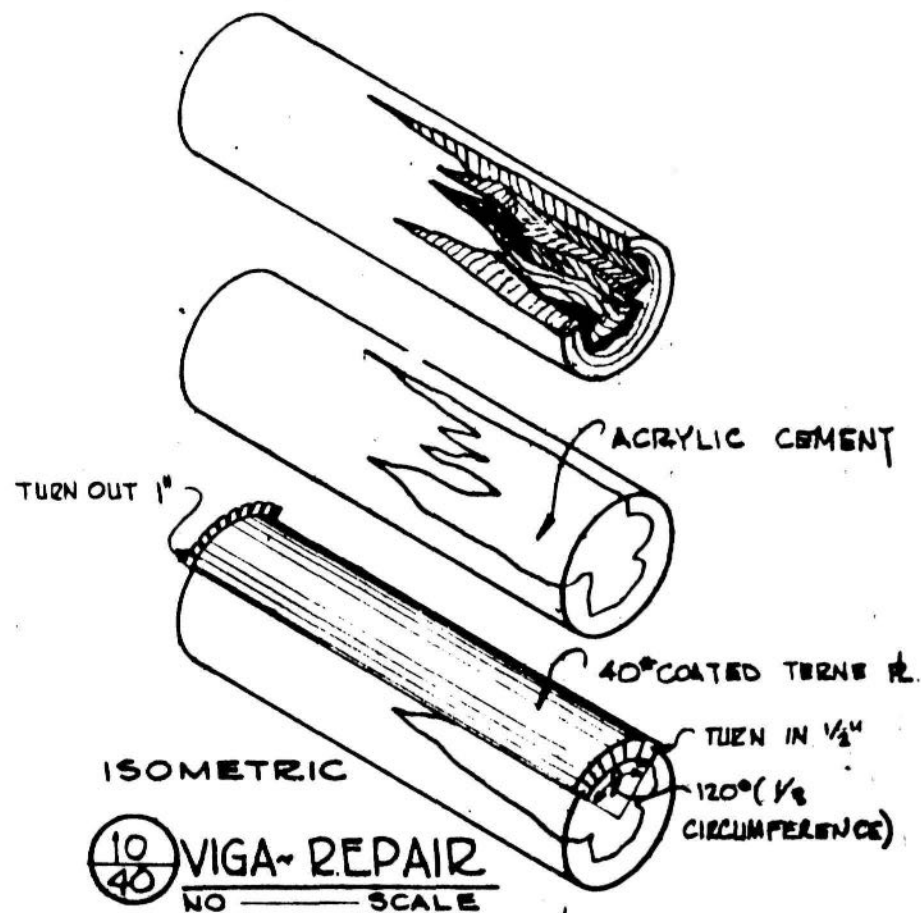
Figure 47.

The viga removal and repair plan shows many of the materials and techniques used when replacing vigas.

During the 1967 remodeling, half of the 209 vigas were in immediate need of repair or replacement. Where the exposed upper surfaces or ends of the vigas were in a severe state of decay, the rotted wood was removed and the viga was rebuilt to its original shape with an acrylic cement. After the cement had set, the viga tops were covered with a metal terne plate and cut back to a maximum projection of 2 feet. Of all the vigas repaired, only two were removed entirely. One of these was on the east side of the building and the other on the west side of the large patio. After the ends had been removed, the

remaining portions of the vigas were cut back to 1 inch inside the adobe surface of the wall. The damaged material was then cleaned down to the sound wood. A wood preservative called pentachlorophenyl was then used to seal the ends. Finally, the viga holes were bridged with metal lath and stuccoed to match the adjacent work (Figure 47).

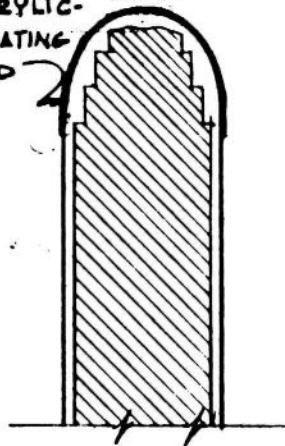
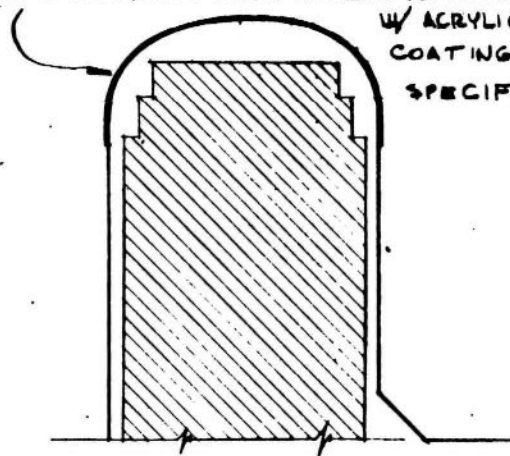
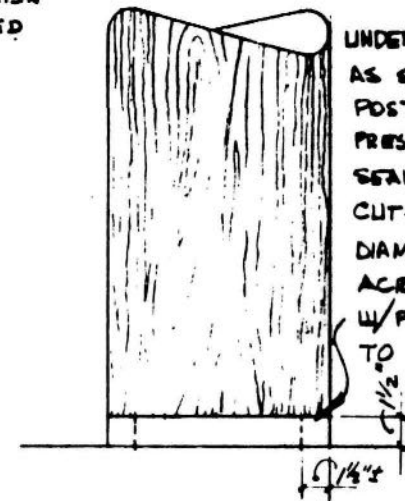
Figure 48.

SANDBLAST TO REMOVE ALL LOOSE & UNBONDED MAT'L. REBUILD WALL WHERE REQ'D & APPLY FABRIC 36" WIDE AS SPECIFIED. FINISH W/ ACRYLIC-FIBERED COATING AS SPECIFIED

$\frac{4}{40}$  CONFINING WALL~WATERPROOF  
SCALE: APPROX.  $\frac{3}{4}$ "=1'-0"

REMOVE EXISTING FABRIC & SAND BLAST TO REMOVE ALL LOOSE & UNBONDED MAT'L. REBUILD PARAPET WHERE REQ'D & APPLY NEW FABRIC 48" WIDE AS SPECIFIED. FINISH W/ ACRYLIC-FIBERED COATING AS SPECIFIED

$\frac{5}{40}$  PARAPET WALL~WATERPROOF  
SCALE: APPROX.  $\frac{3}{4}$ "=1'-0"

UNDERCUT POST ALL AROUND AS SHOWN. COAT ENTIRE POST & UNDERCUT W/ PRESERVATIVE WOOD SEALANT. REBUILD UNDERCUT AREA TO ORIGINAL DIAMETER OF POST W/ ACRYLIC CEMENT. COAT W/ PIGMENTED WD. STAIN TO MATCH POST ABOVE

$\frac{6}{40}$  WOOD POST~REPAIR  
SCALE:  $1\frac{1}{2}$ "=1'-0"

Parapet and wood post details show how the wood posts were undercut and rebuilt with an acrylic cement. Waterproofing of parapet walls was also done at this time.

During the remodeling, many canales on both the exterior walls and patio walls were in need of repair. This was accomplished by renailing the lining and filling the cracks in the wood with an acrylic cement like that used to repair the vigas. Many of the canales' flagstone lintels were removed entirely and the canales were rebuilt in the shape specified. The remaining canales also had the flagstone lintels removed, but these were rebuilt and reinforced as slotted openings. Two canales in the large patio were nonfunctional so they were removed entirely. The parapets around these two canales were rebuilt and new flashing was applied (Figure 48).

The wood posts on the large patio portal were undercut 1-1/2 inches high around the bottom and coated with a preservative wood sealant. The undercut part of the post was rebuilt to the original diameter with an acrylic cement. The undercut was finished with a pigmented wood stain to match the post above (Figure 48).

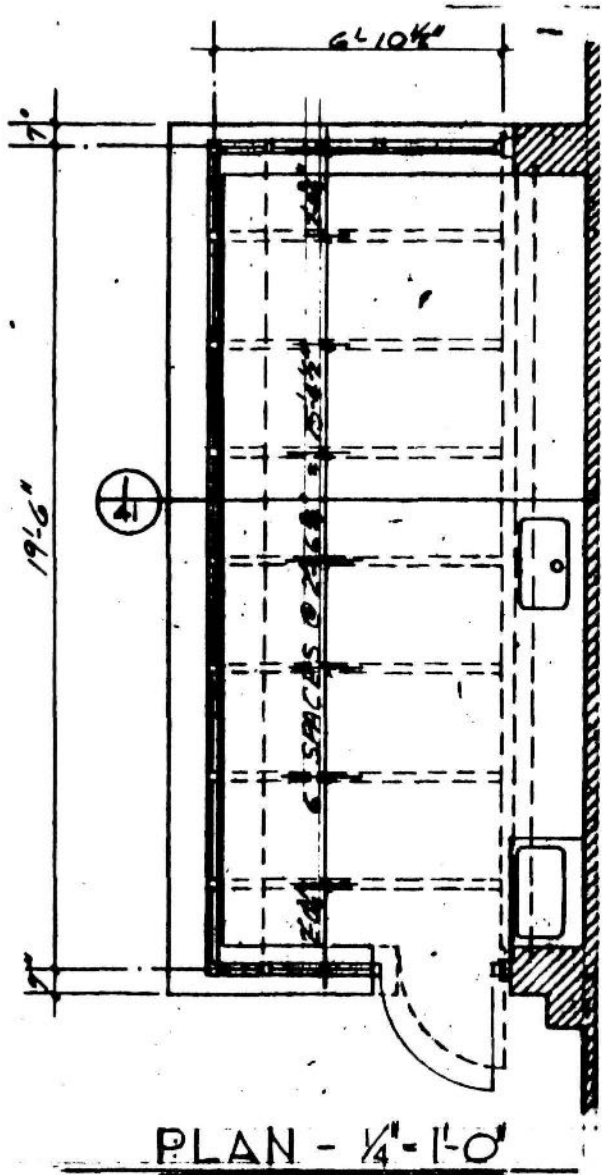
Figure 52.

Greenhouse details showing the existing greenhouse structure to be removed and replaced with a smaller more efficient one.

During the service building remodeling, the existing greenhouse on the south side of the building was torn down and replaced with a smaller, more efficient one. The new greenhouse was built on the same foundation as the original, but displays a smaller, more compact design. The structure is 6 feet 10 inches wide by 19 feet 6 inches long. The original concrete wall, which serves as the foundation for the new greenhouse, was cut down approximately 1 foot, making the height of the new building lower than the original greenhouse. The current greenhouse has a continuous hinged vent 2 feet 4 inches wide running the length of the structure. The door is a standard product of the greenhouse manufacturer. In an interview on May 25, 1984, Frank Martinez, GSA maintenance worker, said that "the existing greenhouse is currently unused because GSA doesn't have the personnel to maintain it." (Figure 52)

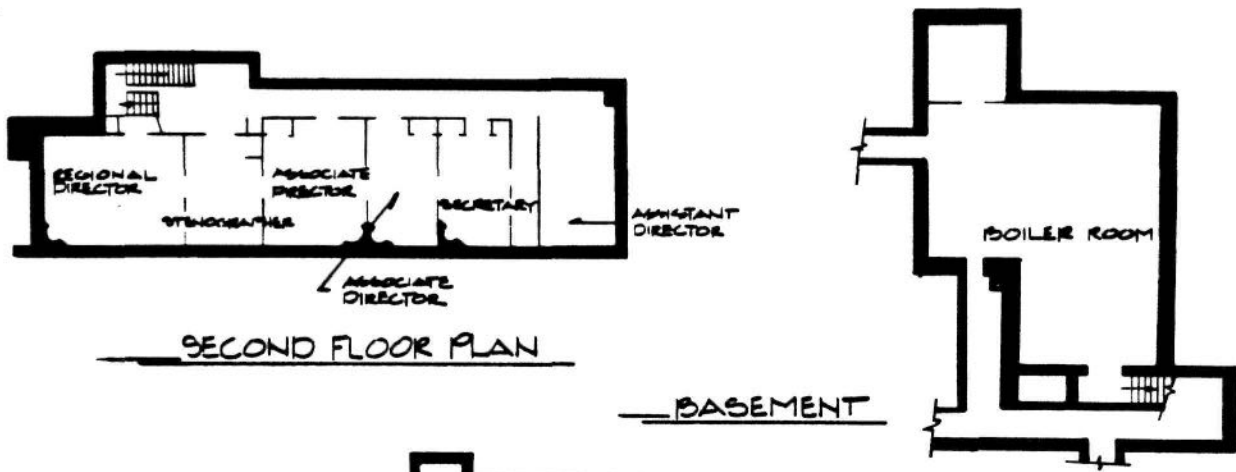
Figure 55.

**EVOLUTION OF SPACES  
1938**

Floor plans showing the use of each space when the building was designed in 1938.

beautifully landscaped courtyard on the northeast corner of the building. The second floor has always been occupied by the Region's executive officers. This portion of the building is much smaller in scale than the rest of the building. (Refer to Evolution of Spaces drawings in Appendix A, Figures 55, 56 and 57).)

Since 1938 the evolution of offices has changed considerably, but not to as destroy or alter the building's original appearance. The following three floor plans illustrate how many of the departmental offices have changed since 1938.

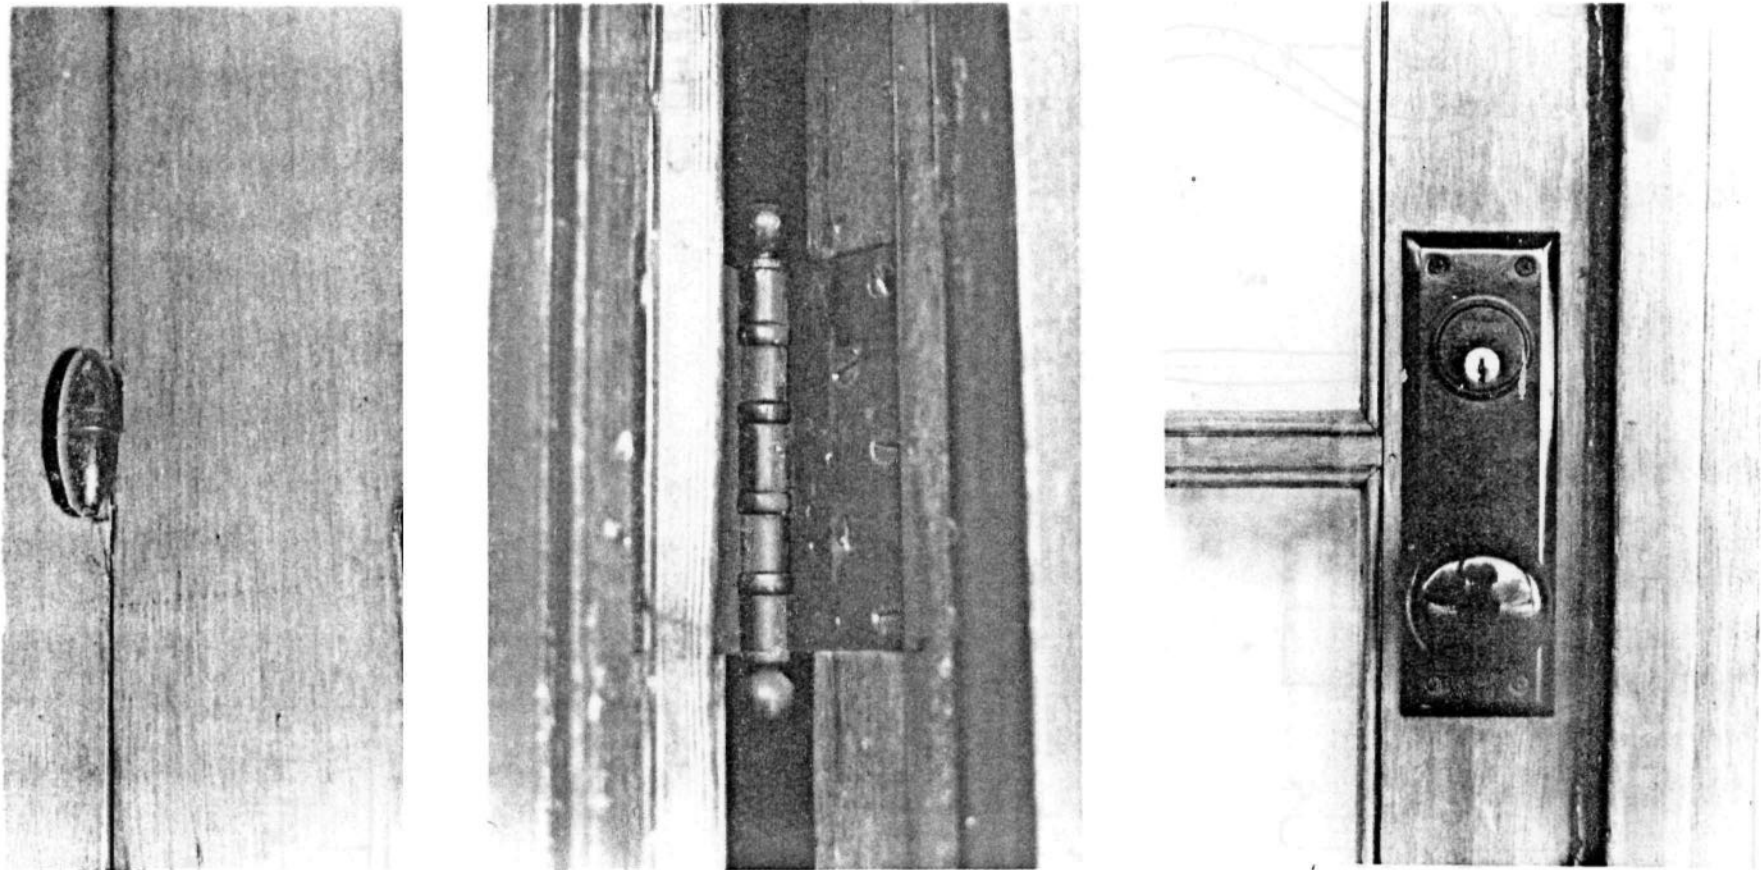
Figure 60.

Examples of original hardware. From left to right: A ball bearing of the knuckle hinge seen on the north entrance doors, a typical four-ball bearing door hinge and a residence tabular entrance door set.
