Energy Procedia 132 (2017) 765-770

11th Nordic Symposium on Building Physics, NSB2017, 11-14 June 2017, Trondheim, Norway

Moisture damage with magnesium oxide boards in Danish facade structures

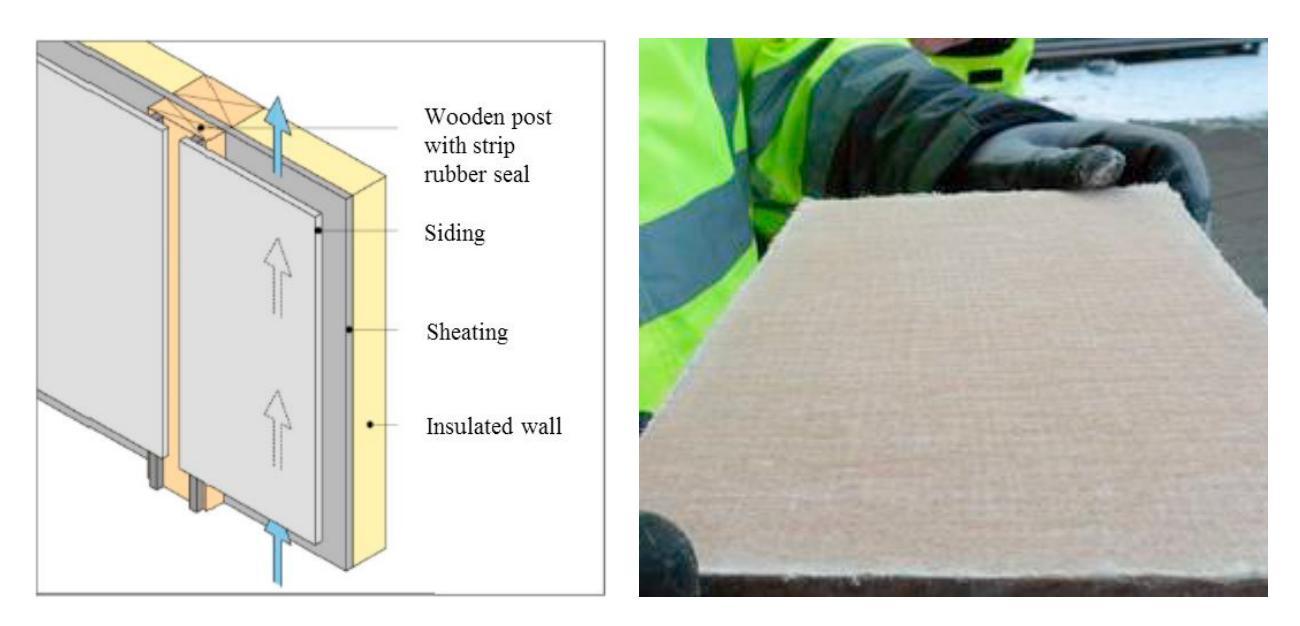
Fig. 1. (a) Sketch of a typical façade construction where a sheathing board is used as wind barrier. Adapted from [1]; (b) Photo of 8 mm thick MgO-board with a glass fibre mesh on both surfaces.

Many moisture damages were observed in winter 2014/15 in ventilated facades of new or newly renovated Danish buildings. The damaged facades had magnesium oxide-boards (MgO-boards) as sheathing facing the ventilated air gap behind the exterior siding. MgO-boards have often been used as sheathing behind a ventilated air gap as shown in Figure 1a and Figure 2a. A photo of an MgO-board is shown in Figure 1b. Examples of saltwater leaks and subsequent damage are shown in Figure 2b, 3a and 3b.

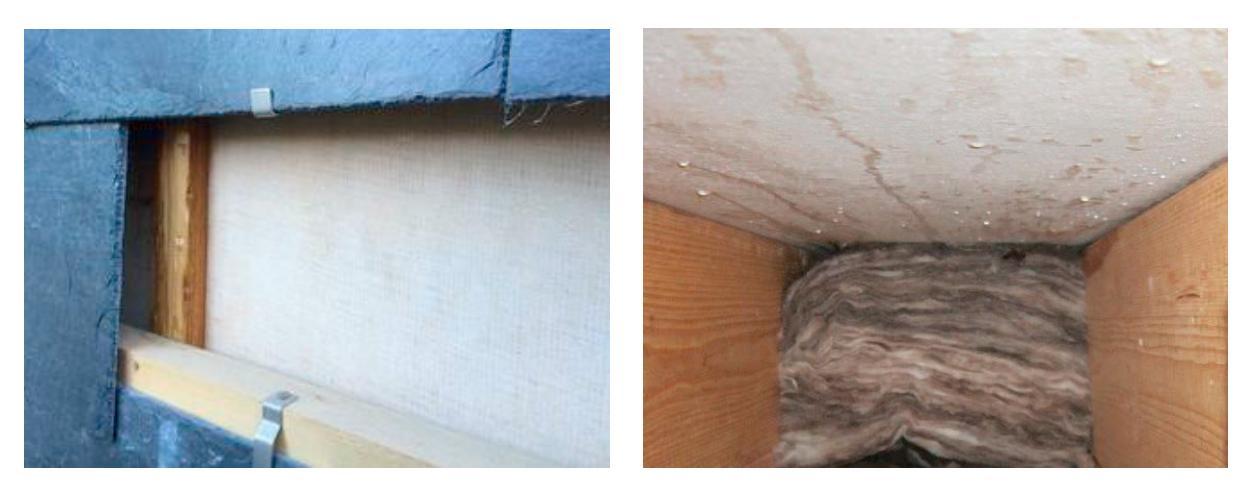
Fig. 2. (a) The MgO-board is placed facing the air gap, which is behind the siding boards made of natural slates; (b) Salty water drops on a vertical MgO-board on the side that faces the insulation filled cavity inside the wall.

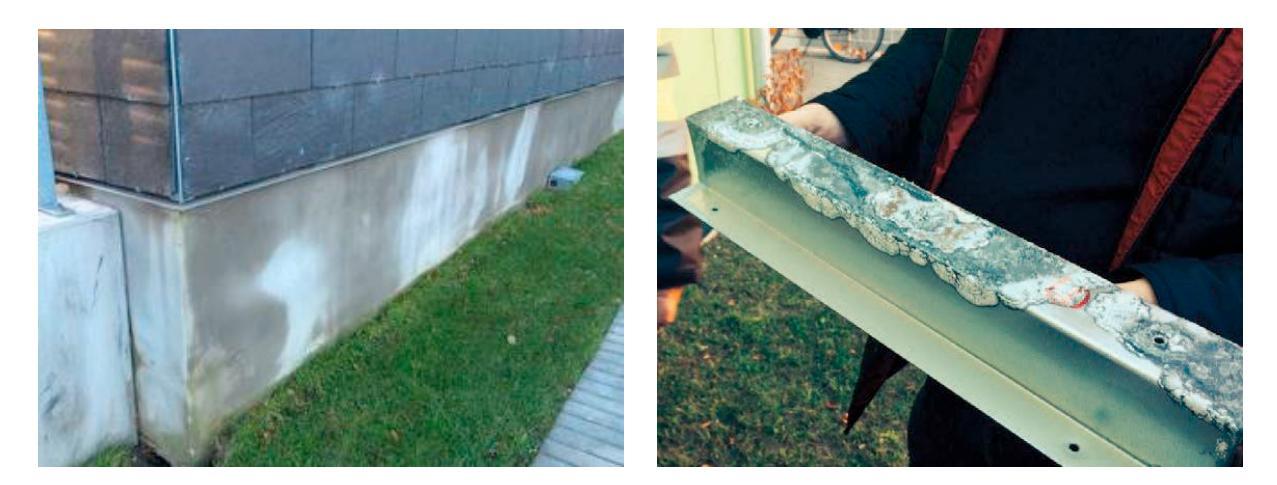
Fig. 3. (a) Water drops containing chloride ions run down the vertical MgO-boards and drain out of the wall from behind the wall's siding boards; (b) Zink covering of the steel profile is corroded as a result of direct contact with salty leaked water from the adjacent MgO-board.

Salt from MgO-boards is highly corrosive on metal fasteners and profiles. Zink flashings of 0.8 mm corrode in 1-2 years. Electro galvanized steel profiles, nails and screws will corrode through to the steel in 1-2 years. Aluminum alloys have different resistance against corrosion and the best alloys have been seen undamaged for 2-3 years. Stainless steel of A2 and A4 can be used without problems. When MgO boards have been sitting on a wooden structure, MgCl₂ salt will have been absorbed by the wood, which is then corrosive to metallic fasteners other that stainless steel.

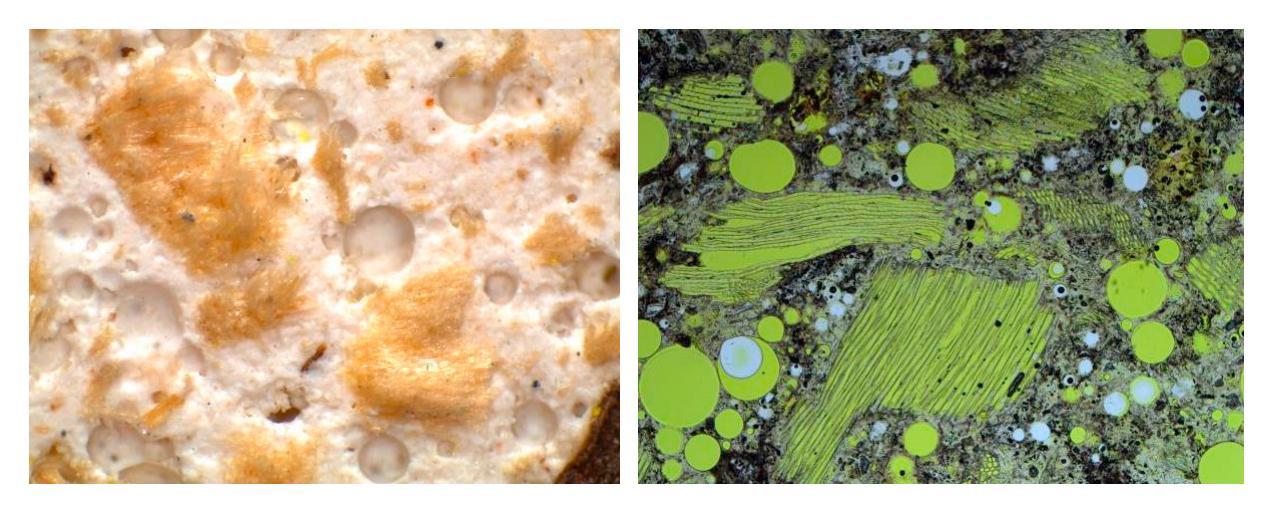
Fig. 4. (a) Cut of a MgO-board investigated in a stereo microscope at 10 times magnification; (b) Micro analysis of a thin section of a specimen at 50 times magnification.

The binder in MgO-boards is formed by a chemical reaction between MgO and MgCl₂, typically in a weight ratio of 2.5-3.5 parts MgO to one part MgCl₂. The product is quite similar to Sorel cement, which was first produced by Stanislas Sorel in 1867 [2] and used as a flooring material. Various explanations about the product and its possible use and qualities can be found in literature [3-10]. The hydrated product is hard and strong but the product decomposes over time by contact with water or air at high relative humidity (RH). MgO-boards often have organic additions, such as sawdust, and inorganic fillers such as sand, lime or volcanic ash. Figure 4a shows a picture of an MgO-board from a stereo microscope at 10 times magnification. Figure 4b shows a microanalysis of a thin section of a specimen at 50 times magnification that reveals that the investigated MgO-board contains a high amount of very porous organic material, and a high number of fine spherical air pores. All investigated MgO-boards have glass fibre felt as facer.

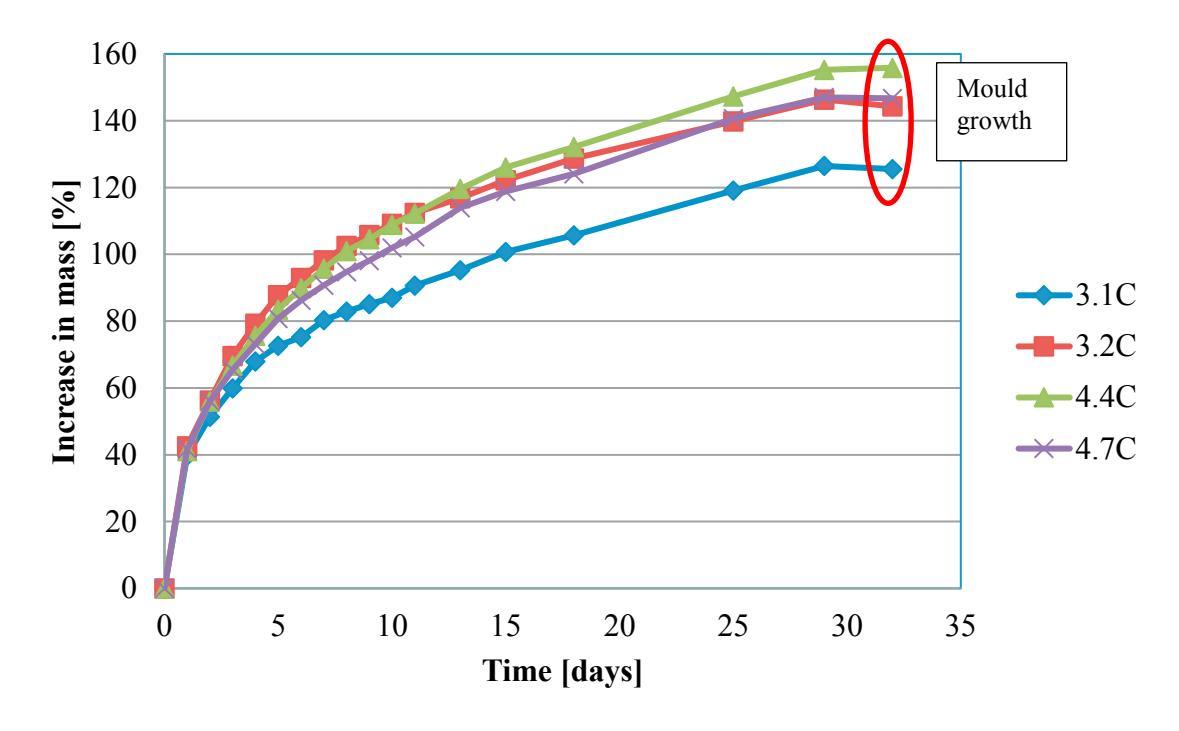
Fig. 5: Course of the moisture retention at 95% RH.

Moisture absorption in MgO-boards from the surrounding air was measured at three different levels of relative humidity at 23 $^{\circ}$ C: 35% RH, 80% RH and 95% RH. Before start of the moisture exposure, samples of size 5 x 4 x 3 mm were dried at 105 $^{\circ}$ C for 4 days. MgO-samples with a total weight of about 2 g were put in a petri dish, which was placed in a Teflon basket, and weighed without removal from the climate chambers. The specimens were weighed after 0, 1, 2, 3, 4, 5, 7 days and after 2 and 4 weeks. Specimens exposed to 35 % RH reached 6-7 % moisture content by weight after a week and then remained at that level, while specimens exposed to 80 % RH reached 26 % by weight after a week, and about 30 % after 4 weeks (48 % for one of the specimens). Results are presented in Figure 5 for specimens exposed to 95 % RH. Mould growth was seen after 30 days of exposure to 95% RH.

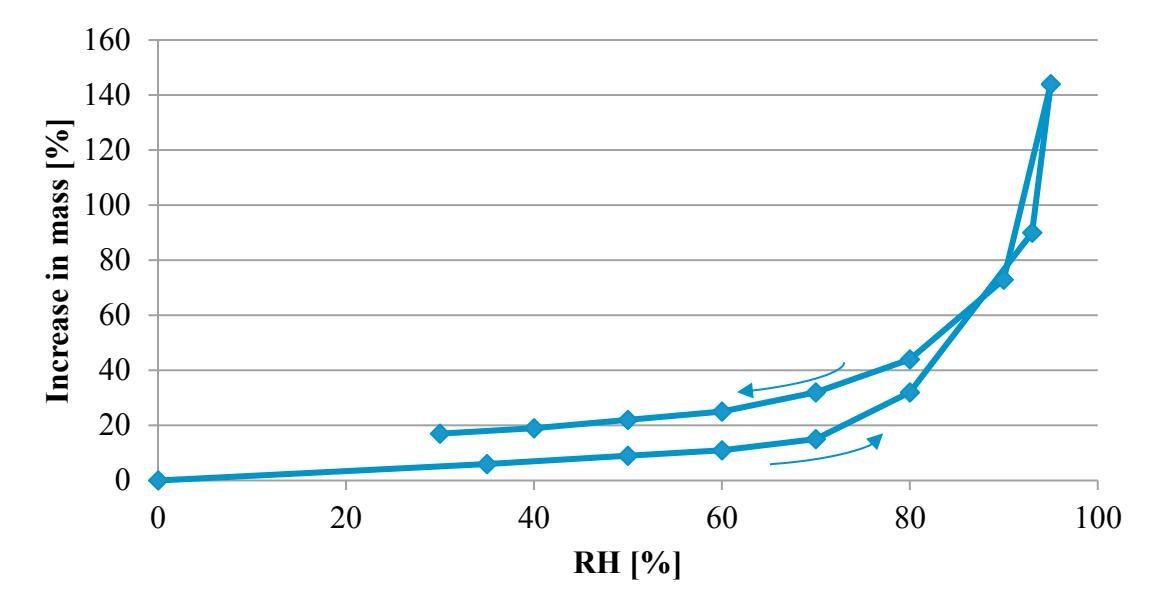
Fig. 6: Results of the absorption and desorption measurements for one of the specimens.

Absorption was measured for specimens that were originally used for initial moisture absorption at 35% RH. The absorption points were measured from 35% RH and up to 92% RH. An example of the results of the absorption and desorption measurements is shown in Figure 6.

As described above, the RH was gradually increased from 80% RH to 92% RH in steps of 2% RH with the purpose to find out at which RH the MgO-board starts sweating. It must be stated that the specimens stayed more than 30 days at 80% RH before the humidity was increased to 82% RH. The results of this gradual increase in RH showed the initially sweating on the specimens' surfaces or in the cup below the specimens at 84% RH.
