ORIGINAL ARTICLE

Magnesium oxychloride boards: understanding a novel building material

Timothy A. Aiken · Mark Russell · Daniel McPolin · Leo Bagnall

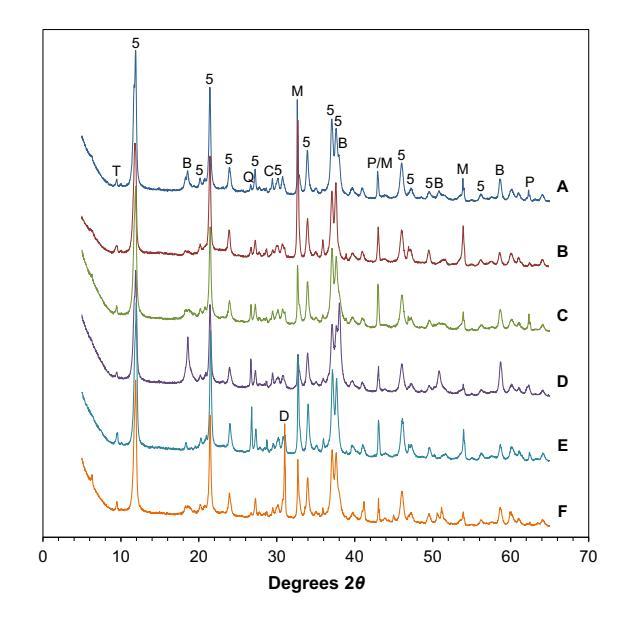
Fig. 1 XRD pattern of each board. 5 5-phase magnesium chloride hydroxide hydrate, B brucite, M magnesite, Q quartz, C calcite, P periclase, D dolomite, T talc

MgO. As shown by XRD (Fig. 1) not all of this relates to MgO, rather to numerous other minerals which also contain magnesium. The main minerals identified by XRD are 5-phase magnesium chloride hydroxide hydrate $(5 \text{ Mg}(\text{OH})_2 \cdot \text{MgCl}_2 \cdot 8\text{H}_2\text{O}),$ magnesite (MgCO₃), brucite (Mg(OH)₂), quartz (SiO₂), talc (Mg₃Si₄O₁₀(OH)₂) and calcite (CaCO₃). Board F also contains dolomite $(CaMg(CO_3)_2)$ which is in agreement with the increased calcium content present in board F (Table 2). In general, the same minerals are present in all six boards. However, there appears to be subtle differences in the quantity of each mineral. Table 3 shows the quantified values of each mineral. These values only account for crystalline materials, not the X-ray amorphous content such as the wood and perlite. The main binder component of each board is 5phase with 63.4% in board B and as much as 83.8% in

board C. The 5-phase mineral is the most desirable magnesium oxychloride phase as these crystals provide superior mechanical properties compared with other magnesium oxychloride cement phases [12]. Each board also contains magnesite which makes up between 4.3 and 16.8% of the binder of each board except for board B which has almost 30% magnesite in its binder. The presence of magnesite may be due inadequate calcination, in terms of temperature or duration, of the raw material (magnesite) [12, 40]. Brucite is present predominantly in boards A and D with as much as 27.6% in board D and 12.2% in board A. This is likely due to the use of greater amounts of magnesium oxide in the original mix design as suggested by the XRF data in Table 2. This indicates there was surplus MgO available than was needed to react with all of the MgCl₂ present meaning in theory no chloride ions would remain unreacted. The chemical formula below shows the chemical reaction which takes place to perfectly form 5-phase.

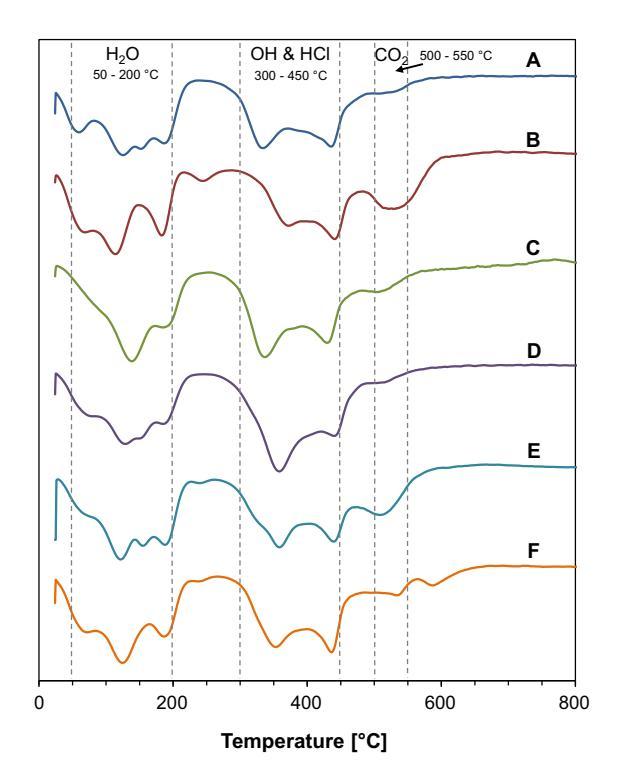
Fig. 2 DTG of each board sample

TGA of each board was carried out and the derivative of the TGA traces (DTG) is shown in Fig. 2. The gas evolved during thermal analysis was analysed using MS. Generally, all 6 boards have

similar endothermic peaks but the locations vary slightly. Losses observed below 50 °C can generally be related to the release of non-chemically bound moisture. Between 100 and 200 °C the samples have either 2 (B, C and F) or 3 (A, D and E) endothermic peaks. Data obtained from mass spectrometry indicates that mass loss in this region was related to the release of H₂O molecules. This is in agreement with Luo et al. [42] who noted two main peaks in this region for magnesium oxychloride cements due to the release of crystal water from 5-phase in two steps forming 5 Mg(OH)₂·MgCl₂. They reported the first step between 50 and 130 °C and the second between 140 and 200 °C. Between 300 and 450 °C, 5 Mg(OH)2-MgCl₂ is thermally decomposed into MgO, also in two steps with the release of OH (300-350 °C) and HCl (350–450 °C) [43, 44]. The peak at around 450 °C can also be related to the decomposition of Mg(OH)₂ and the peak located between 500 and 550 °C is related to the release of CO_2 in the decomposition of MgCO₃ [42]. Board B has the largest peak in this region which is in agreement with findings from XRD which suggest board B has more magnesite than its counterparts. Finally, board sample F has an additional peak at approx. 600 °C which is likely due to the release of CO₂ from dolomite.

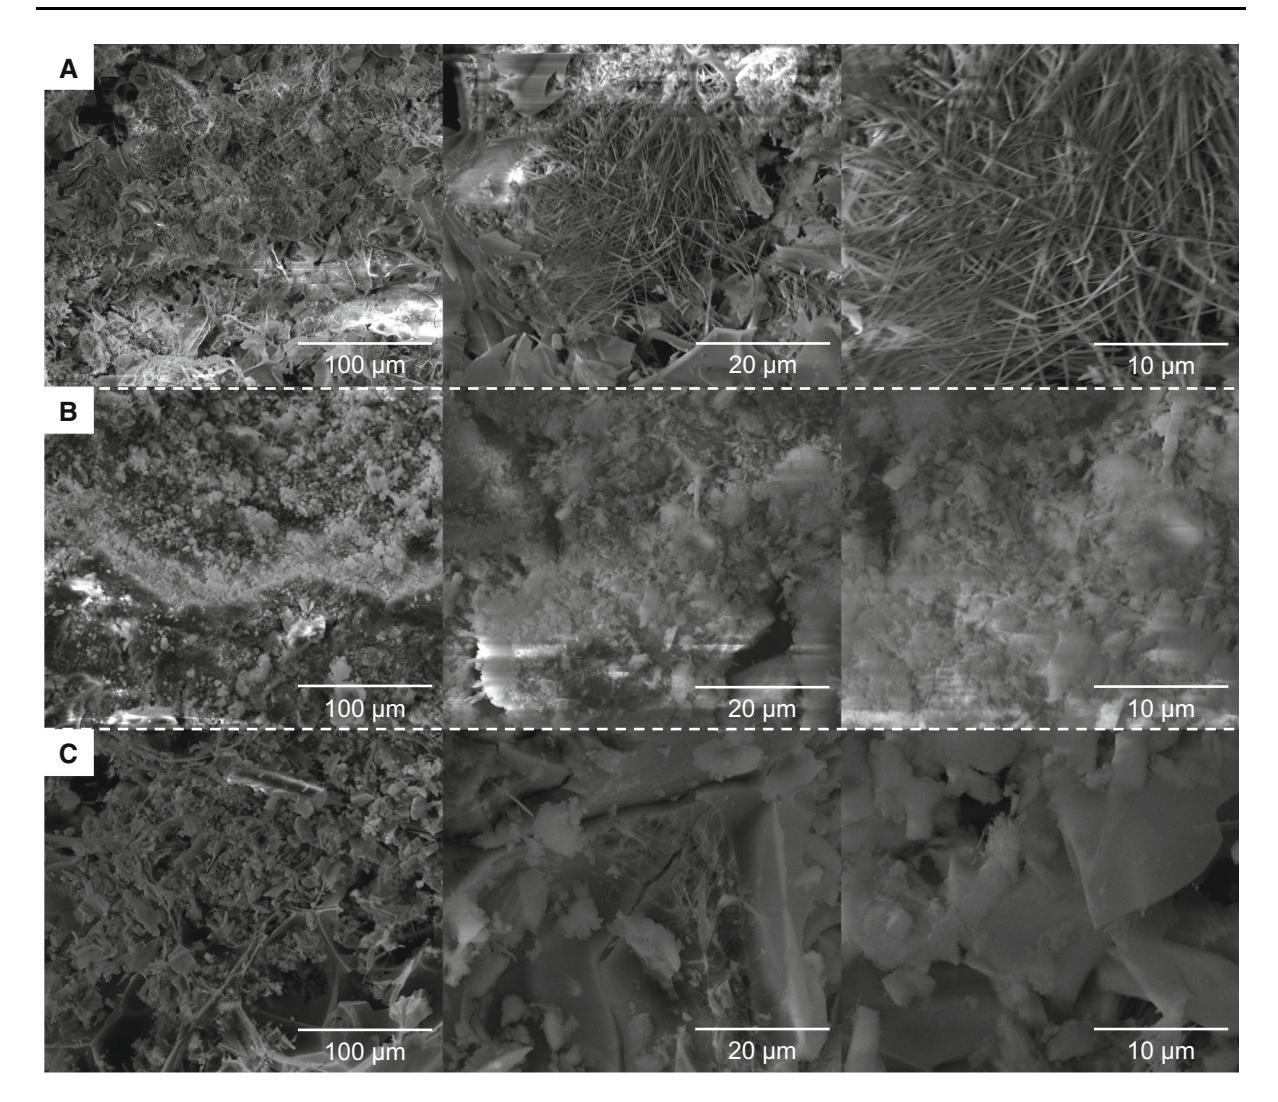
Fig. 3 SEM images showing morphology of boards A, B and C

Figure 3 shows the morphology of boards A, B and C on fractured surfaces at magnifications of 1000, 5000 and 10,000. Due to the quantity of wood fibres, perlite and other possible fillers, interpretation is not as straightforward as it would be for pure magnesium oxychloride cements. Board A has pockets of well-defined needle-like structures which are more easily seen at higher magnification. These needles are 5-phase and are interlocking which contributes to the strength they provide [45, 46]. Tan et al. [47] reported that the addition of phosphoric acid resulted in a matrix with more needle like crystals on the fracture surface. It was not possible to identify needle like

structures in boards B and C. This could be related to the phosphorus content of board A in relation to B and C (Table 2). Huang et al. [48] also agrees that the addition of phosphoric acid results in a well crystallised needle shaped 5-phase. Chen et al. [49] reported that 5-phase can also appear as plate-like crystals similar to those observed in board C. The morphology observed in board B appears similar to that of magnesite [17, 50].

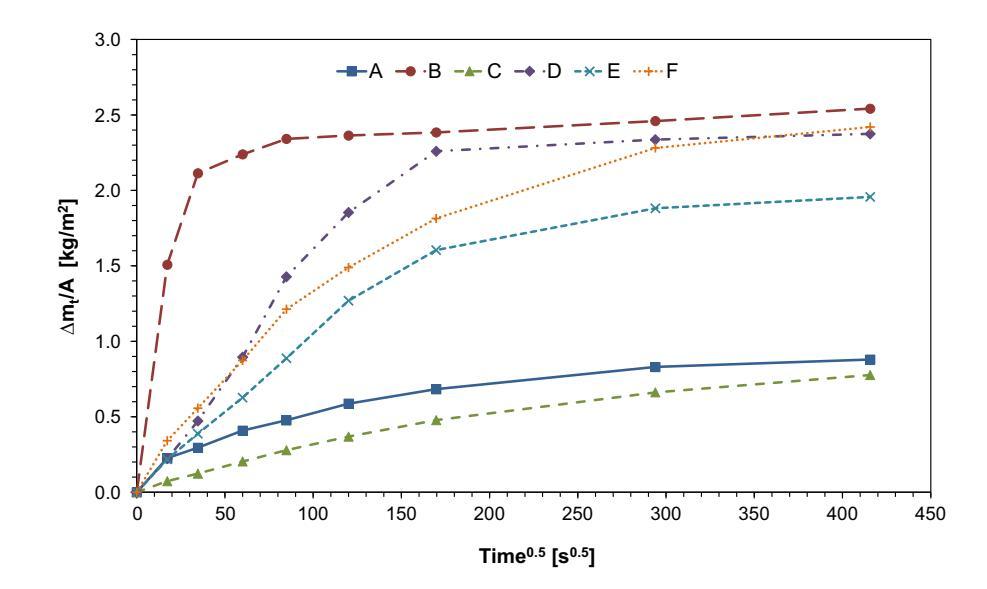
Fig. 4 Water absorption by partial immersion—change in mass over surface area against square root of time

During 48 h of water absorption by partial immersion the mass change was recorded at various intervals. Figure 4 shows the mass change per area for each board over time as per the guidelines in BS EN ISO 15,148 [39]. By 48 h the mass of each board had generally stabilised indicating they had reached complete saturation. Board B absorbed water much faster than any of the other boards with much of its mass increase observed in the first 20 min. Boards D, E and F absorbed water more slowly but eventually absorbed a similar amount of water as board B. On the other hand, boards A and C absorbed much less water and at a lower rate.

According to the classification in BS EN ISO 15,148 [39], the graph for each sample will be type A or B and the water absorption coefficient (A_w) is calculated accordingly (Table S1). Boards A and C exhibited the best performance, with a water absorption coefficient of 0.0028 and 0.0026 kg/m² \cdot s^{0.5}, respectively. The water absorption coefficient for boards D, E and F was approximately 3 to 4 times larger $(0.0093-0.0132 \text{ kg/m}^2 \cdot \text{s}^{0.5})$. While the water absorption coefficient was much larger for board B $(0.0350 \text{ kg/m}^2 \cdot \text{s}^{0.5})$. It is worth noting boards E and F were thicker than each of the other boards (Table 1) meaning the sample volume was larger and therefore more space was available for water to be absorbed. These results indicate that board B is much more susceptible to water ingress than each of the other boards and is in agreement with the water impermeability test (Table 5). Findings also indicate that boards A and C absorbed the least amount of water and are the most resistant to the uptake of water. Boards A

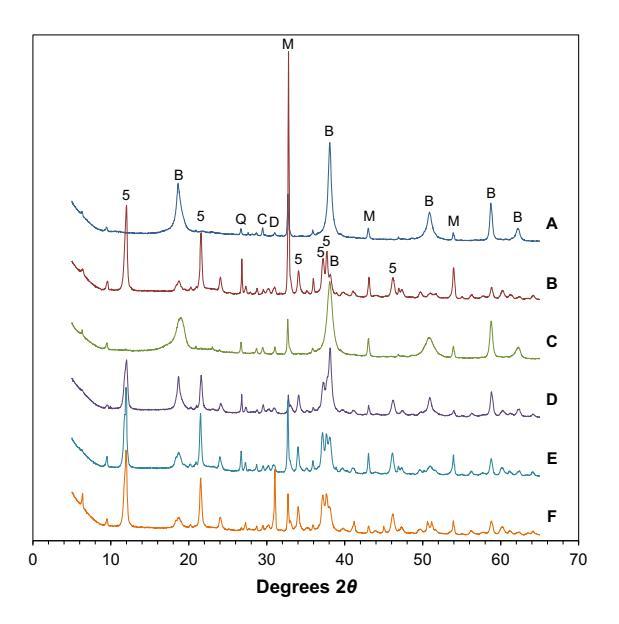
Fig. 5 XRD patterns of each powdered sample following 24 h in water. 5 5-phase magnesium chloride hydroxide hydrate, B brucite, M magnesite, Q quartz, C calcite, D dolomite

The mechanism of crying has been investigated by accelerated board deterioration and observing board performance in environments with different levels of moisture available. Three different methods of accelerated ageing have been employed. The first method used was assessment of powdered samples, which were agitated in water for 24 h. The samples were finely ground, thus increasing surface area to volume ratio. Figure 5 shows the XRD patterns of the powdered samples following exposure to water for 24 h. There is a significant reduction in the quantity of 5-phase and there is a significant increase in the presence of brucite. The magnesite, quartz and calcite remain relatively unaffected. A similar trend was observed for each board. The only difference was how much of the 5-phase mineral had broken down after 24 h. For boards A and C the 5-phase mineral was completely broken down whereas for the other boards some 5-phase still remained. This is due to the testing procedure undertaken and not relevant to boards experiencing RH in-service. It is expected that continual breakdown occurred for boards A and C due to the lower pH of their water solution (Table 6), allowing the continuation of ion transfer between powdered board sample and water solution. In the case of boards B, D, E and F the pH of the water solution

was slightly higher which meant the water solution and powdered boards were in equilibrium and further ion transfers and breakdown of 5-phase were limited. It is stressed that this procedure is not relevant to real life exposure as wall boards are not submerged into a fixed volume of water in-service and the samples used were fine powder. However, this procedure was used to force the breakdown to occur in order to gain a better understanding of the process of chemical

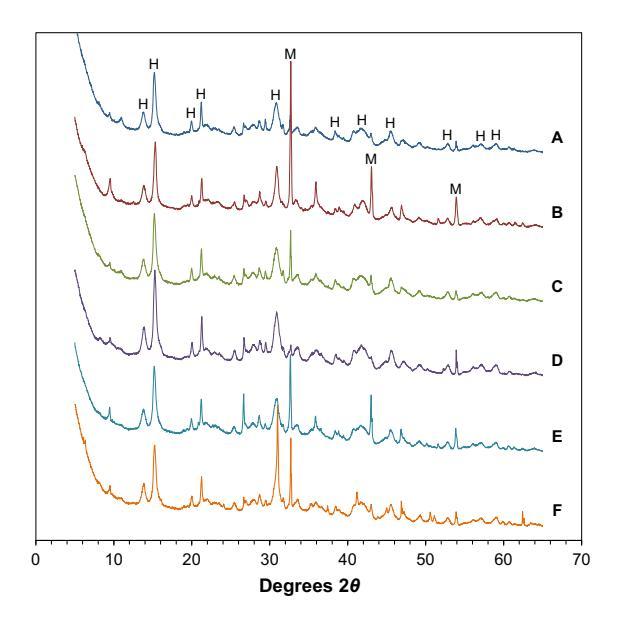
Fig. 6 XRD patterns of each powdered sample following 40 weeks at 90% RH. *H* hydromagnesite, *M* magnesite

The second method of accelerated deterioration employed was the exposure of powdered samples to a temperature of 23 °C and RH of 90% for 40 weeks. Figure 6 shows the XRD pattern of each sample following exposure. For each sample, 5-phase and brucite are no longer present and hydromagnesite (4MgCO₃·Mg(OH)₂·4H₂O) had formed instead. The mechanism is slightly different than that for the powders exposed to water for 24 h. Hydromagnesite has formed due to the carbonation of 5-phase and the breakdown of MgCl₂. As shown in the formula below, the formation of hydromagnestite following the carbonation of 5-phase results in free water molecules and Mg²⁺ and Cl⁻ ions which could become dissolved in solution, forming a potential crying liquid containing Cl⁻ ions:

was broken down allowing the formation of other minerals which contain less water molecules. Therefore, this transformation of 5-phase to hydromagnesite could also easily account for the failures observed in Denmark. Whilst this method is useful to understand the mechanism of change when samples are exposed to high RH, it is not relevant to the performance of these particular boards in-service because the samples were powdered to accelerate their deterioration. Therefore, the third method of accelerated ageing will assess the performance of individual boards in a more realistic in-service environment.

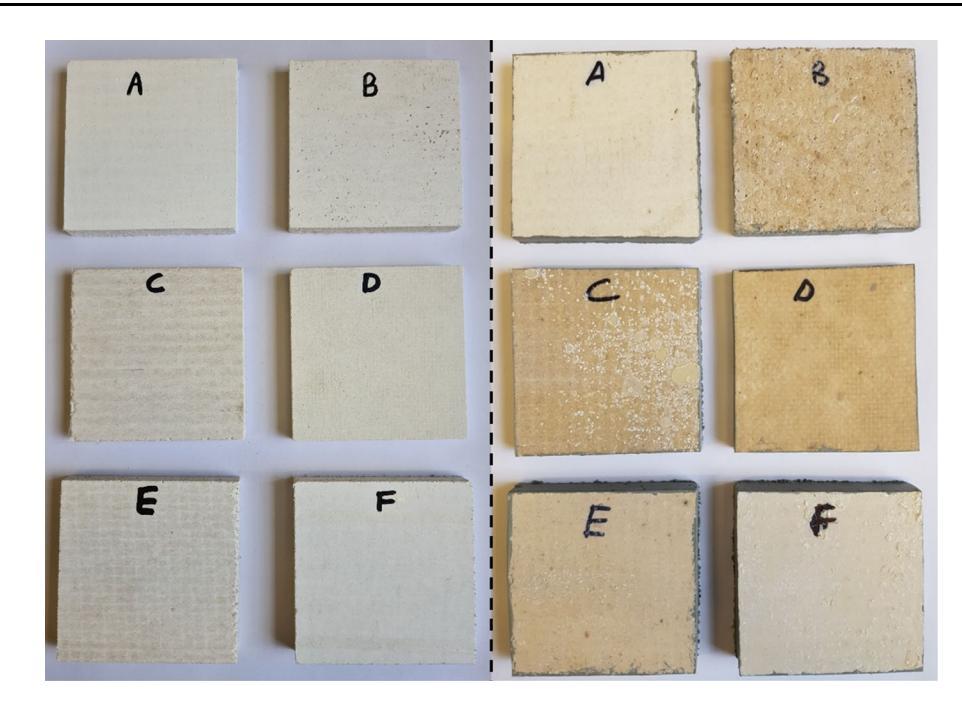
Fig. 7 Photograph of each board unexposed (left) and following 60 weeks exposure to 90% RH (right)

To obtain a more realistic understanding of how the different boards may perform in-service a third method of accelerated ageing was employed. This involved a crying test on sections of each board exposed to a temperature of 30 °C and 90% RH. This test is more representative of in-service conditions than the previous tests carried out on powders and provides insight into the performance of different boards when exposed to high RH in-service. The crying time for each board is shown in Table 7. Boards B and C were observed to have cried by 11 days whilst boards F and E cried after 28 and 57 days, respectively. After 60 weeks boards A and D had not displayed any signs of crying. Figure 7 shows a photograph of each board after 60 weeks exposure, unexposed samples are also shown for comparison. Boards B, C, D and E have adopted a yellowish/brown colour whereas A and F remain almost white. There is a visible white deposit on the surface of boards C and F which was found to be the dypingite form of magnesium carbonate hydroxide hydrate. It is similar in structure to hydromagnesite, except it contains one additional water molecule.

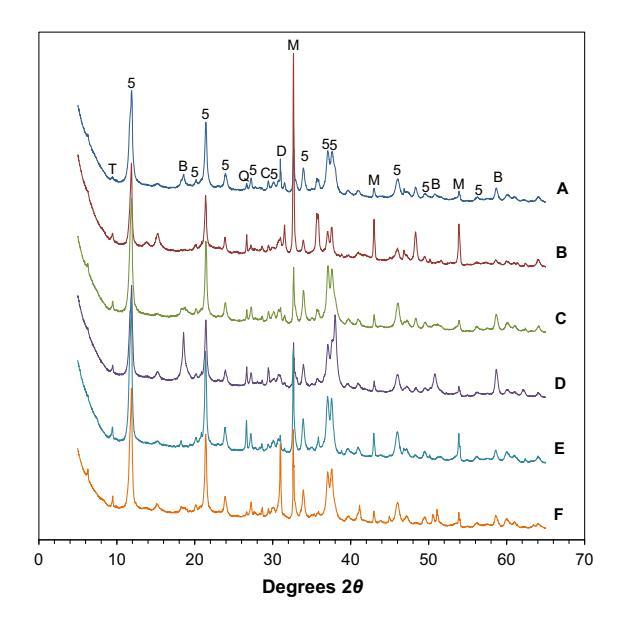
Fig. 8 XRD patterns of each board sample after exposure to 30 °C and 90% RH for 60 weeks. 5 5-phase magnesium chloride hydroxide hydrate, *B* brucite, *M* magnesite, *Q* quartz, *C* calcite, *D* dolomite, *T* talc

dolomite meaning insufficient MgO was available to react with all of the MgCl₂ present. It is interesting to note that these are the boards which also displayed crying. Boards A and D which did not cry had more

brucite initially, indicating that all of their MgCl₂ had reacted with MgO and surplus MgO was left over and formed brucite. This means it is unlikely boards A and D had any unreacted residual MgCl₂ available to go into solution and present as crying.
