The Preservation of Historic Barns

Preservation Briefs

20

Michael J. Auer

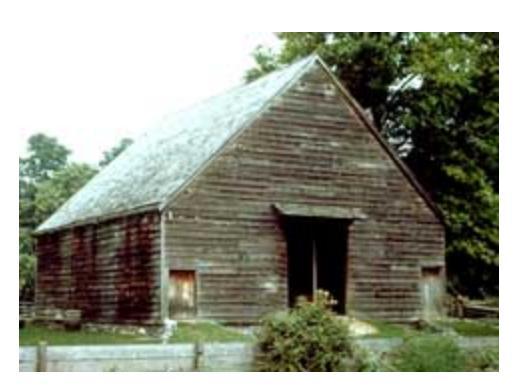
A gable roof, center wagon doors with pent roof, stock door at the corners, and horizontal clapboarding are all typical features of the Dutch barn. Photo: S. Matson.

On the narrow end the Dutch barn features center doors for wagons and a door to the stock aisles on one or both of the side ends. A pent roof (or pentice) over the center doors gave some slight protection from the elements. The siding is typically horizontal, the detailing simple. Few openings other than doors and traditional holes for martins puncture the external walls.⁽³⁾ The appearance is of massiveness and simplicity, with the result that Dutch barns seem larger than they actually are.

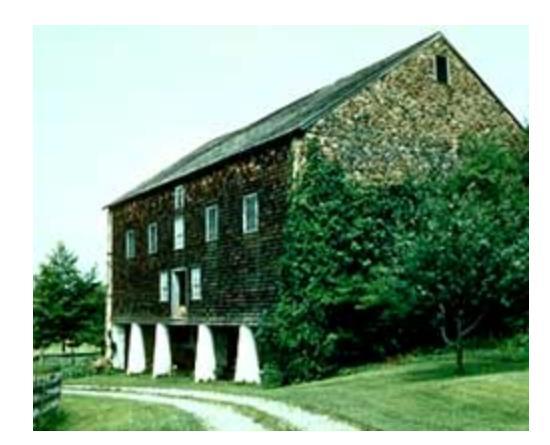
A gently sloping roadbed shows the "bank," from which bank barns get their name. Photo: NPS files.

The bank barn gets its name from a simple but clever construction technique: the barn is built into the side of a hill, thus permitting two levels to be entered from the ground. The lower level housed animals, the upper levels served as threshing floor and storage. The hillside entrance gave easy access to wagons bearing wheat or hay. (Fodder could also be dropped through openings in the floor to the stabling floor below.) The general form of the bank barn remained the same whether it was built into a hillside or not. Where a hill was lacking, a "bank" was often created by building up an earthen ramp to the second level.

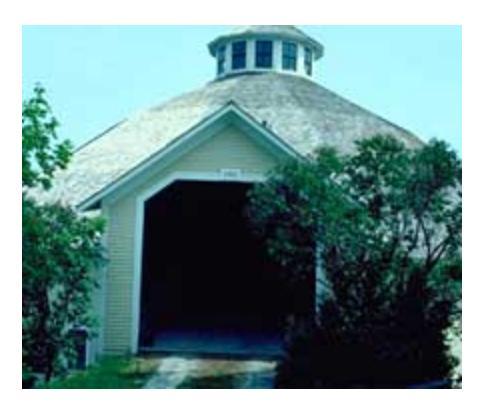
Circular barns are found throughout the country. This round barn, dated 1910, is in Vermont. It is 80 feet in diameter. Photo: Jay White.

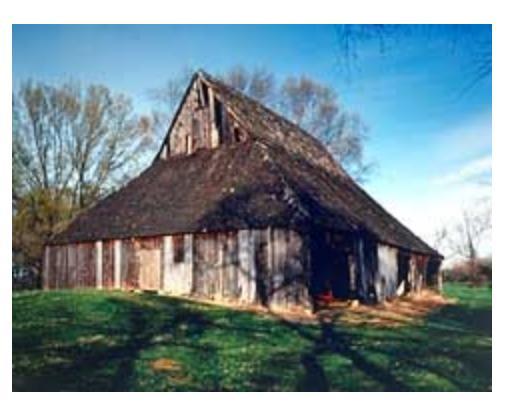
This 19th century tobacco barn, characterized by its steep gable-on-hip roof, is located in Prince Georges County, Maryland. Photo: Jack E. Boucher, NPS.

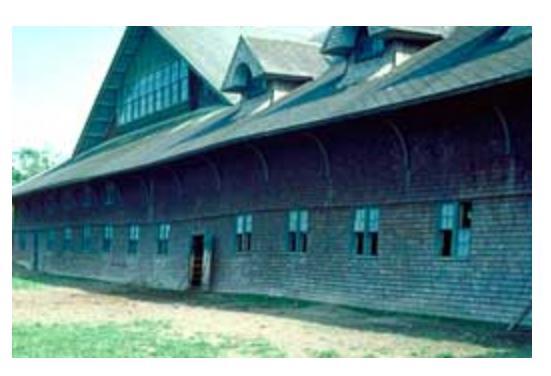
This enormous late 19th century barn in Shelburne, Vermont, displays a complexity and sophistication of roofing elements. See interior, below. Photo: NPS files.

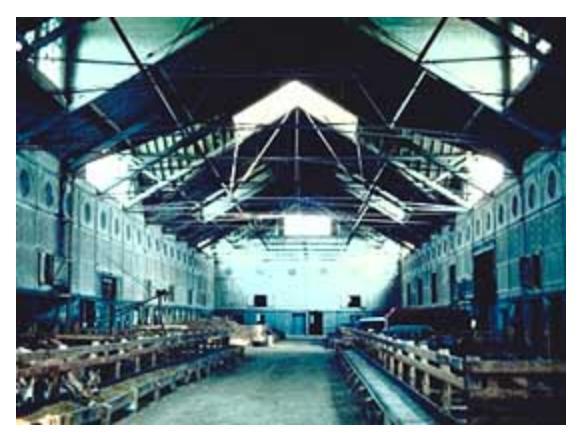
The interior of the barn in Shelburne, Vermont, is a magnificent space that included an overhead hay loft with tracks that allowed workers to drop hay to the floor below. Photo: NPS files.

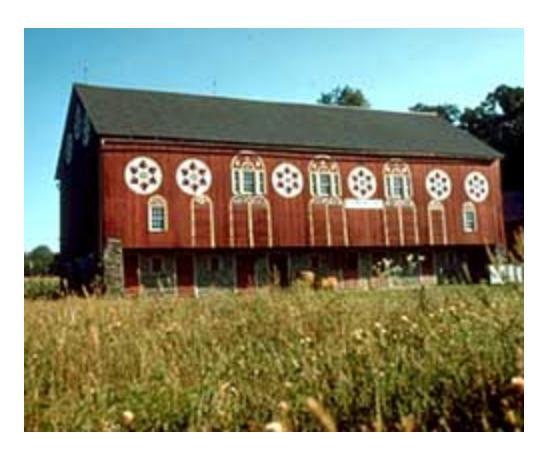
Hex signs are among the wide range of decorative elements found on American barns. Photo: NPS files.

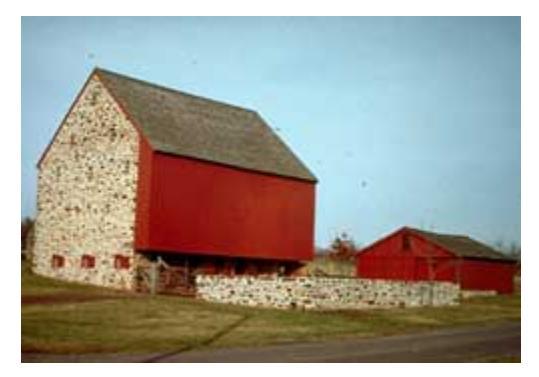
This well-maintained late 18th century barn is located in Worcester, Pennsylvania. Note the use of indigenous stone in the structure and surrounding fencing. Photo: Robert McCullough.

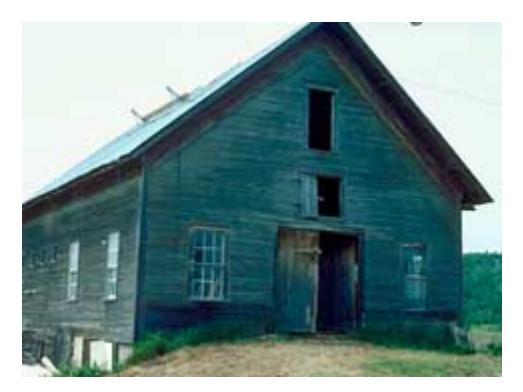
This horse barn, ca. 1875, is in Stowe, Vermont. Its cupola has been removed for repair. Photo: NPS files.

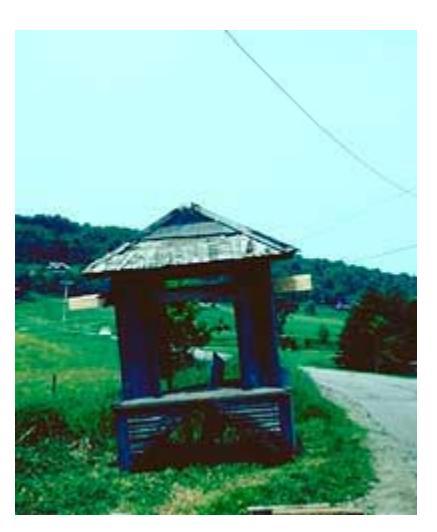
This cupola will be repaired and returned to the horse barn roof (see photo, above). Photo: NPS files.

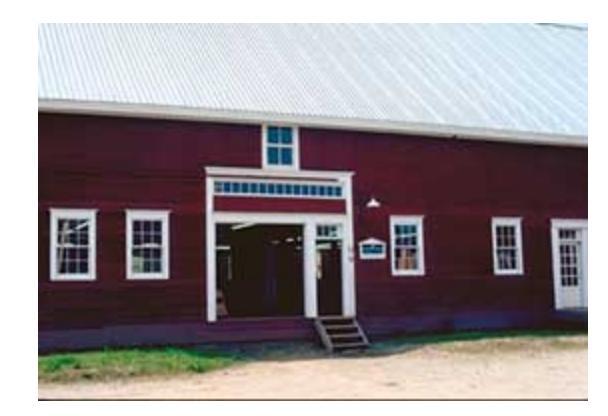
This historic barn was successfully converted into a furniture factory. Photo: NPS files.
