16 Preservation Briefs

National Park Service
U.S. Department of the Interior

The Use of Substitute Materials on Historic Building Exteriors

Sharon C. Park, AIA

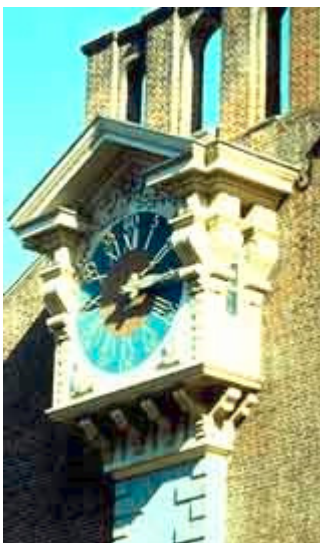
In the reconstruction of the clock tower at Independence Hall, the substitute materials used were cast stone and wood with fiberglass and polyester bronze ornamentation. Photo: NPS files.

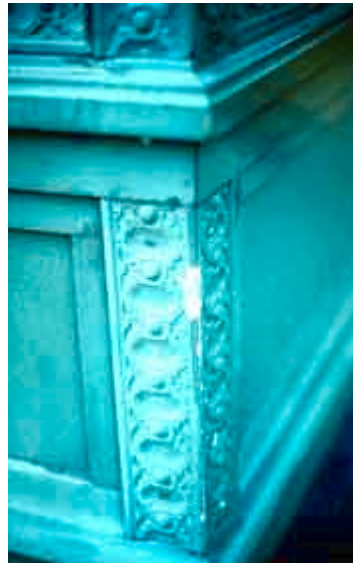
Substitute materials need to be located with care to avoid damage. The fiberglass column base has chipped, whereas the historic cast iron would have remained sound. Photo: NPS files.

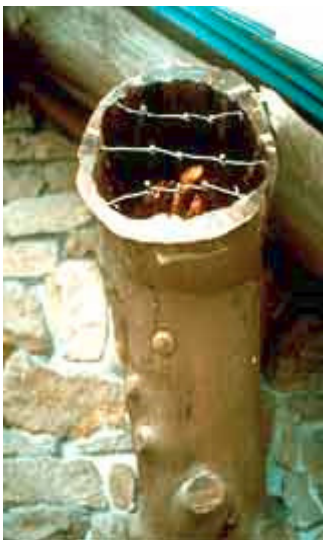
The core of a deteriorated wood outrigger was first drilled out. Photos (left and right): Courtesy, Harrison Goodall.

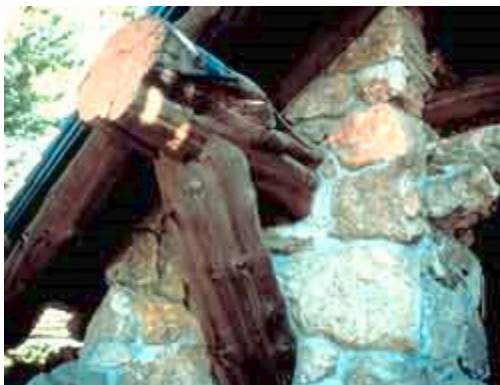
An inert material was injected into the hollow outrigger, permitting the outer wood to be retained and preserved.

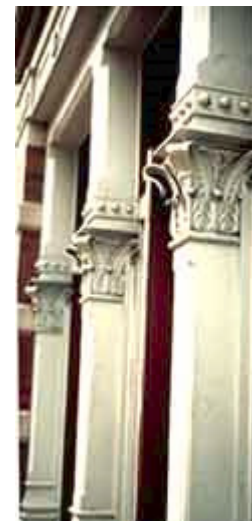
Cast aluminum has been used as a replacement material for cast iron. Photo: NPS files.

Application: Cast aluminum can be a substitute for cast iron or other decorative elements. This would include grillwork, roof crestings, cornices, ornamental spandrels, storefront elements, columns, capitals, and column bases and plinth blocks. If not self-supporting, elements are generally screwed or bolted to a structural frame. As a result of galvanic corrosion problems with dissimilar metals, joint details are very important.

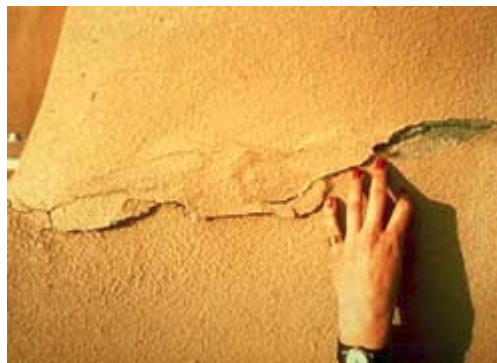
A waterproof coating is an inappropriate substitute material to apply to adobe as it seals in moisture and may result in spalling. Photo: NPS files.

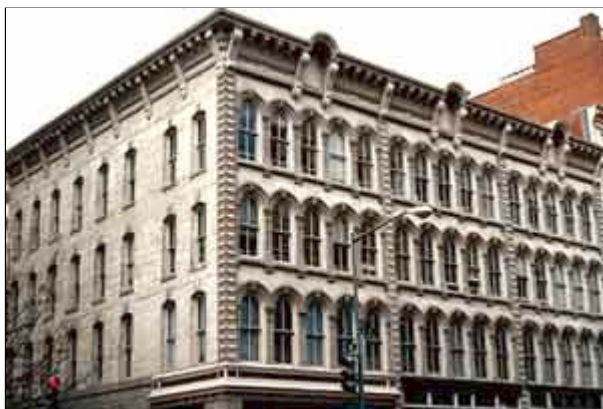
The historic cornice was successfully replaced with a fiberglass cornice. Photo: NPS files.
