Vinyl Siding Distortion

Instances of vinyl siding distortion have been reported along with questions related to how it occurs. This bulletin provides information related to a study and analysis conducted by Cardinal Glass Industries along with general recommendations on how to avoid vinyl siding distortion.

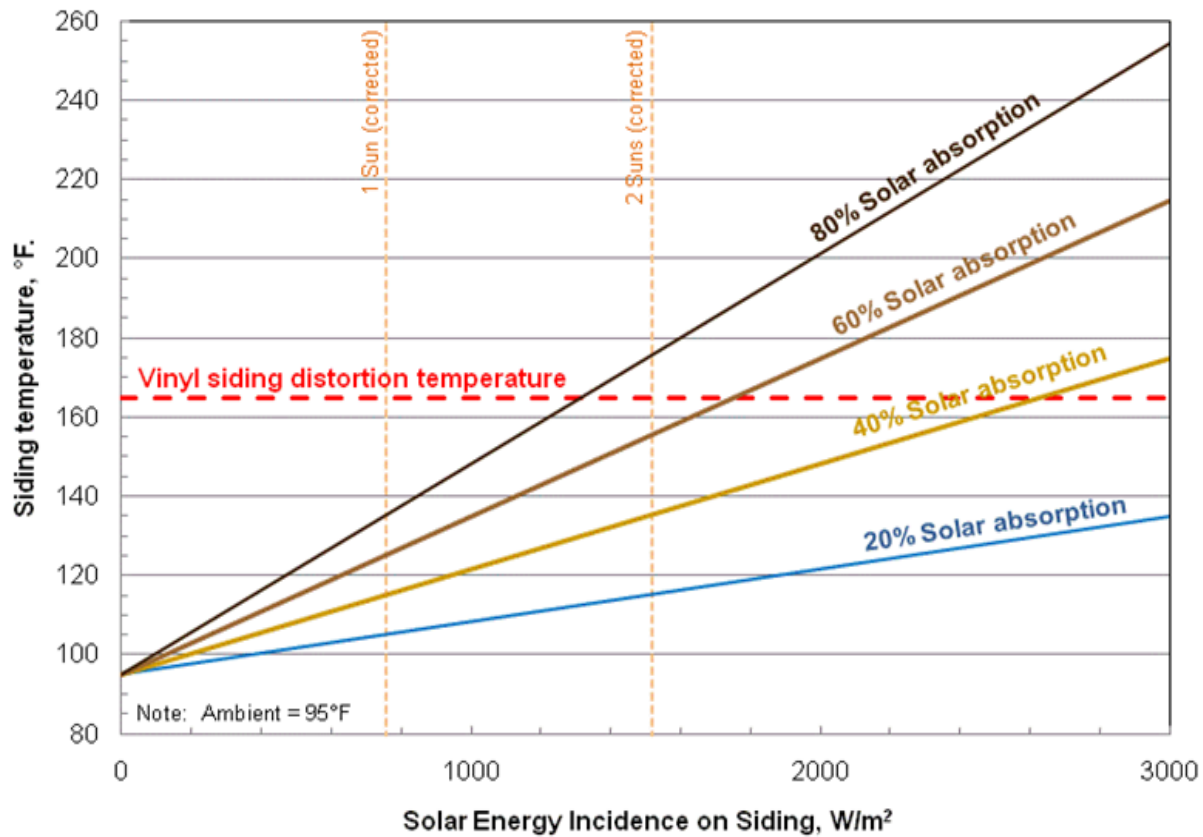
Figure 1. Temperature vs. Solar Irradiance

There is a direct correlation between vinyl siding solar absorptance and the heating of the vinyl siding above the ambient air temperature. Figure 1 shows surface temperature versus solar irradiance for four vinyl siding products at various solar absorptances. (Clear, non-windy day, with an ambient air temperature of 95 °F)

½ Sun	1 Sun	1-1/2 Suns	2 Suns
Partly cloudy	Clear sunny day	Clear sunny day + ½ sun material reflection	Clear sunny day + 1 sun material reflection

With no sun on the siding, the vinyl siding temperature is the same as the ambient air temperature. At 20% and 40% solar absorptance, vinyl siding is able to withstand greater exposure to solar irradiance before distorting, than darker vinyl siding at 60% and 80% solar absorptance.

Current testing requirements for the vinyl siding industry are per ASTM D3679, *Standard Specification for Rigid Poly (Vinyl Chloride) (PVC) Siding*. This standard specification has a maximum test level of 120 °F. This is significantly below the temperature that vinyl siding can experience when exposed to direct sunlight. See Figure 1.

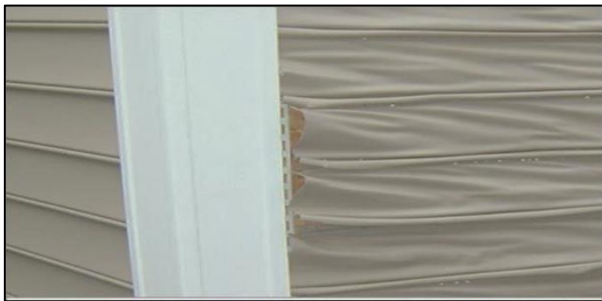
Figure 2. Vinyl Siding Distortion

All plastics relax at their glass transition temperature. Vinyl siding tends to shrink above this temperature. Consequently, when vinyl siding is heated to its glass transition temperature after installation, the frozen-in strains relax, creating buckling and wrinkles as shown in Figure 2. The figure also demonstrates how white vinyl products (with a lower absorptance) perform better when exposed to the same solar energy. Notably, the white vinyl corner shown in Figure 2 has not distorted, while the adjacent darker siding has visibly distorted.

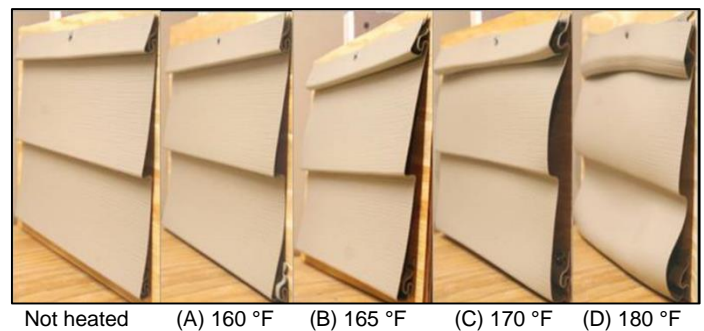
Figure 3. Vinyl Siding Heated for One Hour

Modulus refers to a material’s rigidity or stiffness. All plastics are subject to a time-temperature superposition principle that can be used to predict the behavior of the plastic over time. Like other plastics, the modulus of vinyl siding is time and temperature dependent. Figure 3 shows the appearance of PVC vinyl siding specimens (0.038 inch thick) after being heated for one hour in an oven at four different temperatures (160 °F, 165 °F, 170 °F and 180 °F). After one hour of exposure to 165 °F of heat, vinyl siding visibly distorts.

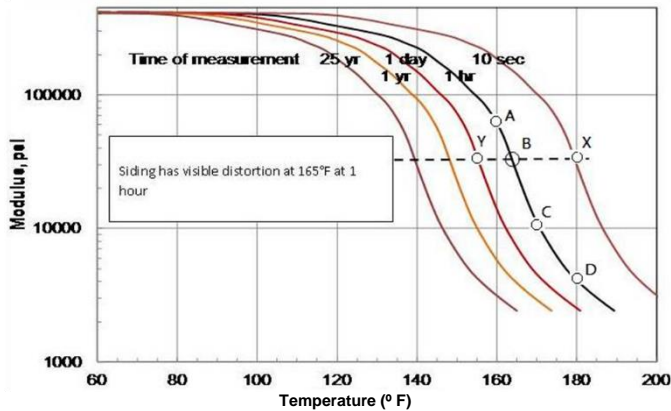
Figure 4. Vinyl Siding Modulus vs. Temperature with Respect to Time

The modulus of vinyl siding (material stiffness and rigidity) is time dependent. The time-temperature superposition principle is used for all plastic materials and Figure 4 above shows the modulus of vinyl siding vs. temperature with respect to time. Plastic materials relax more as the modulus is lower. The vinyl siding product tested relaxed and distorted visibly when subjected to 165 °F for 1 hour as indicated by point “B” in Figure 4.

The information from Figure 4 is further summarized in Figure 5 to demonstrate how the interplay between exposure time and exposure temperature impacts the appearance of the vinyl siding. The exposure over time is cumulative. While the sun’s energy may strike a particular section of vinyl siding only for a short time each day, when repeated on a daily basis, the molecular bonds of the siding are further degraded each day. Therefore, exposure for one hour at 165 °F is equivalent to ten minutes of exposure, repeated for six consecutive days, at 165 °F.

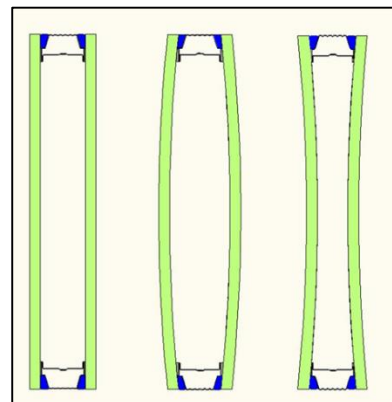
Figure 7. Dynamic Flexing

Figure 7 shows the dynamic flexing of insulating glass lites that may be seen in an insulating glass unit due to temperature and pressure changes in the environment. Most insulating glass units do not flex as much as indicated in the illustration. It is shown for illustrative purposes only.

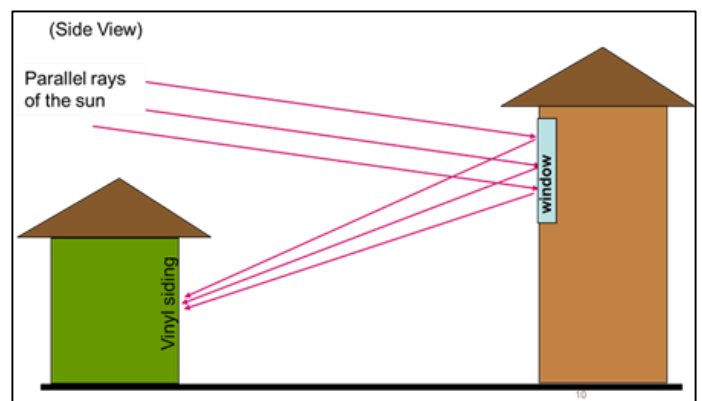
Figure 8. Opposite Wall

Figures 8 and 9 illustrate how the sun’s energy can be reflected off a window or door onto vinyl siding installed on an opposing wall of a neighboring structure (“opposite wall condition”). In this scenario, the solar energy is reflecting off the glass of the insulating glass unit.

When solar energy is reflected off of an insulating glass unit with no or minimal deflection, the resulting reflection stays in relatively parallel lines and does not concentrate. As the amount of deflection increases, the reflected energy becomes more concentrated, resulting in higher temperatures where the light rays converge. As noted previously, some glass deflection is expected due to environmental changes.

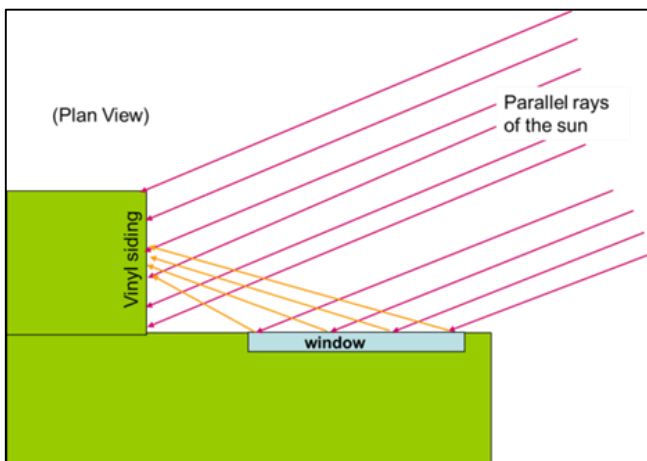
Figure 10. Inside Corner

Figures 10 and 11 illustrate how a vinyl siding clad inside corner can be exposed to solar energy. In this situation, the vinyl siding receives direct exposure to the sun's energy. In addition, sun may reflect off an adjacent glass product at a grazing angle onto the vinyl siding. This results in a near doubling of the solar exposure on the vinyl siding.

The inside corner condition occurs when the sun's rays reflect off a glass product at a very small grazing angle. In this scenario, the solar energy is generally reflecting off the first surface (i.e. outer surface of the exterior lite of glass) of an insulating glass unit. The reflection associated with Figure 11 came from the upper sash of a clear, uncoated dual pane window that did not have a screen on it. Small grazing angle reflections will usually result in the same amount of reflected energy from windows containing a Low-E coating as from windows with clear uncoated glass.

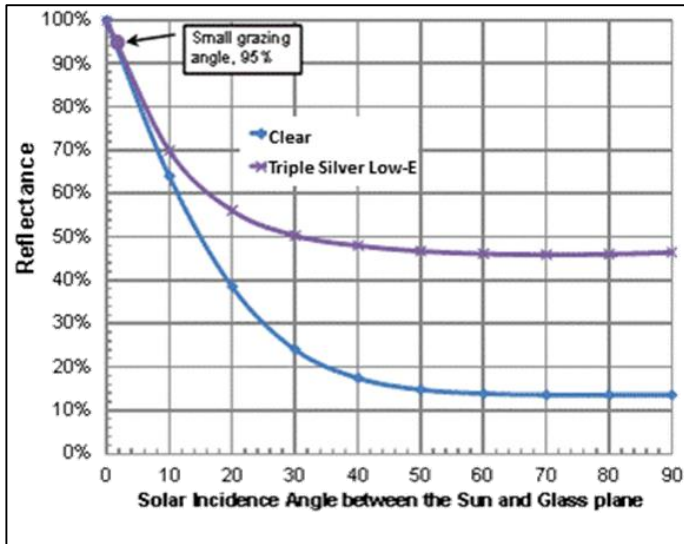
Figure 12. Reflectance at Grazing Angle

At a grazing angle ($<10^\circ$), the reflectance off clear glass is essentially the same as the reflectance off Low-E coated glass. Figure 12 shows how the solar incidence angle between the sun and glass pane impacts the resulting reflectance. As the incidence angle approaches 0° (grazing angle), the reflectance for clear glass and Low-E glass approaches 100%.

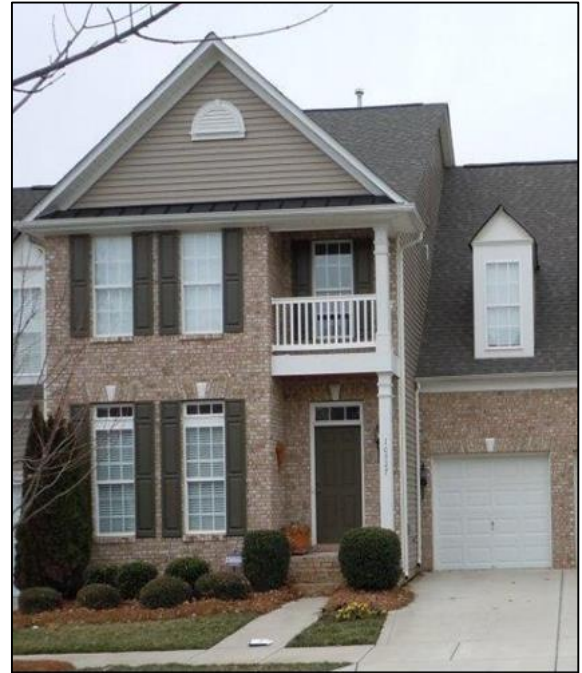
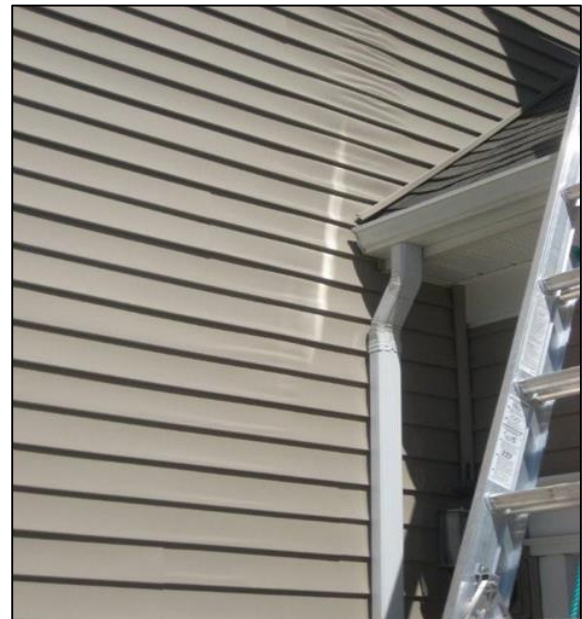
An inside corner condition with vinyl siding distortion was observed during the study of a residential development in North Carolina. Vinyl siding with 65% absorptance was installed throughout the development. The windows in the development contained insulating glass units with two lites of clear glass. Distortion was observed on an inside corner where the vinyl siding was subjected to direct solar energy and energy reflected at a grazing angle off the glass of the upper sash of a single hung window.

Figures 13 and 14 depict the inside corner condition and distortion observed. Note the dark shingles adjacent to the distorted area. The shingles likely contributed to increasing the overall temperature of the vinyl siding through infrared radiation and warm air convection from the hot shingles.

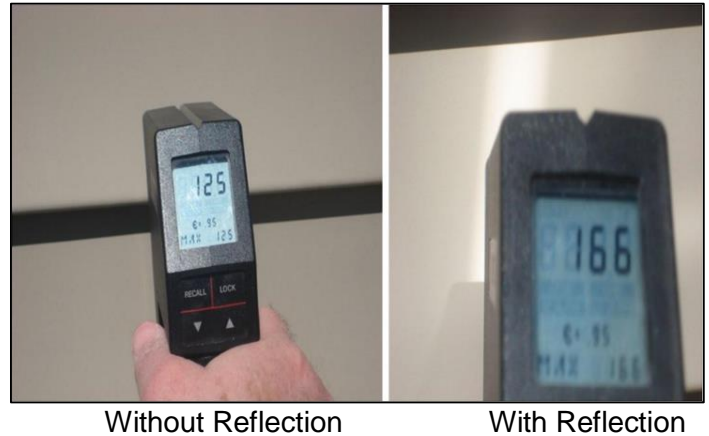
Figure 15. Siding Temperatures

- Outdoor air temperature: 75 °F
- Siding absorptance: 65%
- Thickness of siding: 0.038"
- Color of Siding: Tan
- Angle of siding: 7° from vertical
- Window type: Single hung, no screen
- Glass dimensions: 27" W x 30.5" H
- IG unit construction: 2.2mm clear glass/ 11mm airspace / 2.2 mm clear glass
- Airspace gap reduction: 0.132" (~1/8")
- Glass deflection: 0.066" (~1/16")
- Distance from center of glass (upper sash) to siding distortion: 87" to top of distortion, 116" to bottom
- Other radiating/reflective surfaces: Roof
- Color of the roof: Black
- Solar irradiance on siding without reflectance: 759 W/m² (corrected for 7° slope from vertical wall)
- Solar irradiance on siding with reflectance: >1,766 W/m² (corrected for 7° slope from vertical wall)
- Siding temperature direct sun w/o reflections: 125 °F
- Siding temperature direct sun w/ reflections: 166 °F

Note that these conditions show that the siding temperature can get hot enough to produce visible vinyl siding distortion. The temperature readings are shown in Figures 15.

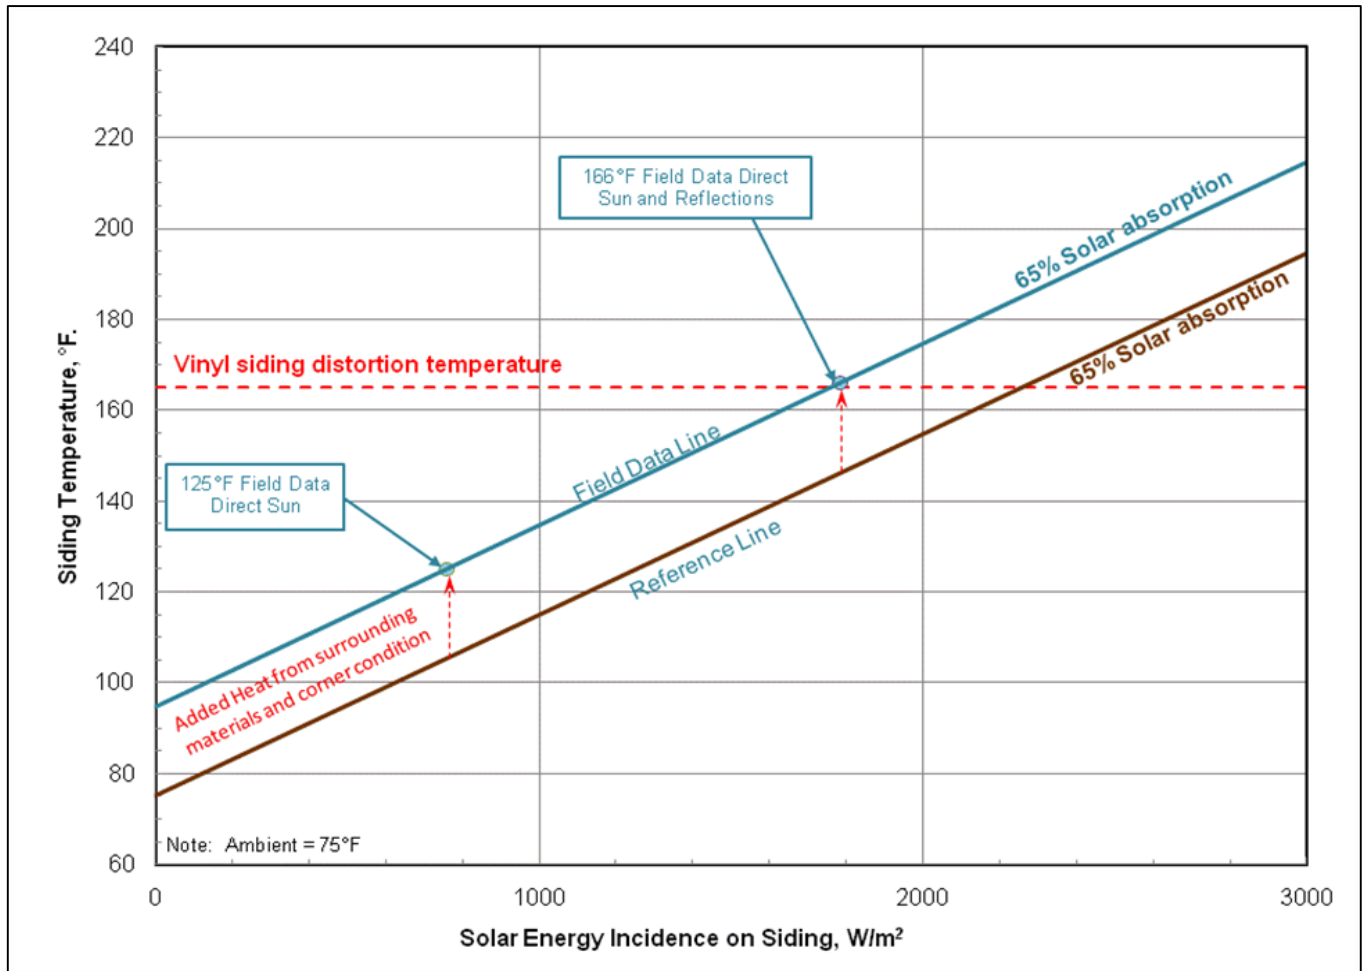
Figure 16. Field Measurements of Siding Temperatures vs. Irradiance

Figure 16 shows the siding temperature versus solar irradiance for a siding with 65% absorptance. Note that there are two plots; one for the field data from the North Carolina project, and one based on projected temperatures from an analysis similar to Figure 1. The higher temperatures in the field data plot can be attributed to the influence of additional heat generated on the siding by the dark shingled roof, reflection of solar energy off of adjacent siding, and the trapping of heat due to the geometry of the inside corner condition. The other plot does not include these other heat sources in the projected temperatures.

In this case, the data shows that at an inside corner condition, with grazing angle reflections from clear glass and adjacent siding, along with additional heat generated from other building materials were conditions present when vinyl siding distortion occurred.
